N238PS — G1000 LOW VOLTS Troubleshooting Guide Aircraft: N238PS

(Diamond DA40NG, MAM40-858) Problem: G1000 NXi displays lower voltage than actual bus voltage, causing intermittent LOW VOLTS annunciations Date: February 2026 Prepared by: Aircraft Owner (Ingram Leedy)

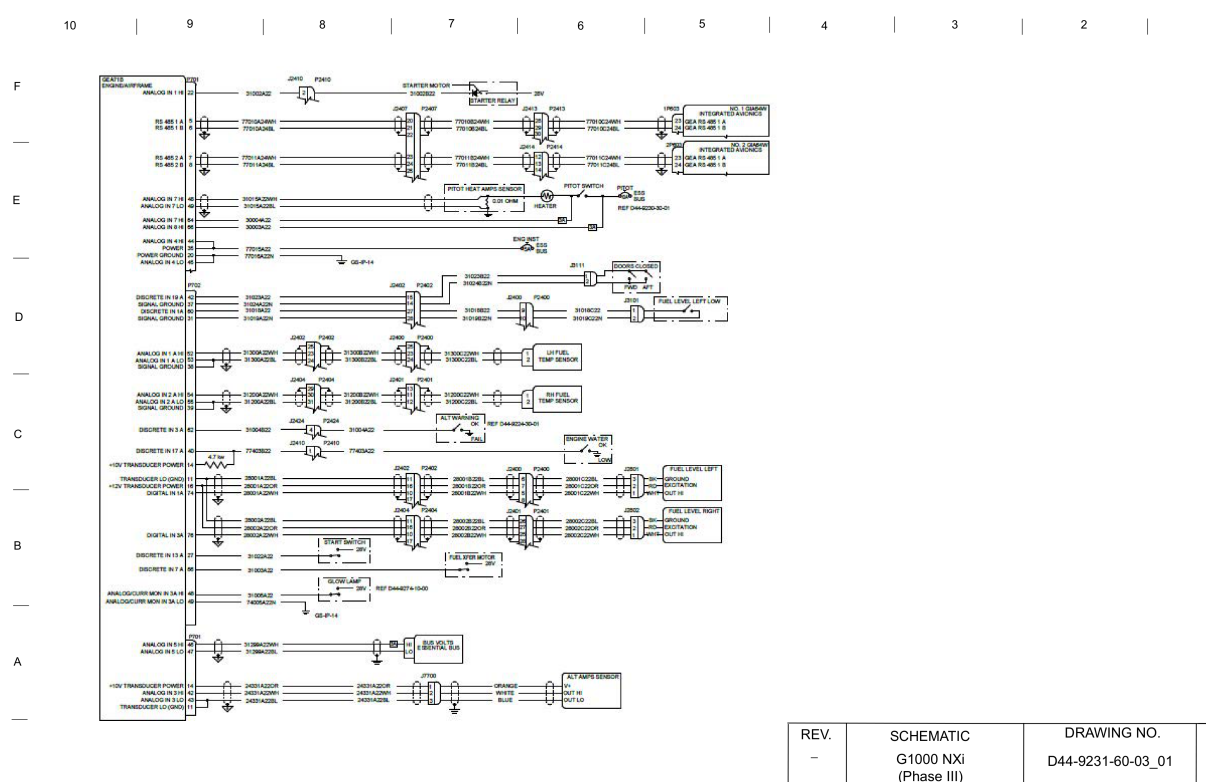
**Figure 6 : GEA 71 / 71B Processor Installation**

GEA 71S senses bus voltage via a dedicated analog input — Pin 46 (ANALOG IN 5 HI) and Pin 47 (ANALOG IN 5 LO), connected to the Essential Bus GEA power: Pin 35 (AIRCRAFT POWER) via wire 77015A22 through the 5A ENG INST breaker Ground reference: Pin 20 (POWER GROUND) via wire 77016A22N to ground stud GS-IP-14 The displayed voltage = what Pin 46 sees on the Essential Bus, relative to the Pin 47/Pin 20 ground reference No software calibration or correction is applied — the G1000 displays exactly what the GEA 71S hardware measures. The offset is a hardware voltage drop, not a calibration or firmware problem. Adjusting the software offset would only mask the symptom — the underlying problem would remain and continue to degrade. [How a Bad Ground Creates a False Low Reading](#) If there's extra resistance in the ground path, current flowing through that resistance creates a voltage drop that only the GEA sees: $V_{\text{displayed}} = V_{\text{actual}} - (I_{\text{load}} \times R_{\text{bad_ground}})$ At 20 amps of avionics load, just 0.05 ohms of extra ground resistance = 1.0 volt of under-reading. That's all it takes. [The Voltage Measurement Path](#) Essential Bus

The GEA 71S grounds through GS-IP-14, which routes through the instrument panel bus bar, IP frame, and fuselage structure to reach the battery negative terminal. Every joint in that chain adds potential resistance. The ECU (located under the pilot's seat) grounds through the GS-RP (Ground Stud — Relay Panel) studs, which use a separate ground path to battery negative. The ECU reads correctly — its ground path doesn't share the instrument panel's bus bar, frame bonds, or GS-IP studs.

- GEA 71S connector P701 — is it fully seated with lock engaged? This is the voltage sensor unit. Check Pin 20 (power ground) and Pin 35 (aircraft power) specifically.
- Ground stud GS-IP-14 — this is where the GEA 71S power ground wire (77016A22N) terminates. Check for loose nut, corrosion, or paint under the ring terminal.
- All GS-IP ground studs on the IP bus bar (see table below) - Look for anything that appears disturbed, loose, or not fully reconnected
