N238PS — G1000 LOW VOLTS Troubleshooting Guide Aircraft: N238PS

(Diamond DA40NG, MAM40-858) Problem: G1000 NXi displays lower voltage than actual bus voltage, causing intermittent LOW VOLTS annunciations Date: February 2026 Prepared by: Aircraft Owner (Ingram Leedy)

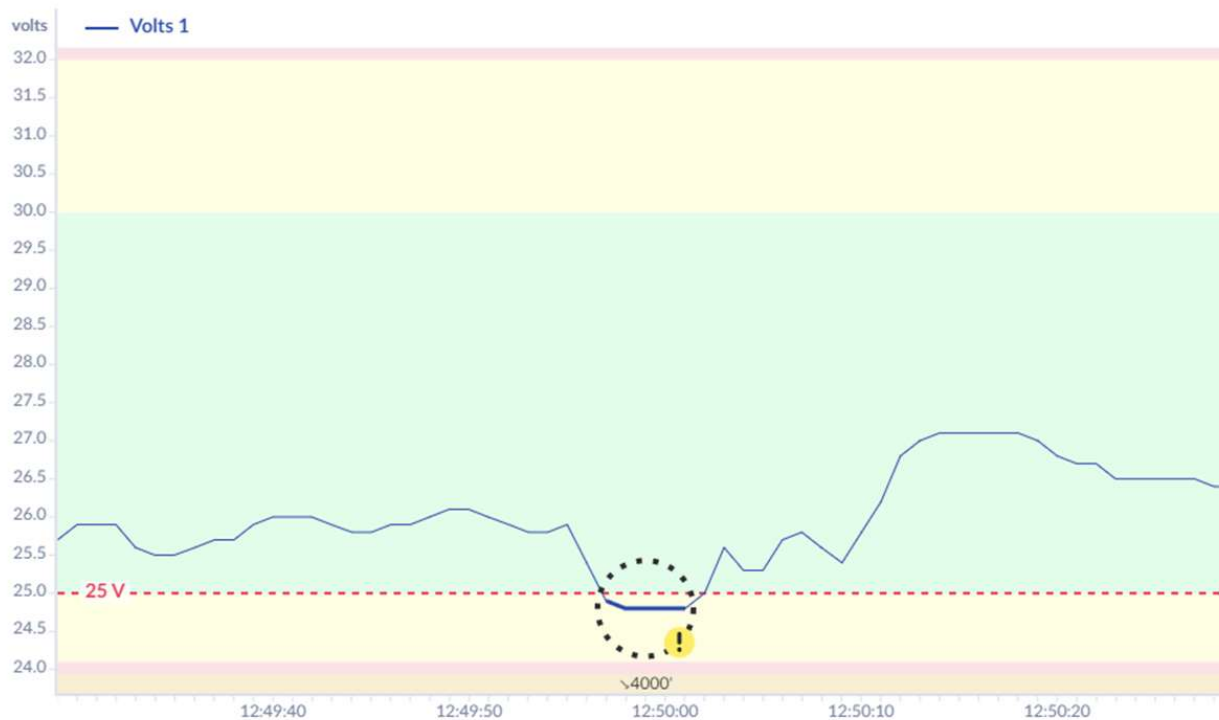
Volts < 25 V for 5 sec

dips are not real — the independent VDL48 logger shows the bus voltage is steady at ~28V during these same periods. The G1000 is the only instrument seeing these drops. **How We Know It's Real** Three independent
