# N238PS — G1000 LOW VOLTS Troubleshooting Guide

**Aircraft:** N238PS (Diamond DA40NG, MAM40-858) **Problem:** G1000 NXi displays lower voltage than actual bus voltage, causing intermittent LOW VOLTS annunciations **Date:** February 2026 **Prepared by:** Aircraft Owner (Ingram Leedy)

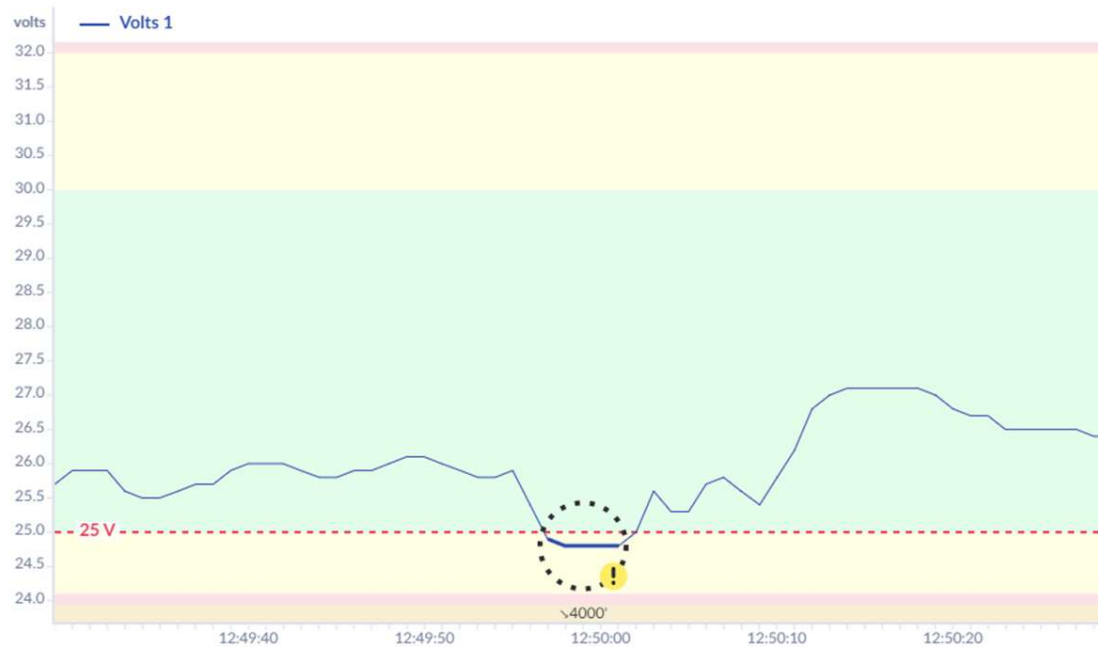
**18 seconds below 25V** — during landing, and **5 seconds below 25V** — at altitude during cruise:

Volts < 25 V for 5 sec

These dips are **not real** — the independent VDL48 logger shows the bus voltage is steady at ~28V during these same periods. The G1000 is the only instrument seeing these drops.

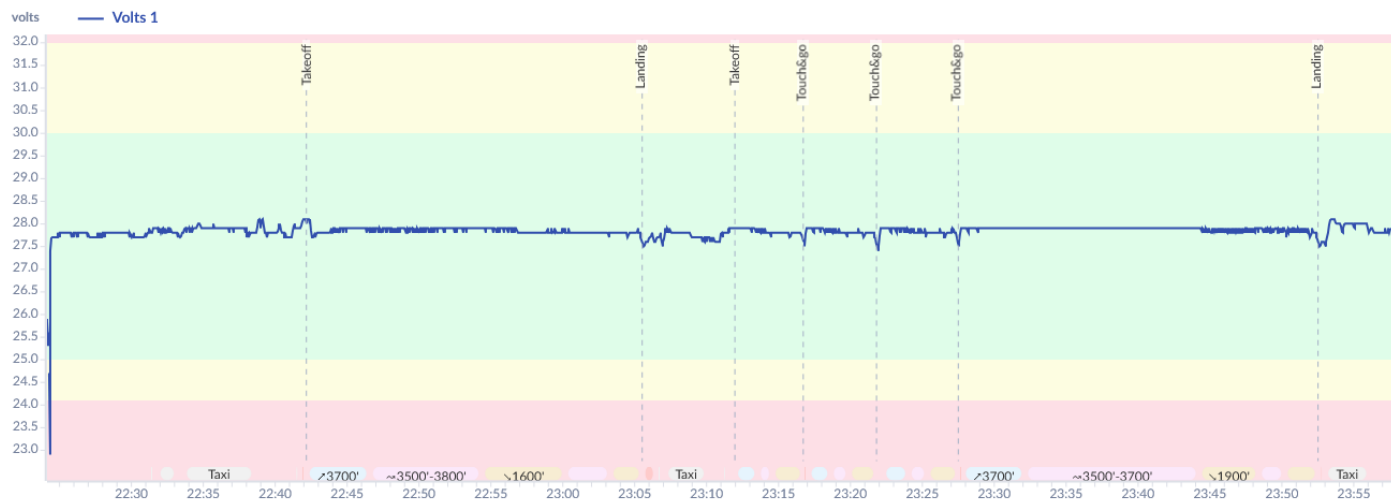
Comparing N238PS to another DA40NG (N541SA) shows something was never right — even from the delivery flight:

N541SA's G1000 reads rock-steady voltage at ~27.8V with barely any fluctuation. N238PS has **never** been this stable:

Even from delivery, N238PS was reading **0.25V low** and had **4–5x more voltage noise** than N541SA. This suggests a marginal ground connection has existed since the factory — the Feb 2024 shop visit then made it significantly worse.

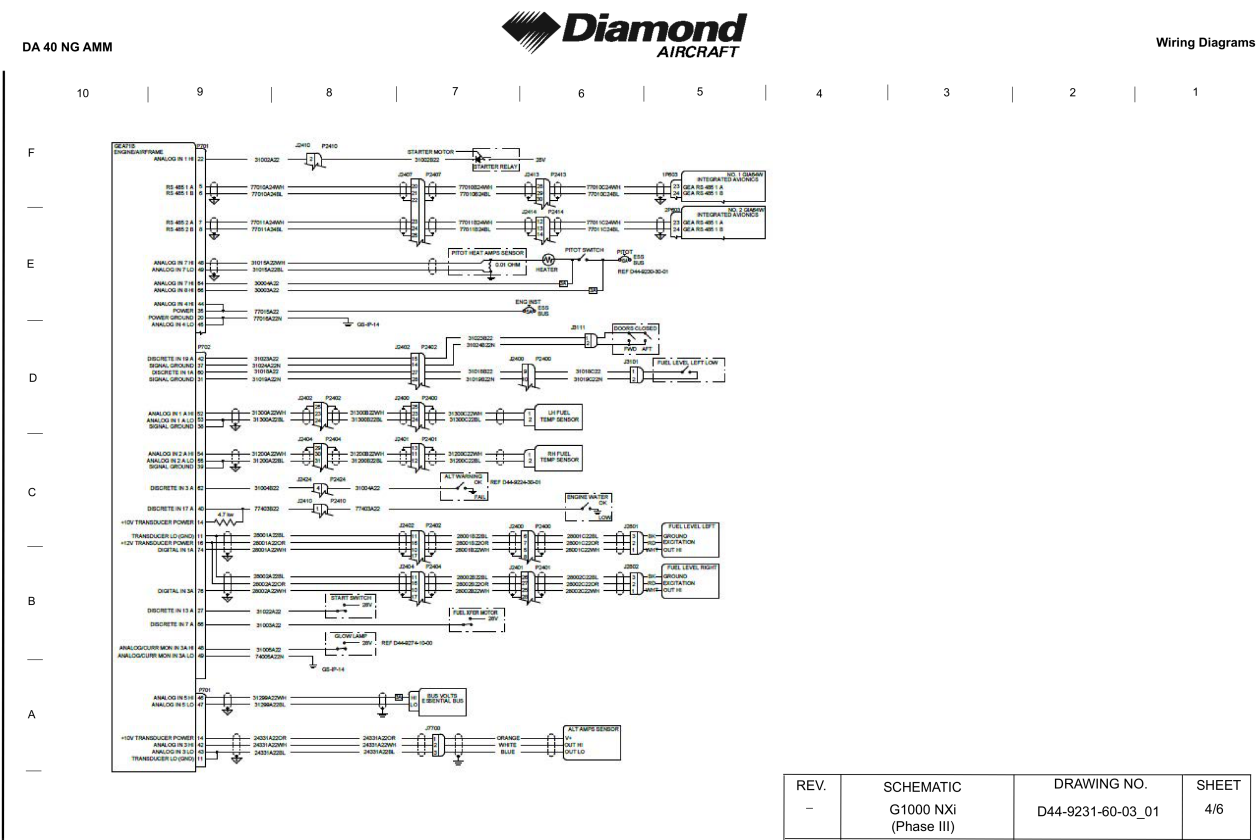
REV.	SCHEMATIC	DRAWING NO.	SHEET
-	G1000 NXi (Phase III)	D44-9231-60-03_01	4/6

- The GEA 71S **senses bus voltage via a dedicated analog input** — Pin 46 (ANALOG IN 5 HI) and Pin 47 (ANALOG IN 5 LO), connected to the **Essential Bus** via shielded wires 31299A22WH/BL. A **3A fuse** protects the HI wire (31299A22WH); its physical location is not identified on the available AMM schematics. This fuse carries essentially no current (high-impedance analog input), so degraded fuse contacts would not cause the observed offset. An open fuse would produce a **0V reading**, not a low reading.

- **GEA power ground:** Pin 20 (POWER GROUND) and Pin 45 (ANALOG IN 4 LO) are connected to each other on wire **77016A22N** → ground stud **GS-IP-14**. Pin 49 (ANALOG/CURR MON LO) via wire **74005A22N** also to **GS-IP-14** (glow lamp circuit, probably unrelated)

- The displayed voltage = what Pin 46 (ANALOG IN 5 HI — voltage sense) sees on the Essential Bus, relative to the GEA's ground reference at Pin 20 (POWER GROUND) and Pin 45 (ANALOG IN 4 LO). Any resistance on ground Pin 20 (POWER GROUND), Pin 45 (ANALOG IN 4 LO), or sense low Pin 47 (ANALOG IN 5 LO) shifts the reading down

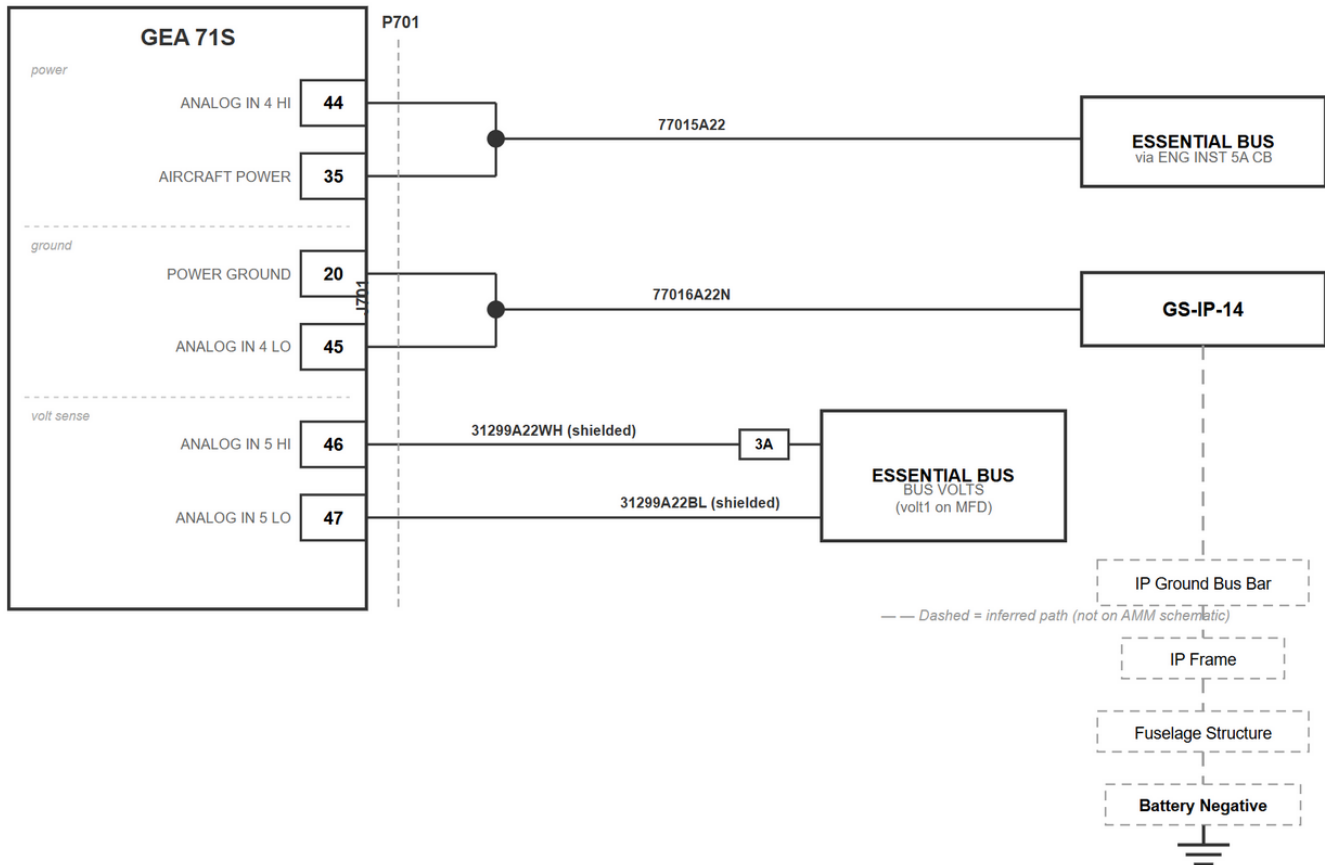
## GEA 71S — Voltage Measurement Path — N238PS (DA40 NG)

Both voltage channels share the same ground reference (Pin 20 (POWER GROUND) / Pin 45 (ANALOG IN 4 LO) → wire 77016A22N → **GS-IP-14**). A high-resistance ground shifts **both** readings down equally.
