# **REPORTABLE INCIDENT REPORT**

**Delphi TVS Technologies Ltd,  
Oragadam**

<b>Department</b>	<b>: Filter Cell</b>
<b>Process / Activity</b>	<b>: Pleating machine -1</b>
<b>Injured person</b>	<b>: T Monish</b>
<b>CC.No</b>	<b>: TIT 1504</b>
<b>Date &amp; Shift</b>	<b>: 29.07.2025 &amp; 2nd shift</b>
<b>Incident Time</b>	<b>: 10.35 PM</b>

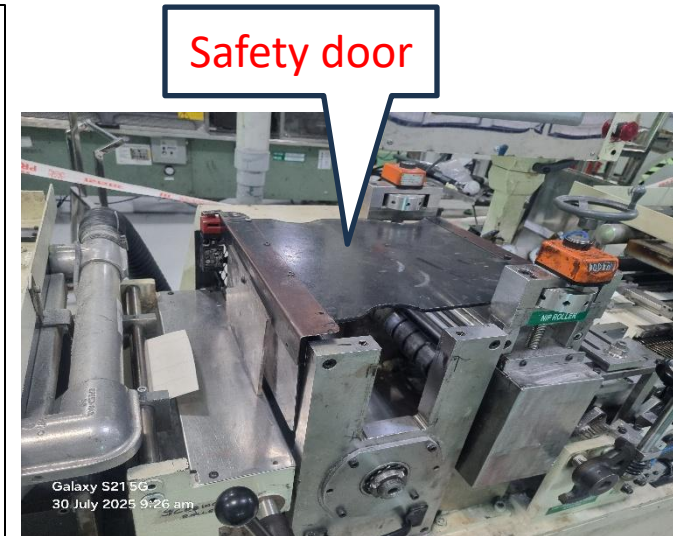
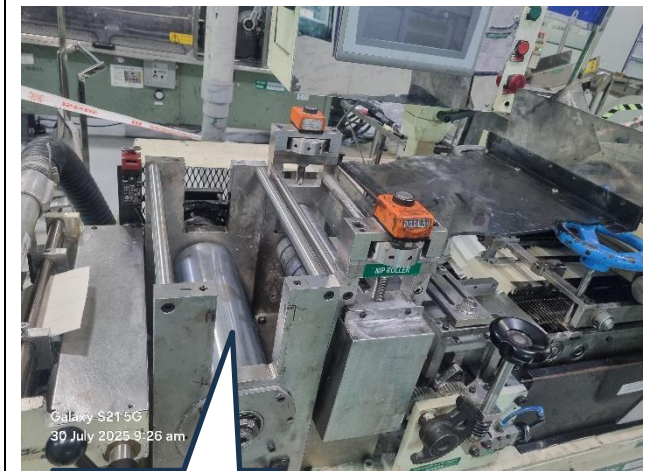
- The running Pleating paper roll emptied
- Trainee loaded new pleating paper roll at the loading point & started feeding to pleating machine
- He found paper struck up (Pop up) inside the roller & removed the paper manually
- Then stopped the pleating roller unit and opened the safety door which was in bye passed condition.
- Trainee tried to insert the paper roll at the pleating roller station manually by switching on the unit simultaneously.
- During the course of this activity, his left hand caught between the pleating rollers and got crush injury in his left index, middle and ring fingers.
- He pressed the emergency button immediately. Upon hearing his noise, the line supervisor and maintenance engineer rushed to the spot and removed the roller manually to free his hand .

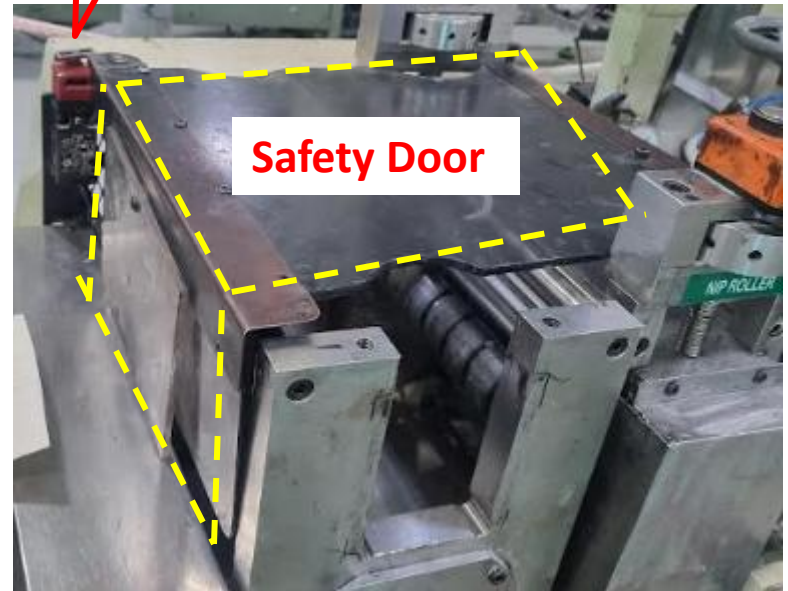
- 1) Pleating Roller safety door switch was found in bye passed condition
- 2) The machine was operated in an unsafe condition; production continued despite the known failure of the safety system by all responsible personnel
- 3) Manual insertion of paper while machine was energized

Safety door switch is not connected with safety door

The operator opened the safety door and inserted his left hand into the running roller. **The safety door switch was in a bypassed condition**

Sl.No	Cause of Accident	Corrective Action	Resp	Status
1	The safety door switch was in a bypassed condition	Install tamper-proof safety interlock switches with bypass detection alarms	Ravikumar	Completed
		Conduct On the Job training to all trainees/freshers and supervisors (with a focus on LOTO and interlocks)	Thiyagarajan	Completed
		Safety FLM gaps to be reviewed by the Supervisors and Managers	Thiyagarajan	Completed
		Review and audit all machines to identify any other bypassed safety systems	Thiyagarajan /Ravikumar	Completed
2	The edges of the running and new paper rolls were not properly joined	Develop and implement SOP for paper roll changeover, including safe methods for feeding	Thiyagarajan	Completed

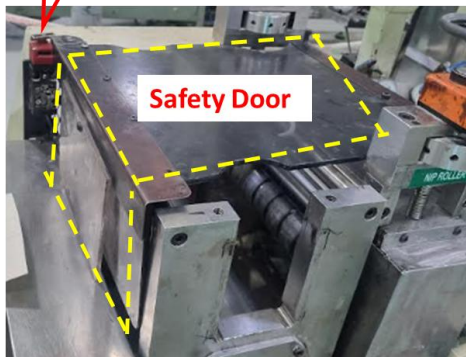
**Safety door switch**

Safety door switch is not connected with safety door

Cause of Accident	Corrective Action
<b>Safety door switch was in a bypassed condition</b>	<b>Installed tamper proof safety interlock switches with bypass detection alarms</b>

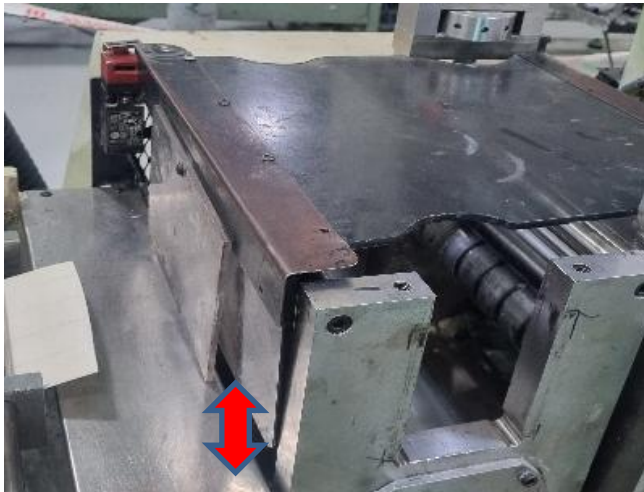
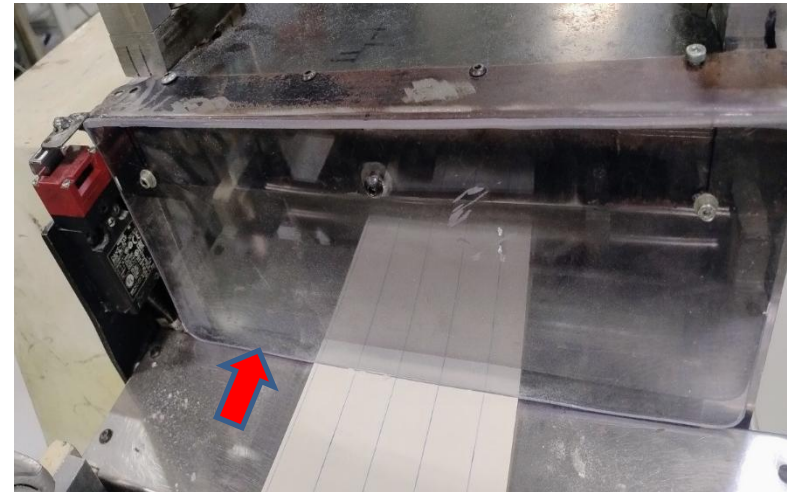
Cause of Accident	Corrective Action
Filter paper entry to roller: Safety door bottom having gap 20mm which having chance of finger may enter inside it	safety door design has been modified to reduce the gap to less than 8 mm
