## MECHANICAL SEAL FINDING REPORT

Date: 05-07-2024

Project:	UZGTL	Location:	Kashkadarya Region, Guzar District		
Unit:	UNIT 45 - PWU Unit	Equipment:	145-PC-026A TUNGSTEN CARBIDE COATING PUMP		
OEM:	DONGYANG CHEMICAL PUMP	Equipment type/Model:	TSB		
Service data: : TUNGSTEN CARBIDE COATING PUMP					
Service fluid	WAX WITH SOLIDS		Design Code	API 610 11 <sup>th</sup> Edition	
	Rated/Nom	Max		Rated/Nom	Max
Suction Pressure [Barg]	9.7	22.9	Operating Temperature [°C]	120/166	185
Discharge Pressure [Barg]	17		Flow rate/Norm [m3/h]	30.8+0.7 (*)	28.0+0.7 (*)
Differential head [m]	109		Vapor pressure [Bara]	10.5	10.5
Direction of rotation	CCW		Driver Rated Power [kw]/rpm	15.86/2945

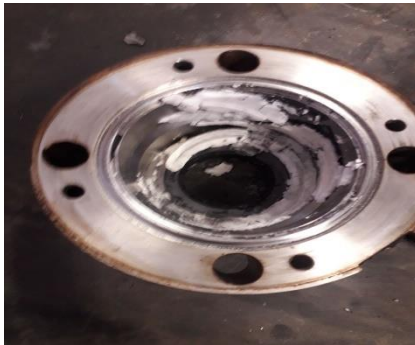
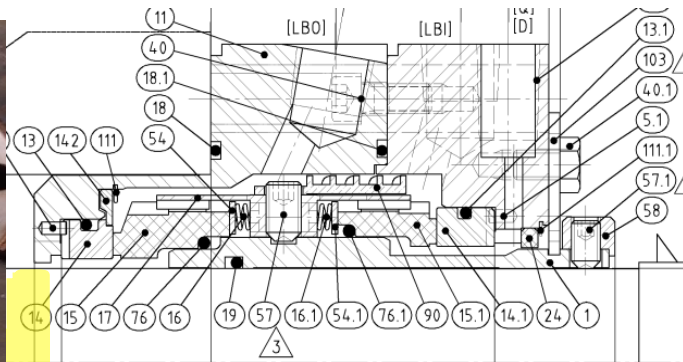
General Findings	Mechanical Seal	
Seal failure findings to determine the potential Root Cause	The pump was stopped and the mechanical seal was removed, the number of leaks on the outer part of the seal exceeded the permissible value.	
Contamination	When the seal was opened, it was found that there were wax and sand inside.	
Stationary face	Inboard seal	Outboard seal
Rotating face	Running marks	Running marks and coking
Item 4 Dual Deflector	Running marks and coking	Running marks and coking
Seal sleeve	Good condition	Good condition
Stationary metal GLAND	Good condition	Good condition
Snap ring and Retainers	Good condition	Good condition
PERFLUOROELASTOMER gaskets	cannot be reused	cannot be reused

1. Inboard Stationary face item **14** : A broken was detected from the lower part of the stationary face

**Recommendations:** Seal shall be reassembled with repair kit and eventually tested as per API 682 at a pressure of 1.8 Barg.

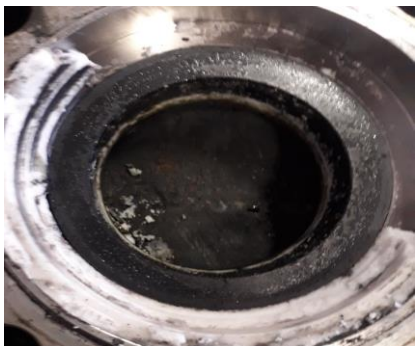
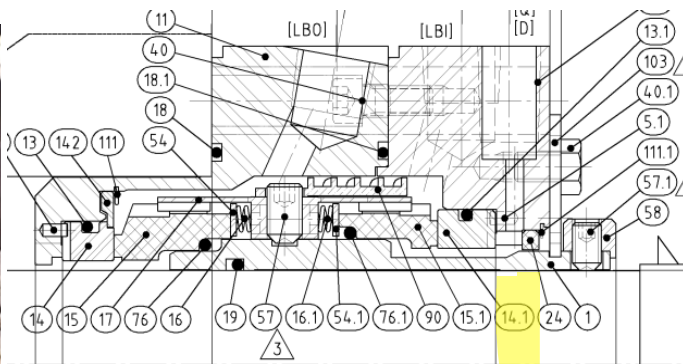
2. Outboard Stationary face item **14.1** : Marks and coking normal wearing off while operation

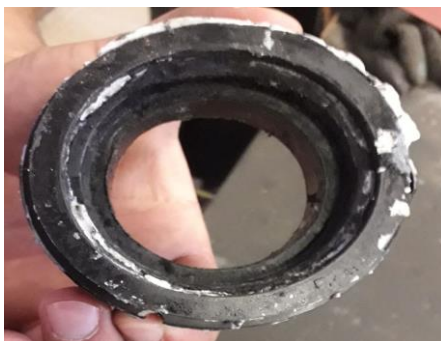
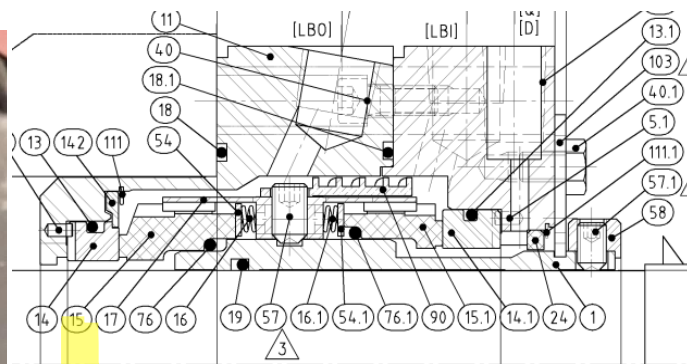
3. Inboard rotating face item **15** : Marks and coking normal wearing off while operation

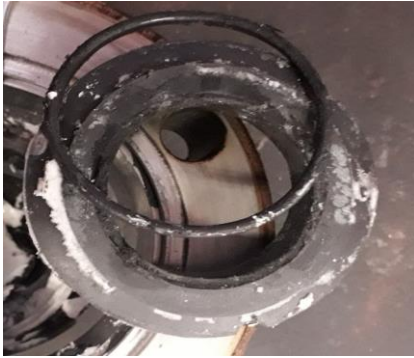
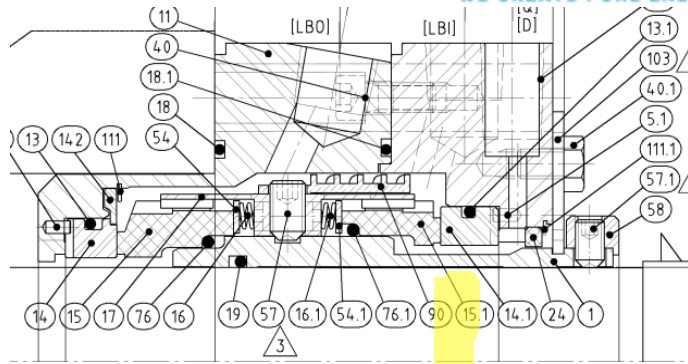
4. Outboard rotating face item **15.1** : Running marks normal wearing off while operation
