## INSPECTION CONDITIONS

**FILE #:** 21-10-7-01.

**INSPECTION SITE:** 309 E 7th St.

**INSPECTION SITE  
CITY/STATE/ZIP:** West Point, Georgia.

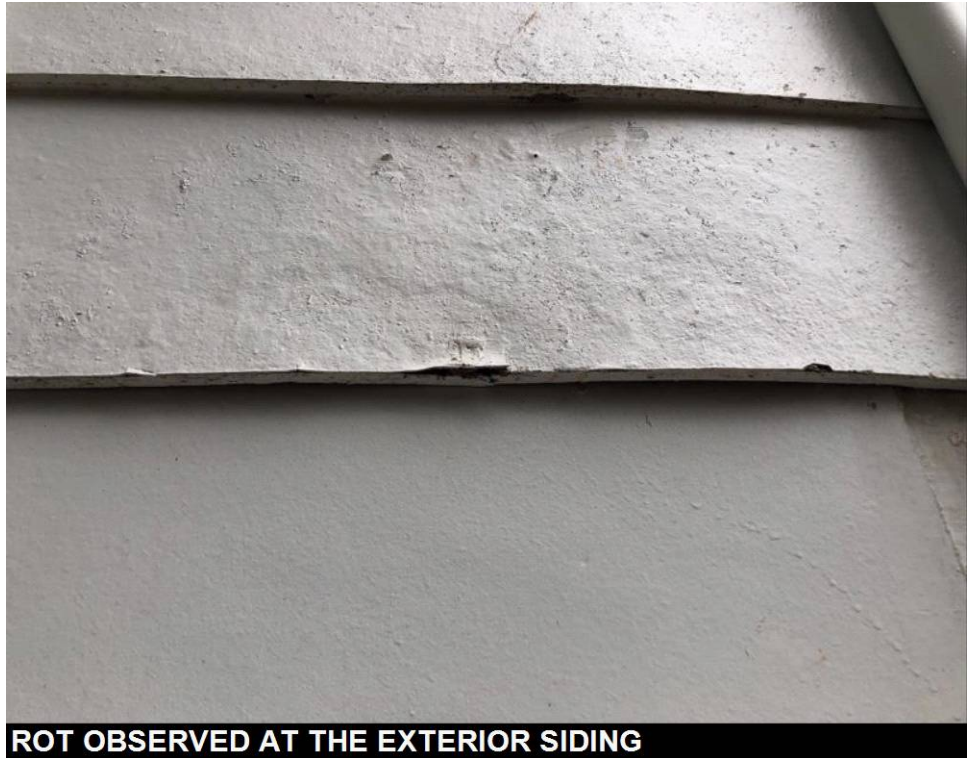
**CONDITION:** Localized rot in areas around the exterior on all sides.

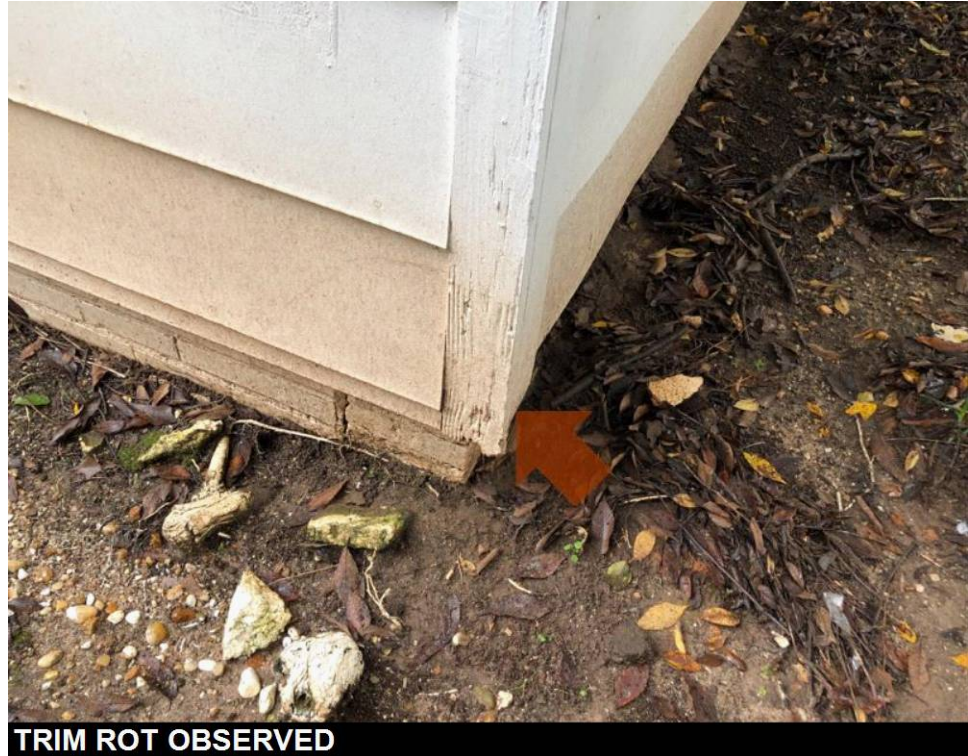
**CONDITION:** Damage noted to exterior trim of the home; Rot observed at right rear corner.

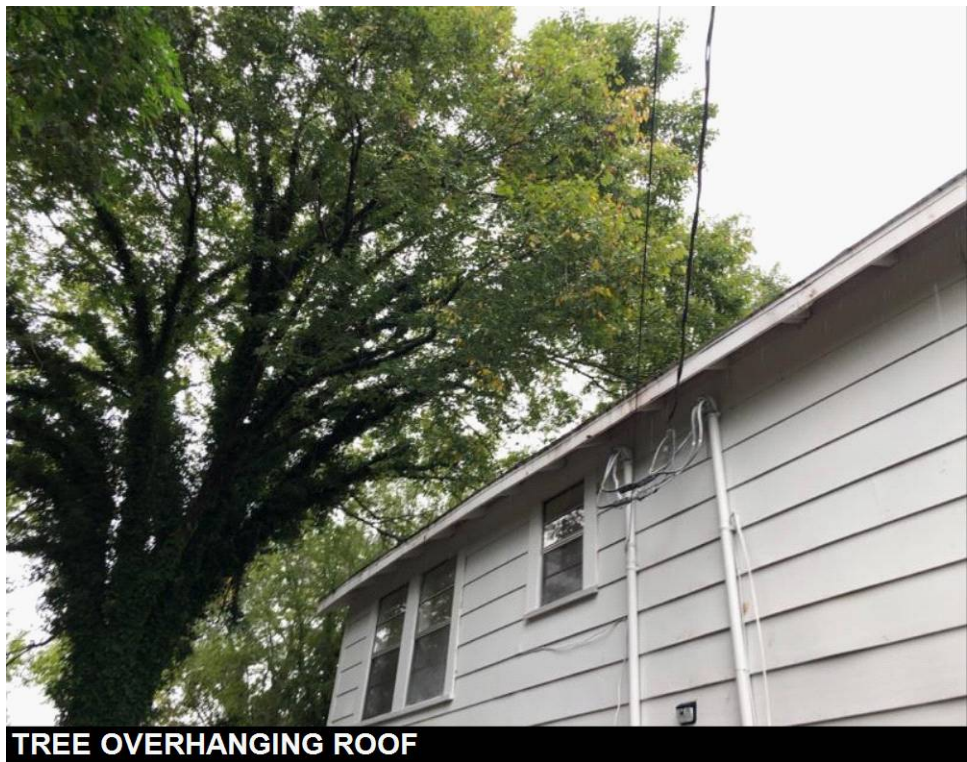
CONDITION: Trees are touching or overhanging the roof. Damage is possible.

TREE OVERHANGING ROOF

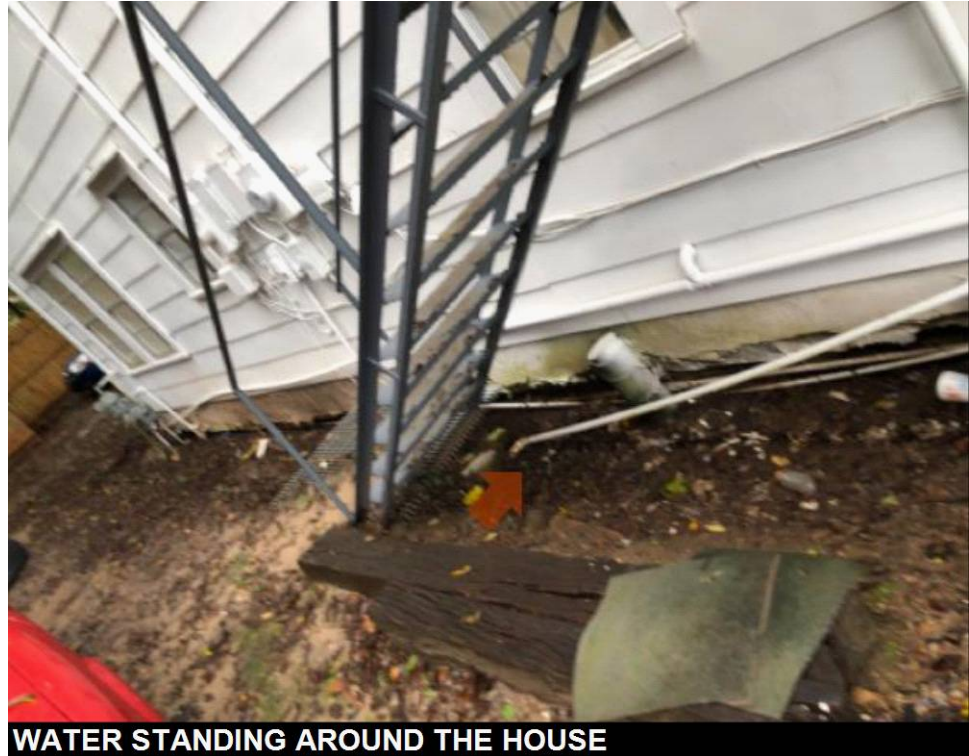
SITE: Gentle slope, Evidence of poor drainage. Water runoff from roof has no where to go but around the perimeter of the house.

**TYPE & CONDITION:** None. **Consider installing gutters and downspouts to help with site drainage.**

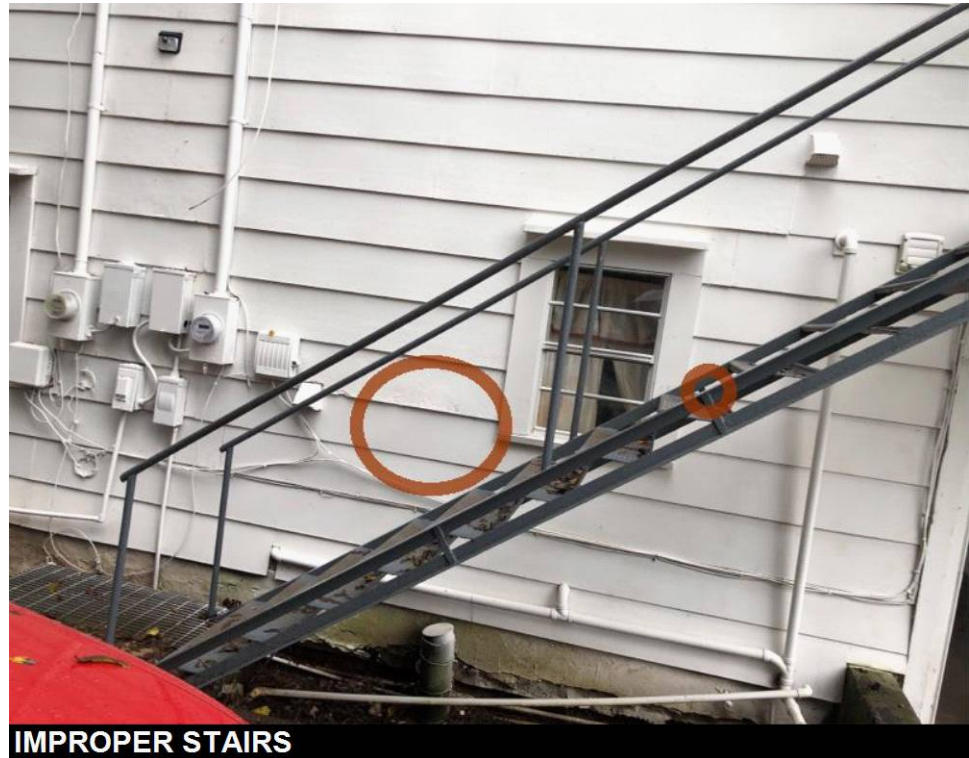
**CONDITION:** The gap in the handrails is a safety issue and needs to be addressed. Handrails should have gaps no larger than 6 inches of space between railing and threads. There should be no more than 4 inches of space between spindles, although these exterior stairs are not equipped with spindles. NO more than 4 inches of height at open threads. Recommend repairs by qualified professional.

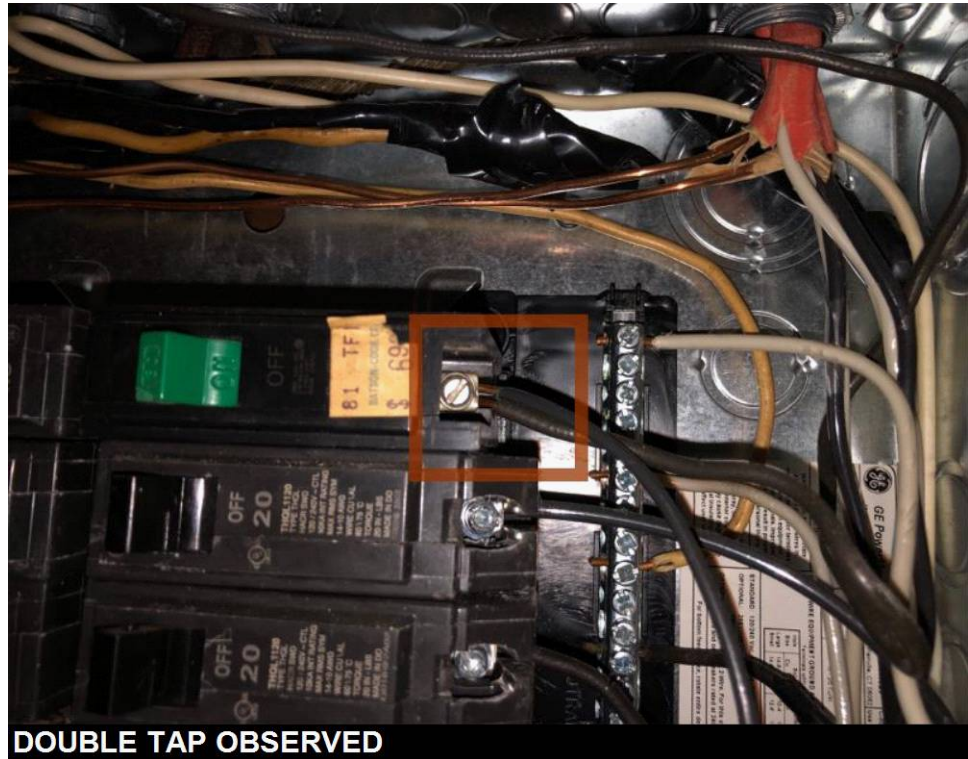
Circuit and wire sizing correct so far as visible, Grounding system is present, **Multiple wires are connected to a single lug on a circuit breaker where only one wire should be connected. The electrical panel does not have detailed labeling for the breakers required by current industry standards. Breakers should be labeled in detail as to the room, ie. Master Bedroom, Front Bedroom, Bonus Room, etc.**

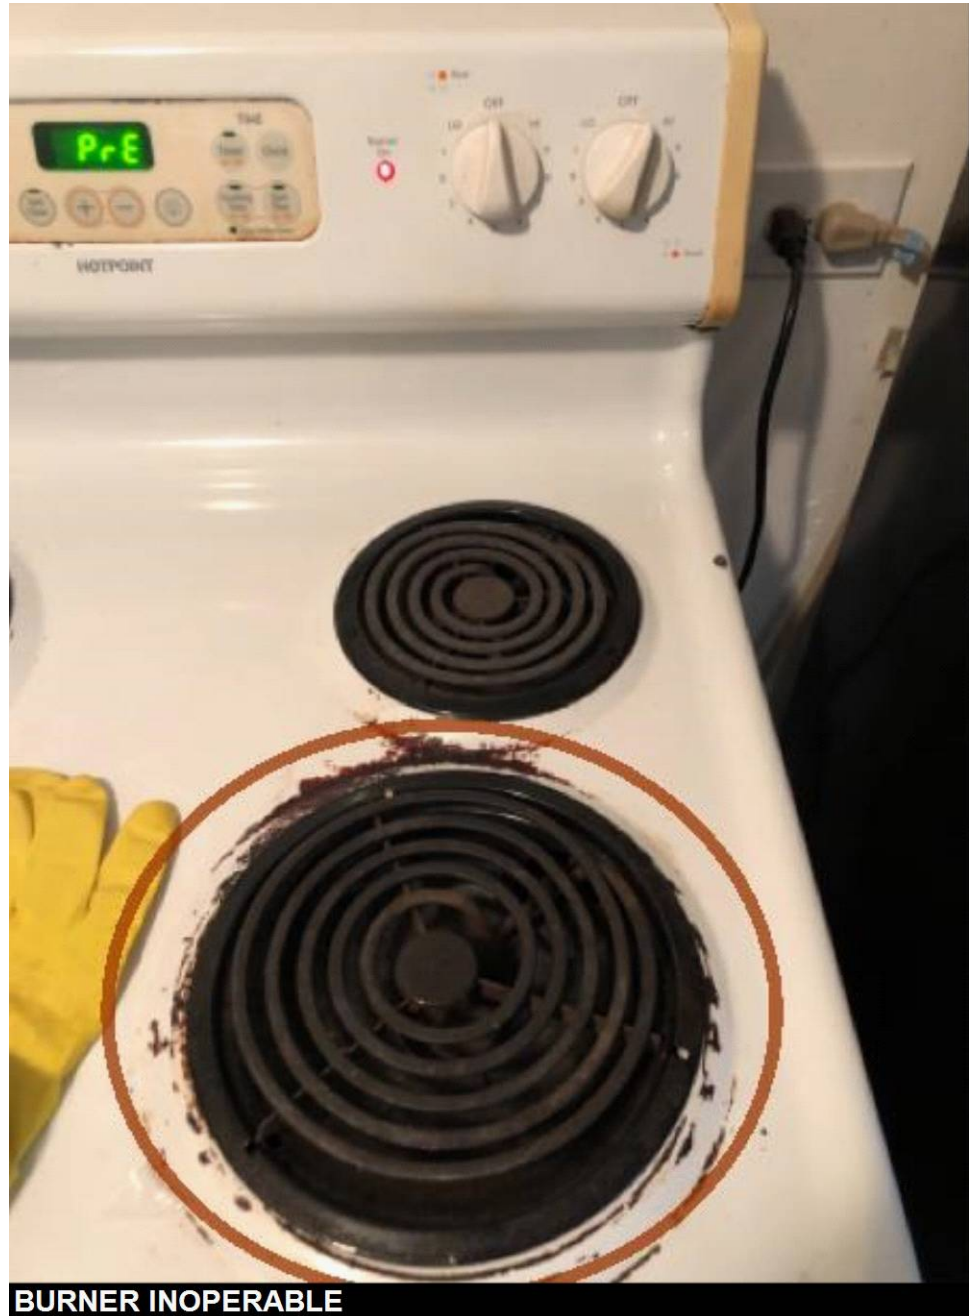
**TYPE/CONDITION:** Electric, Free-standing, **Range burner is inoperative, The Right Front burner did not operate properly.**

**BURNER INOPERABLE**

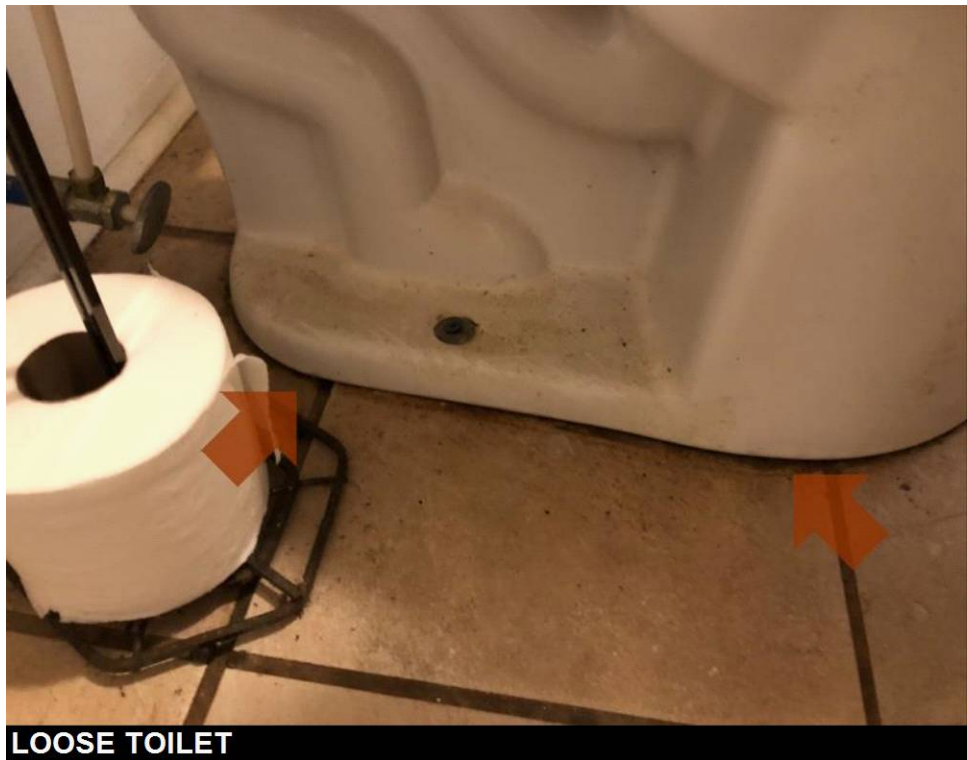
**CONDITION OF TOILET:** The following problems were noted at the toilet: Toilet is loose at floor.

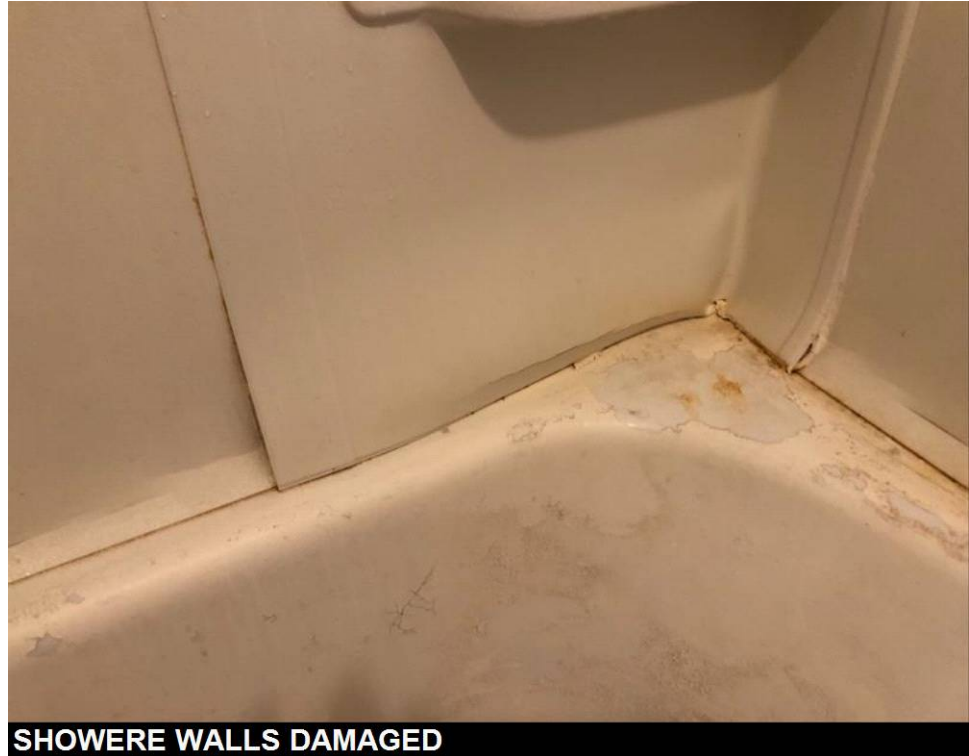
**TUB/SHOWER AND WALLS:** Damage and Deterioration is noted at shower walls.

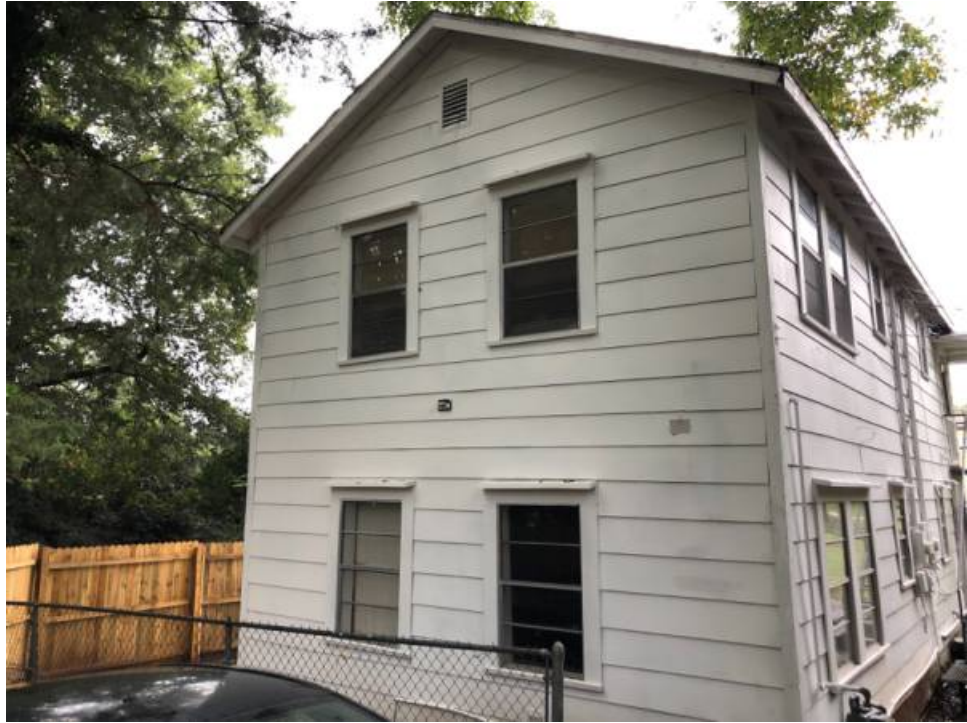
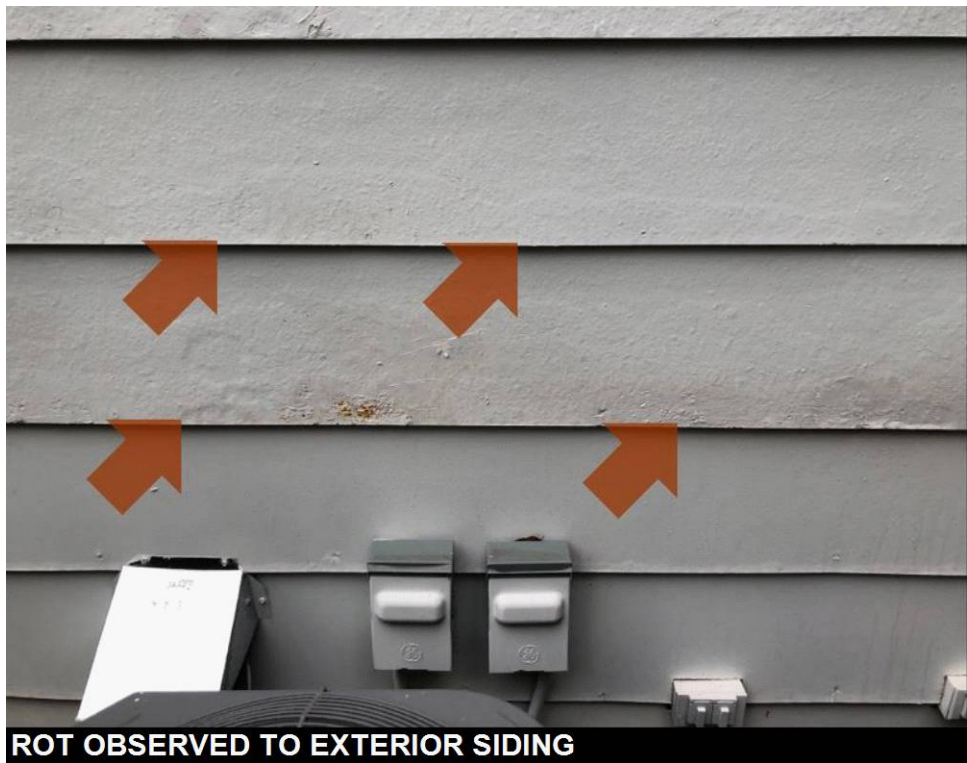
**ROT OBSERVED TO EXTERIOR SIDING**

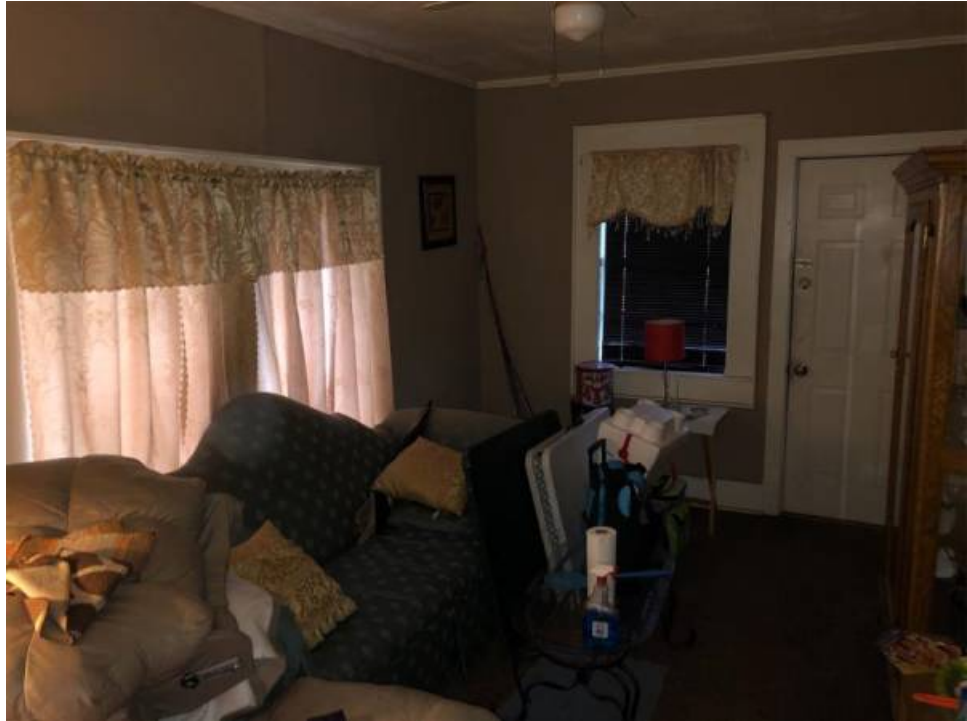
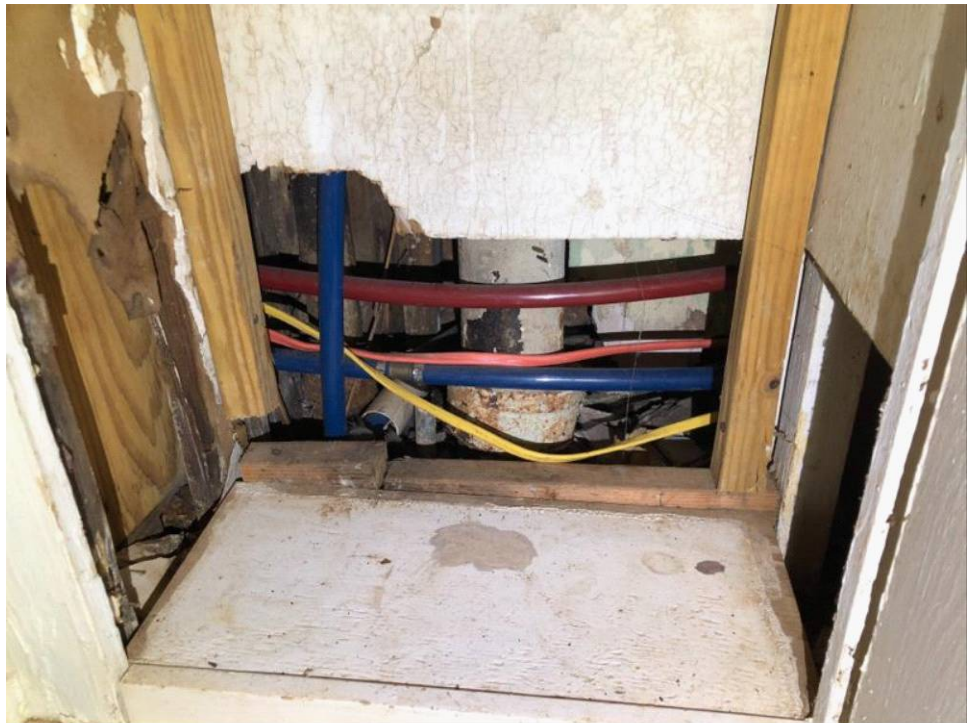
**MATERIAL & CONDITION:** Drywall, Typical cracks noted. **Walls in cabinet to the right of the sink need to be sealed up to keep pests out. Stains observed in bathroom most likely cause by poor bathroom ventilation.**

**INSIDE OF CABINET NEEDS REPAIR/SEALED OFF**

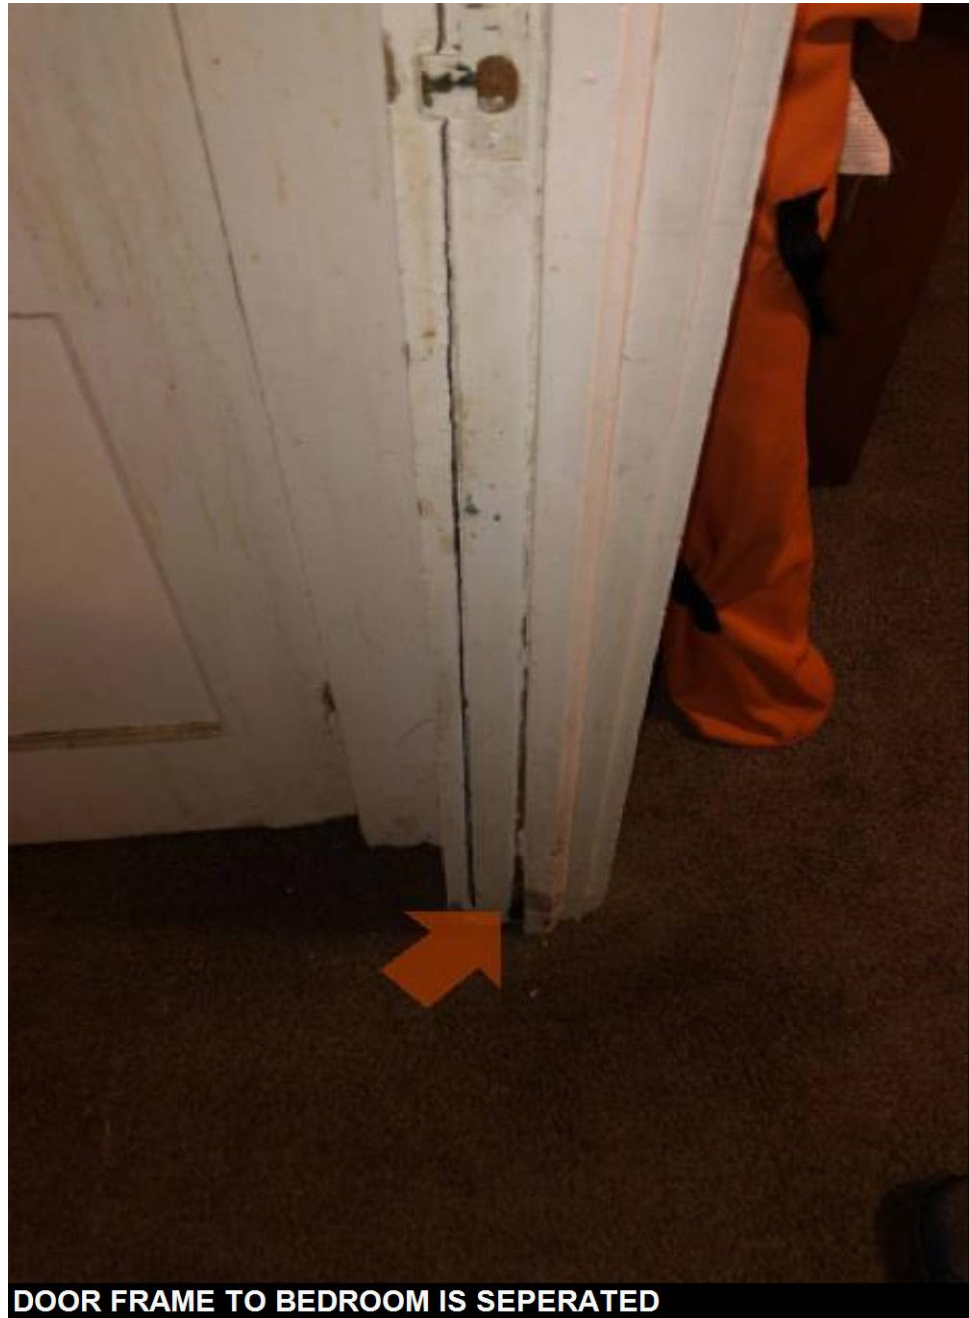
**INTERIOR DOORS:** **Adjustments needed to interior door(s) at, Bathroom door. Bedroom door needs adjustments, wont close properly. Bedroom door frame is pulling apart and needs repair.**

**DOOR FRAME TO BEDROOM IS SEPERATED**
