INSPECTION CONDITIONS

FILE #: 21-10-07-03.

INSPECTION SITE: 309 E 7th St.

**INSPECTION SITE
CITY/STATE/ZIP:** West Point, Georgia.

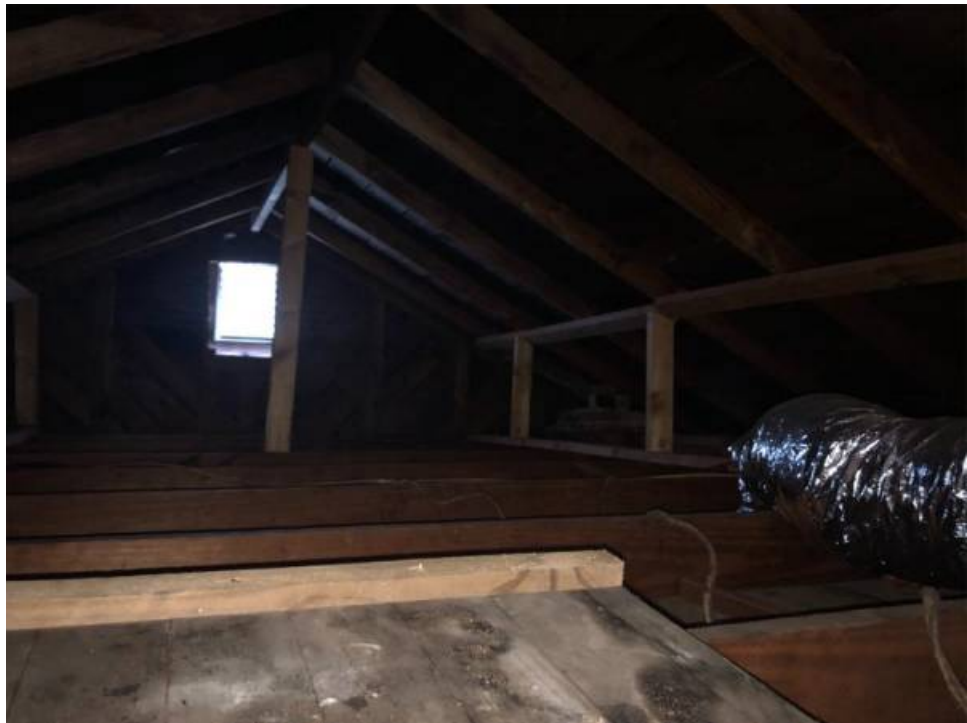
Attic is full size, Viewing was limited, Viewing was limited, to observing from hatch areas only. Access is restricted by low headroom, stored goods and/or limited attic flooring.
Stains are noted. Active leak was observed at the time of inspection.

No insulation is provided. Recommend adding insulation in the attic area.

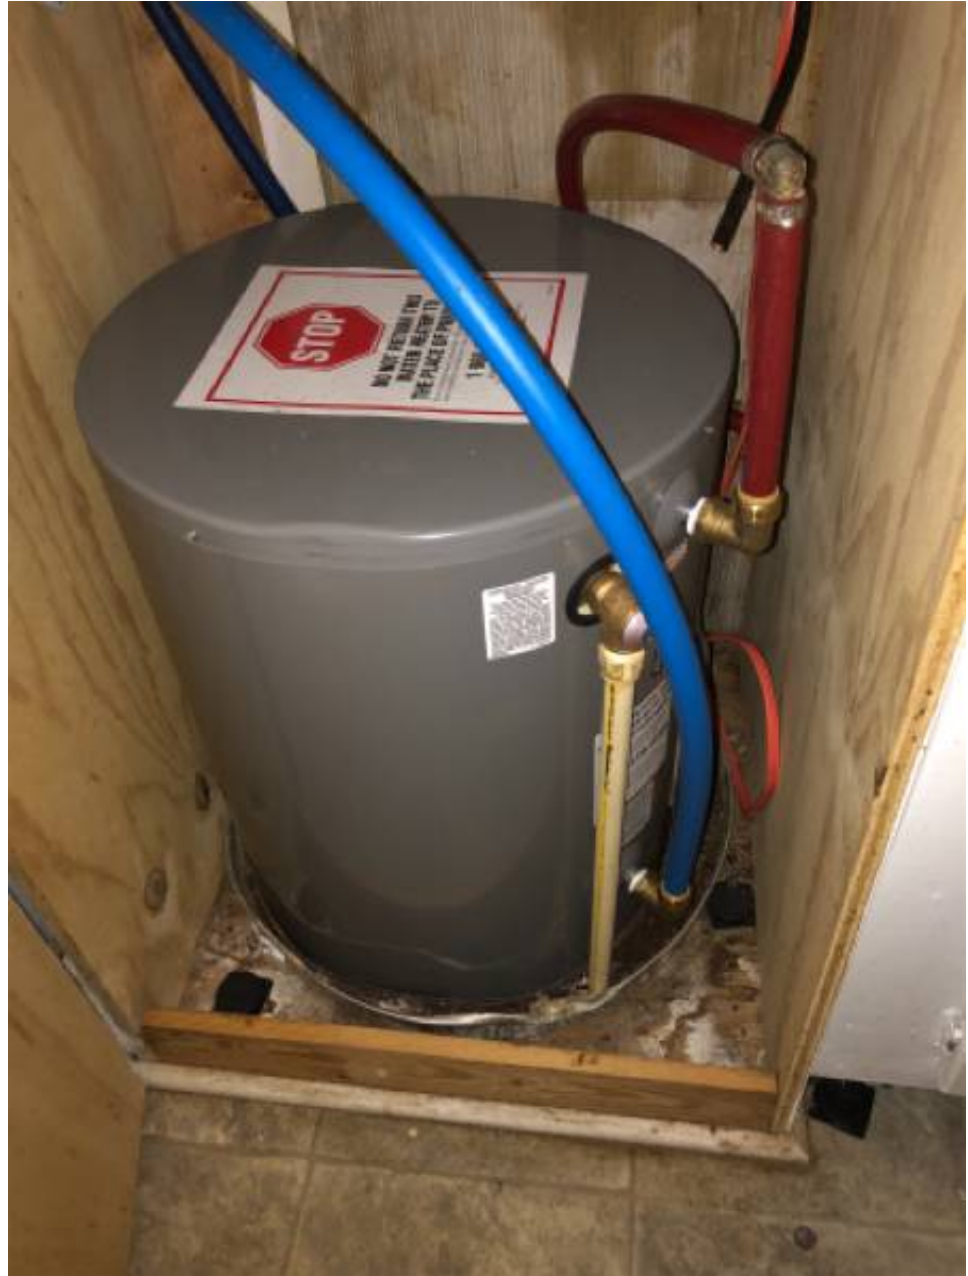
CONDITION: The water heater responded properly during the inspection. **Pressure relief valve drain line for water heater is missing or ends prematurely. This is a SAFETY HAZARD. We recommend this drain line be extended to a safe location. The drain line run to the pan which is okay IF the pan drains to the exterior of the house, but it does not.**

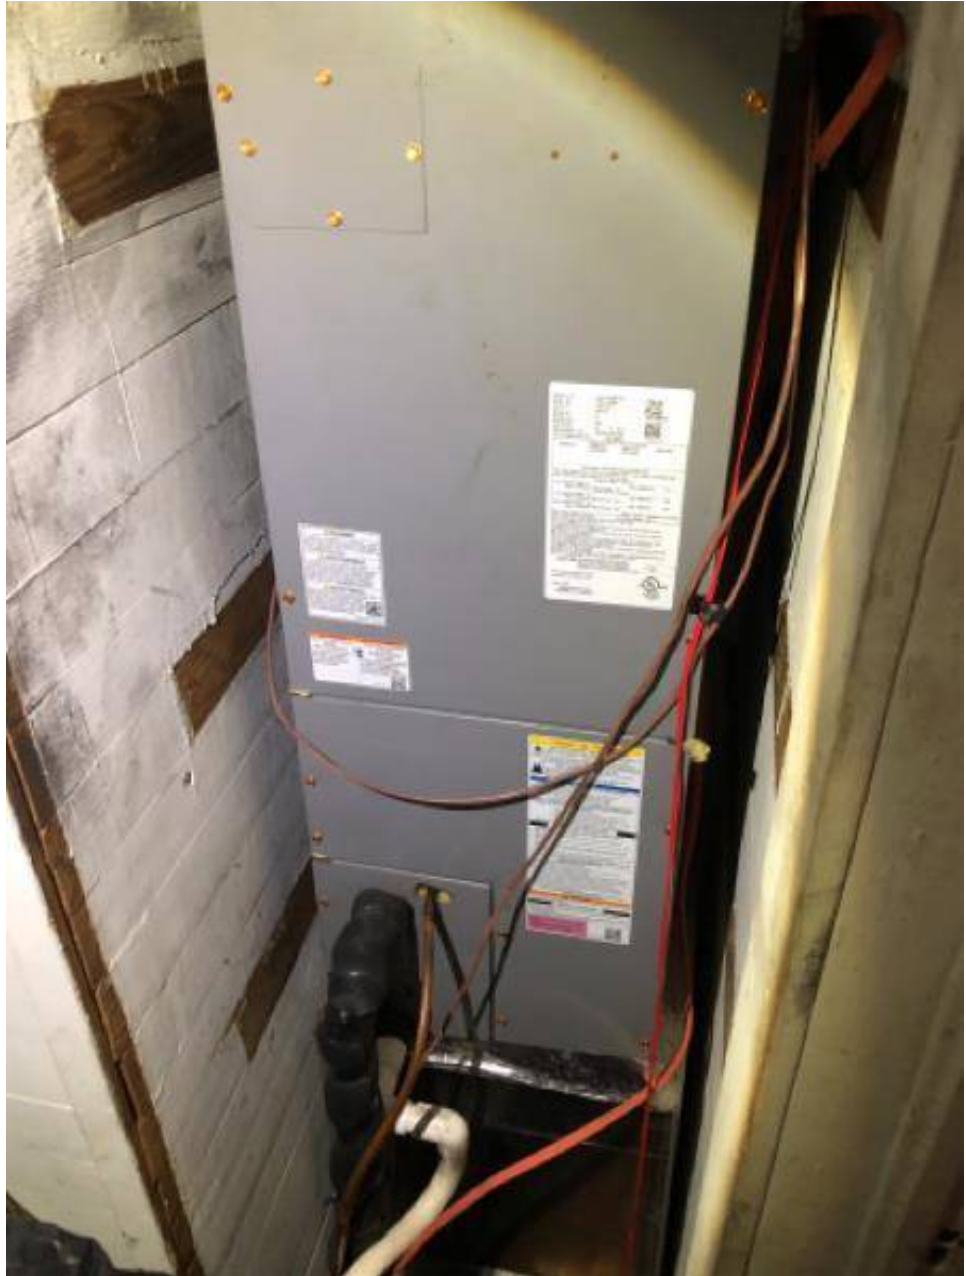
SYSTEM TYPE: Heat pump. The heat pump serves to air-condition or cool the home and also provide heat during cooler weather conditions.

MANUFACTURE: CARRIER.

DATE OF MANF: 2020.

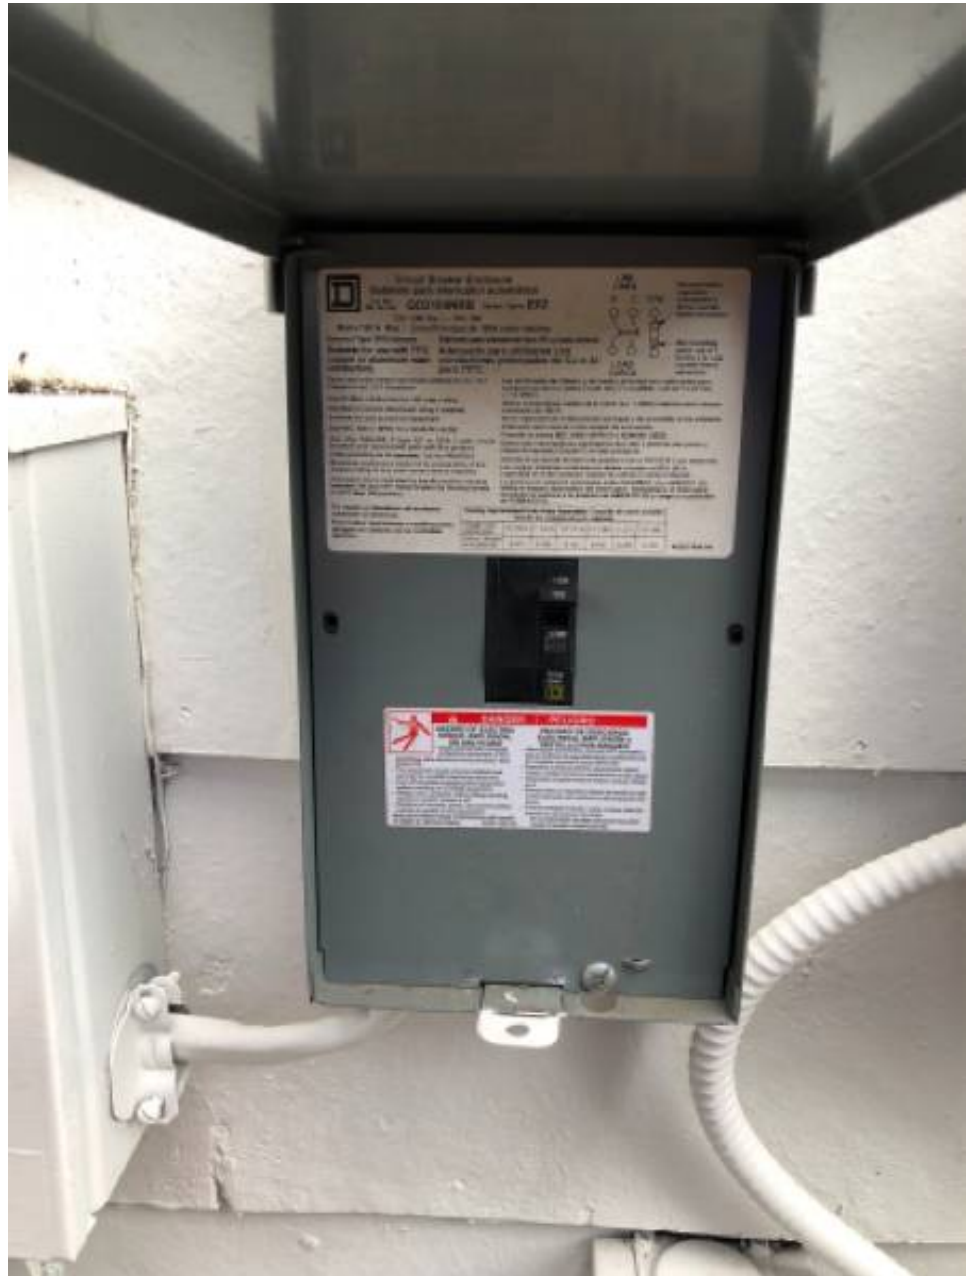
MAIN PANEL LOCATION AND NOTES: Exterior of house.

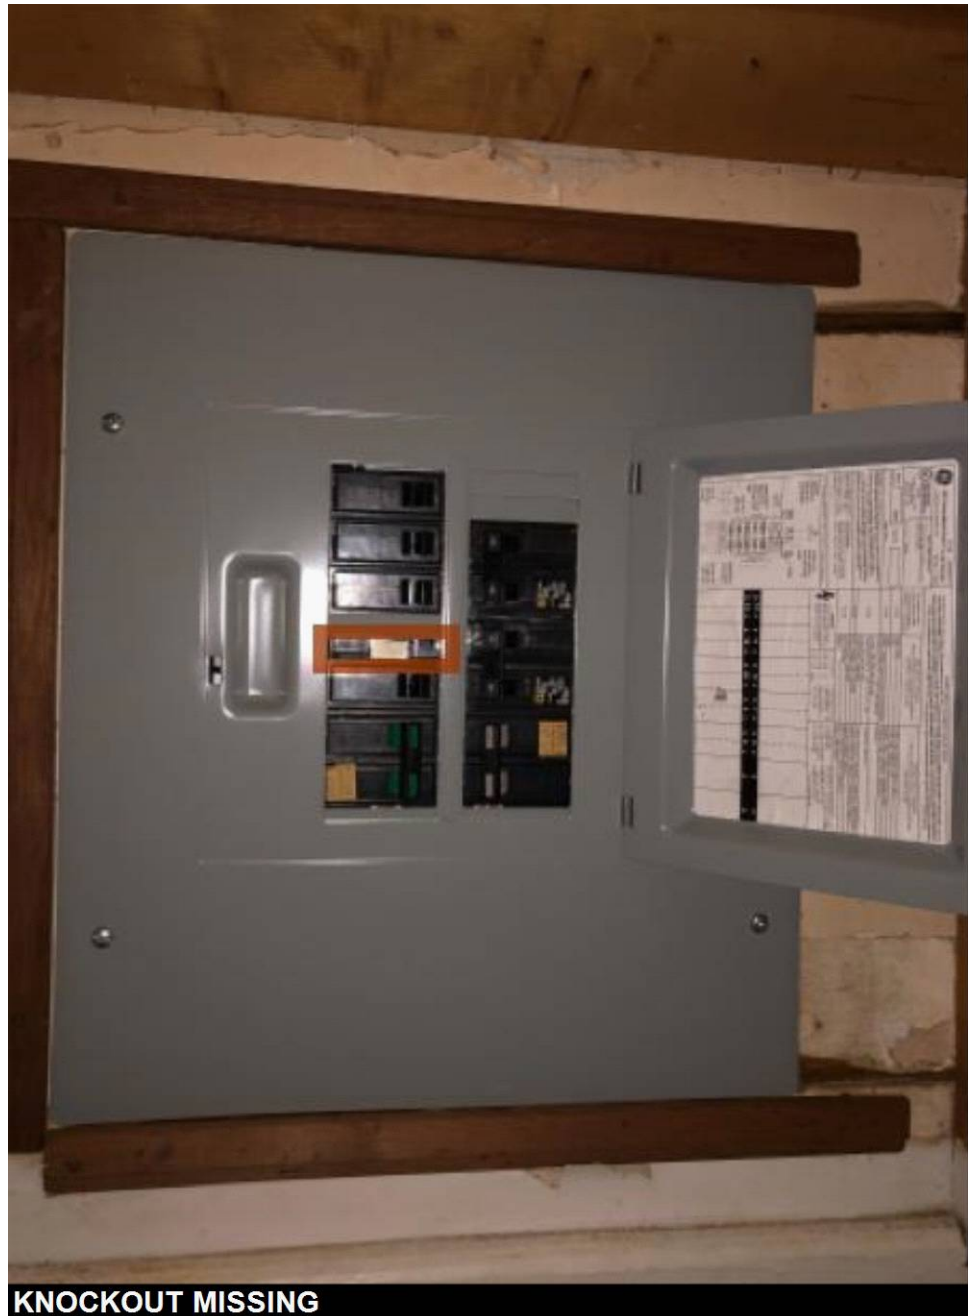
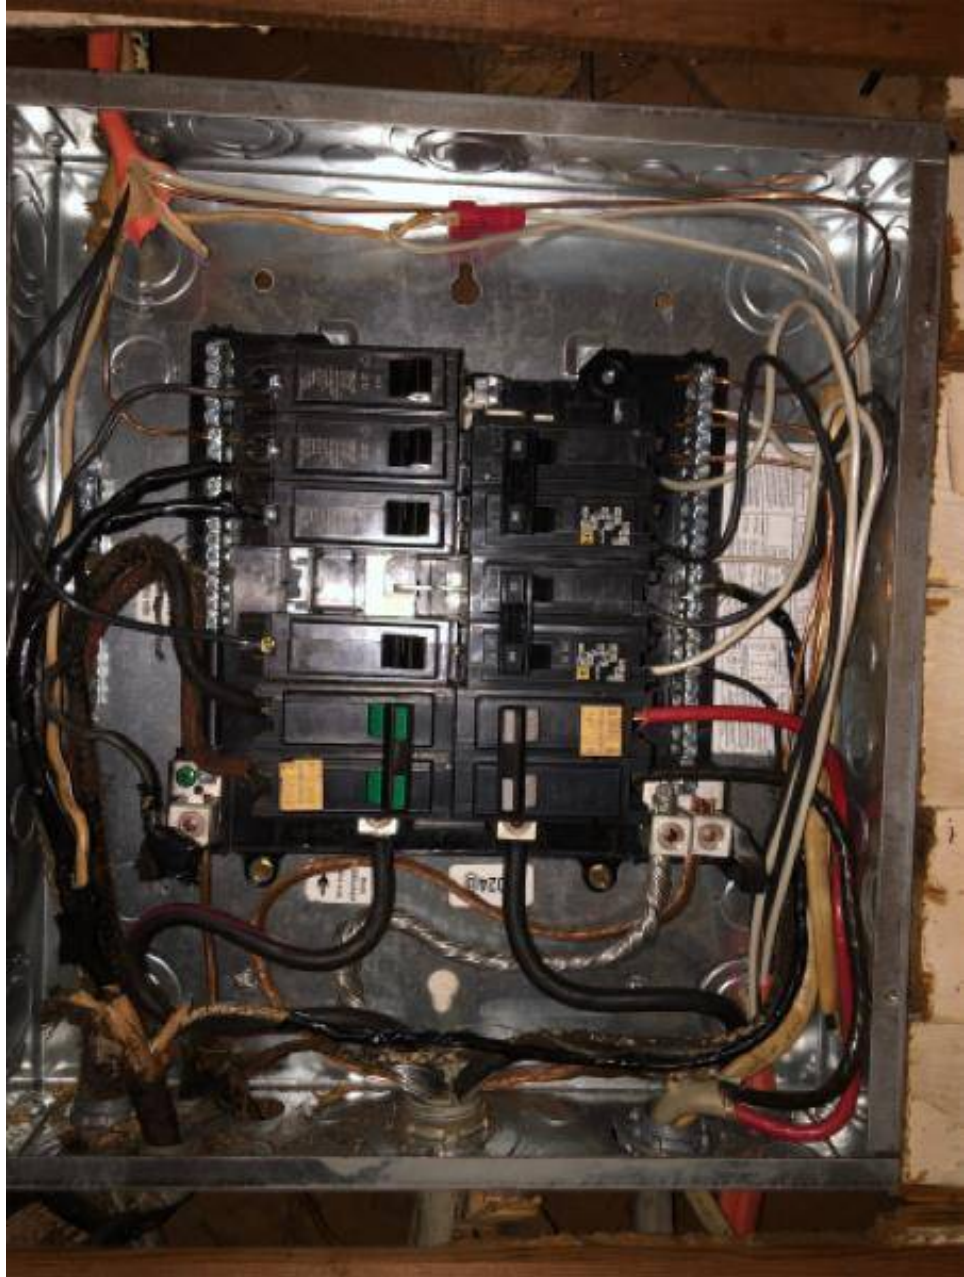
Circuit and wire sizing correct so far as visible, **Knock-outs missing at panel, The electrical panel does not have detailed labeling for the breakers required by current industry standards. Breakers should be labeled in detail as to the room, ie. Master Bedroom, Front Bedroom, Bonus Room, etc.**

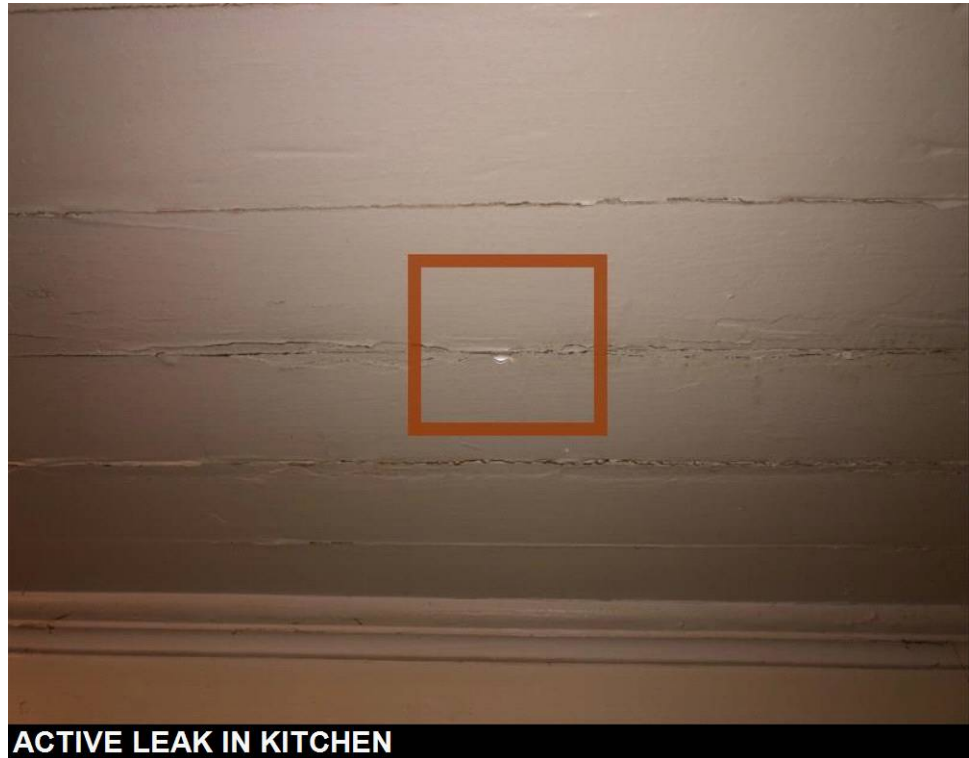
TYPE & CONDITION: Wood, Tile, **Ceiling Stains noted at bedroom, Unable to determine if active leakage exists. Make inquiry with the seller as to the history of leaks. Hole in the ceiling in living room needs to be patched. There is an active leak in the kitchen above the stove.**

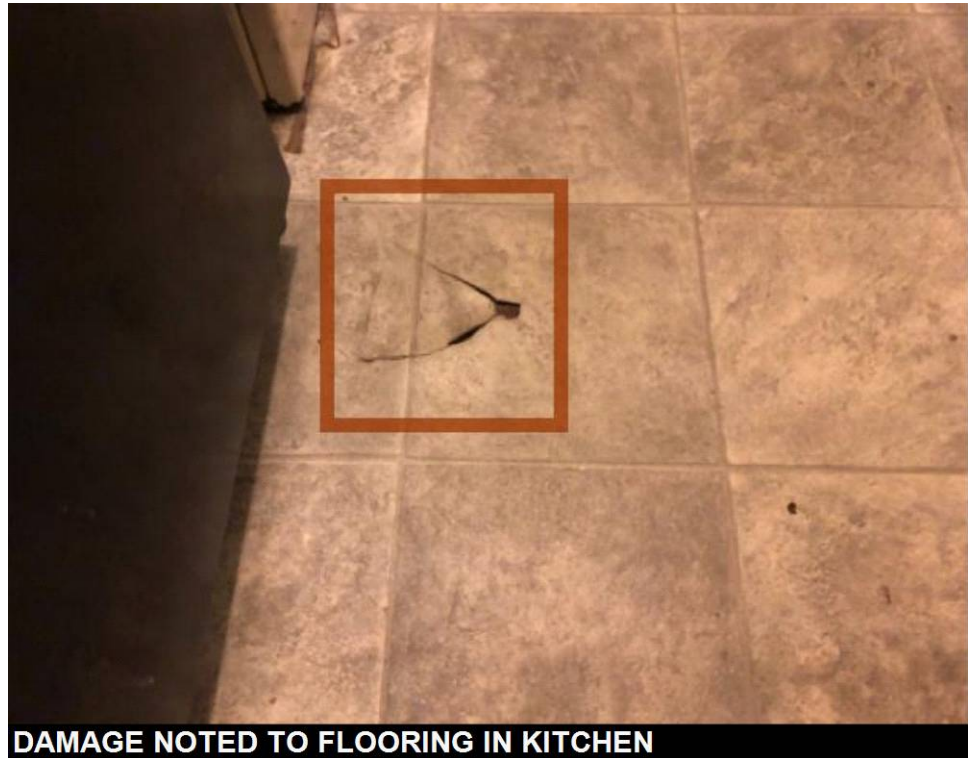
Carpet squares, Wood, Vinyl. **Floor Damage/deterioration is noted, Kitchen.**

DAMAGE NOTED TO FLOORING IN KITCHEN

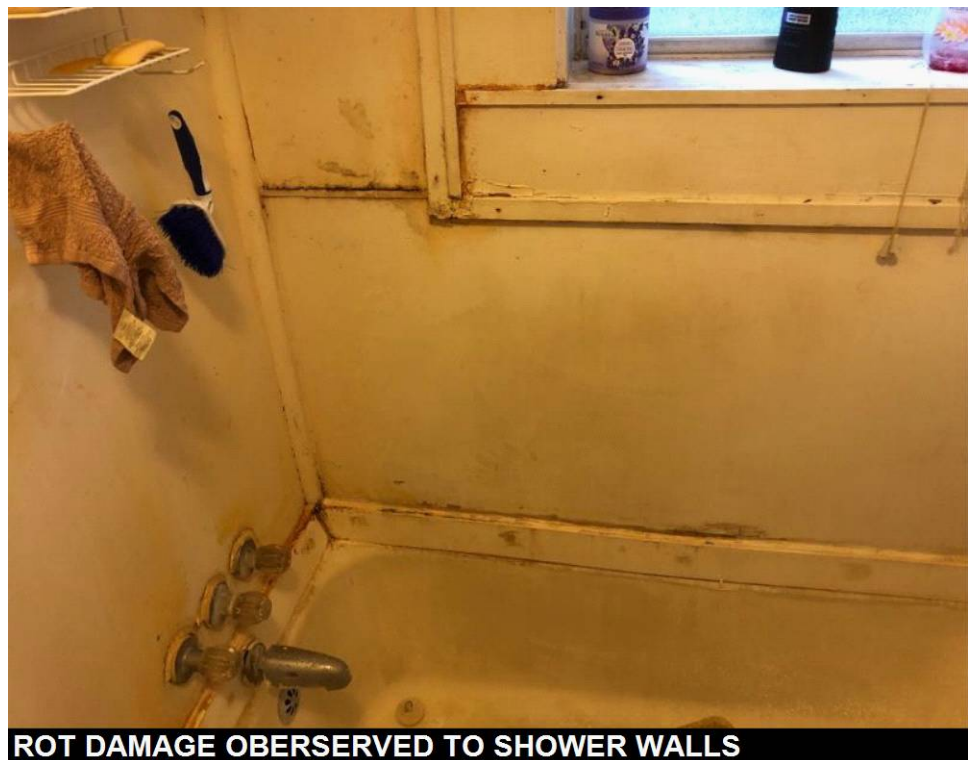
TUB/SHOWER AND WALLS: **Damage and Deterioration is noted.**

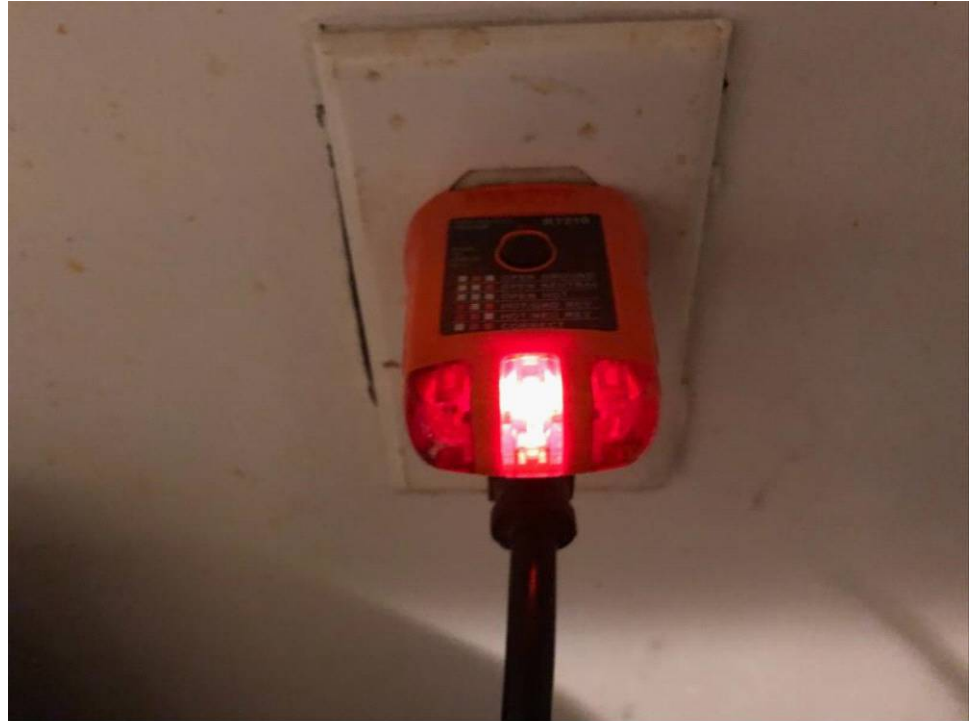
CONDITION: Some grounded type outlets did not appear to be properly grounded. Located in Kitchen behind washer, dryer.

OPEN GROUND IN KITCHEN

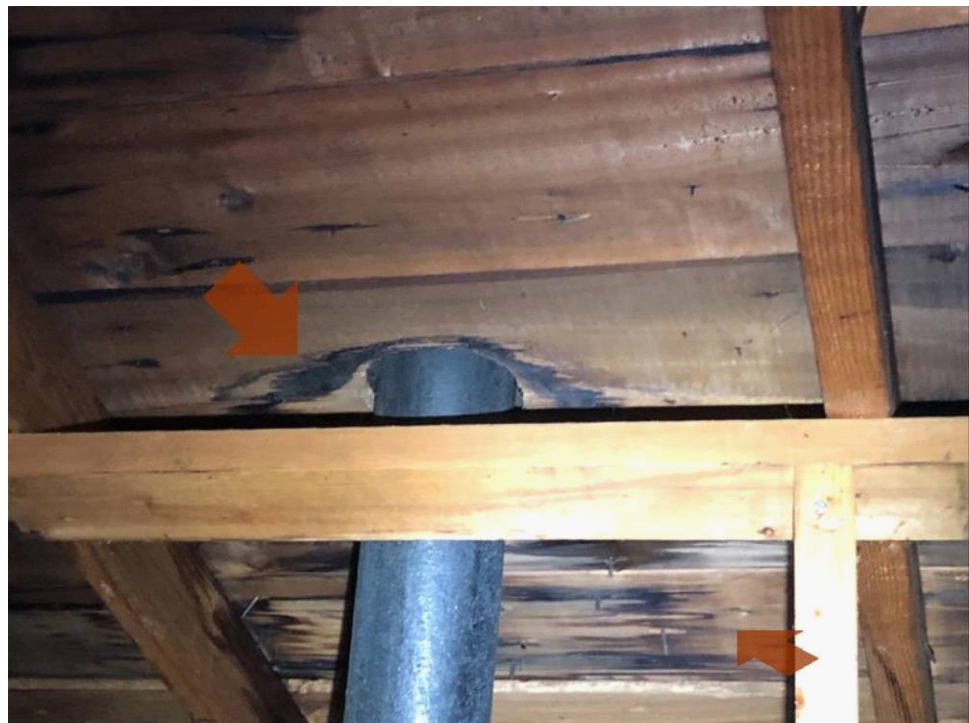
TYPE AND CONDITION: Metal, Active leakage is noted-around waste vent at roof.

STAIN/LEAK AT WASTE VENT IN ATTIC
