AYALA ALABANG R1P

1.1 Fire protection and safety audit

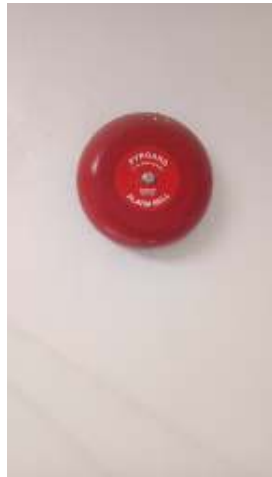
(b) Bell

- Water network room
- Water network conference room
- Remaining 4 devices not tested due to unavailability of keys in the IT room, cashier room, and need scaffolding in the pump room
- All manual call point in good condition
- Three (3) bells were activated every time the smoke detectors and manual call point were activated
- One (1) bell device did not function (not activated-no sound) during testing located at the MCC room.
- There are no smoke detectors at the chlorine tank house and genset room.

Troubleshoot non-functioning bell at the MCC room. Check wiring specially on the termination.

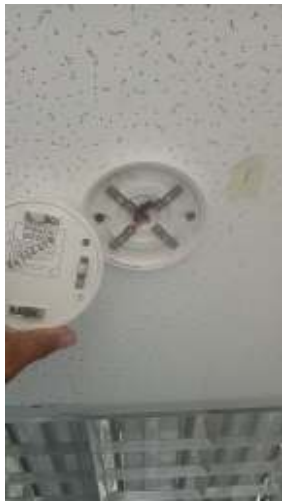
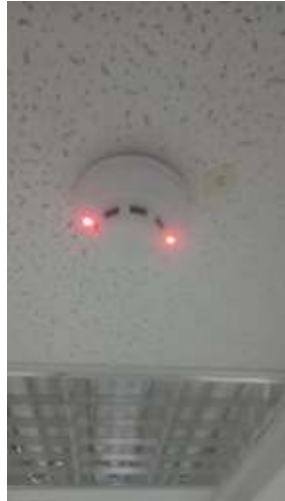
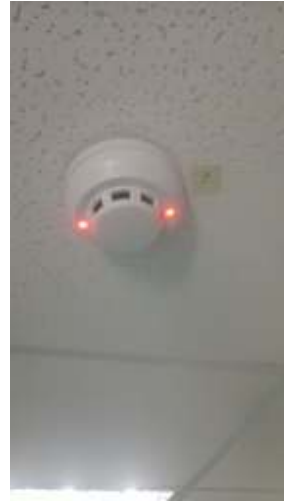
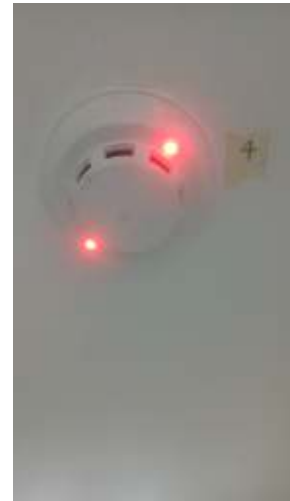
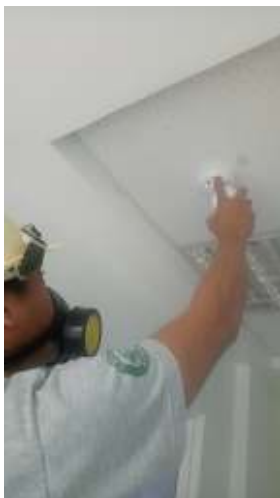
- 16 out of 20 smoke detector devices were tested, activated after spraying of smoke tester. Location of functioning SD are
 - the lobby
 - hallway
 - conference room
 - file room
 - back room
 - pantry
 - customer care
 - utility room
 - Motor control center room

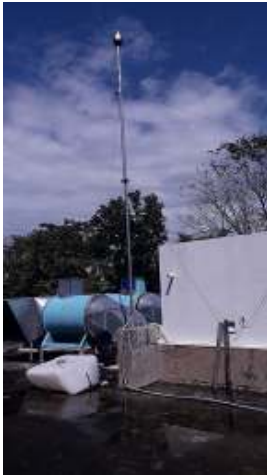
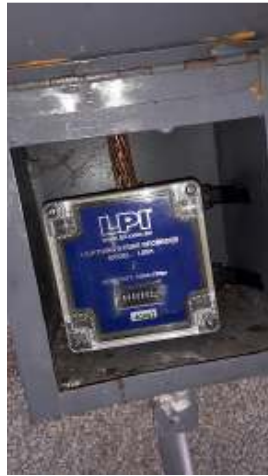
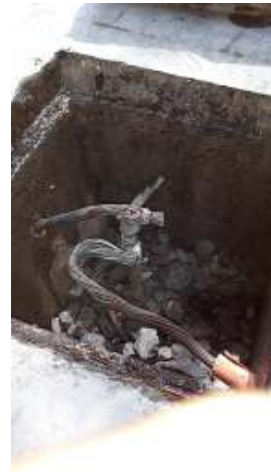
There is a lightning protection system installed for this in pump station. The strike counter has registered previous strikes. Testing the connection of the continuity of bare copper wire connecting the lightning arrester indicated acceptable values but already on the marginal side.

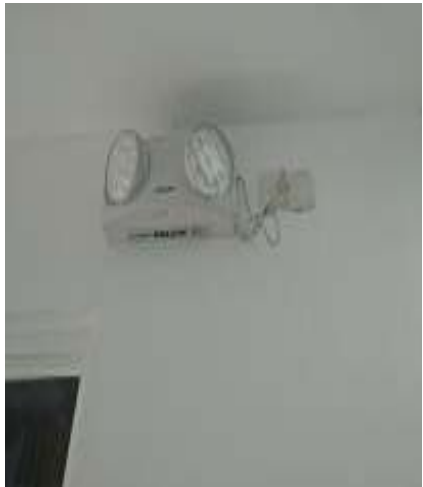
(a) Emergency light w/o inspection tag (b) Ladder w/o cage protection

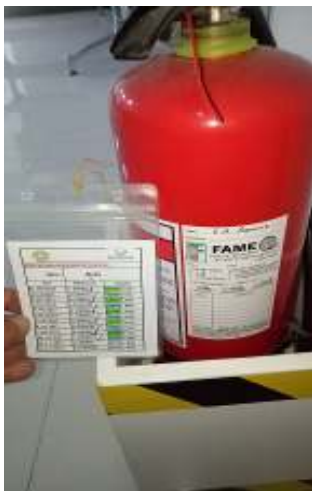
(c) FE-05 tag 10/4/2017 (d) No FEX on designated location

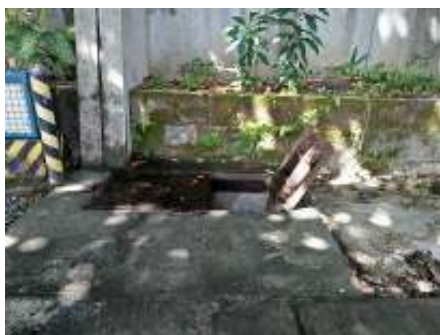
(e) Open manhole w/o barricade and w/o signage (f) Open manhole w/ barricade but w/o signage
