ENVIRONMENTAL MANAGEMENT

PERFORMANCE MONITORING – ENVIRONMENTAL CONTROL MEASURES

Areas of Concern on 14 October 2014 and pending issues on 30 September & 01 October 2014

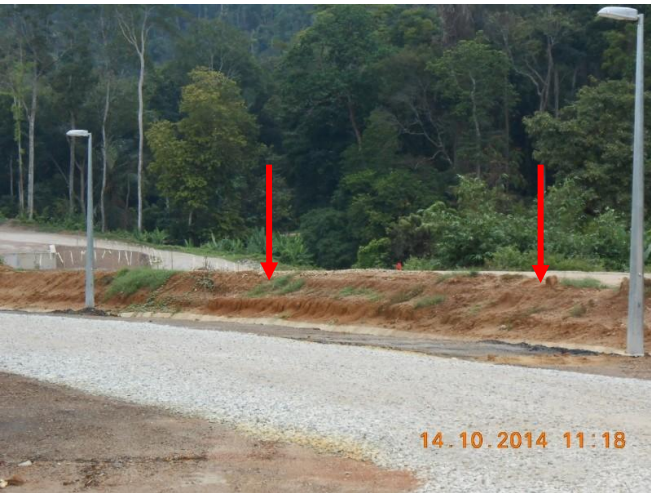
Plate 1a: Exposed slope along the constructed drain (access road).

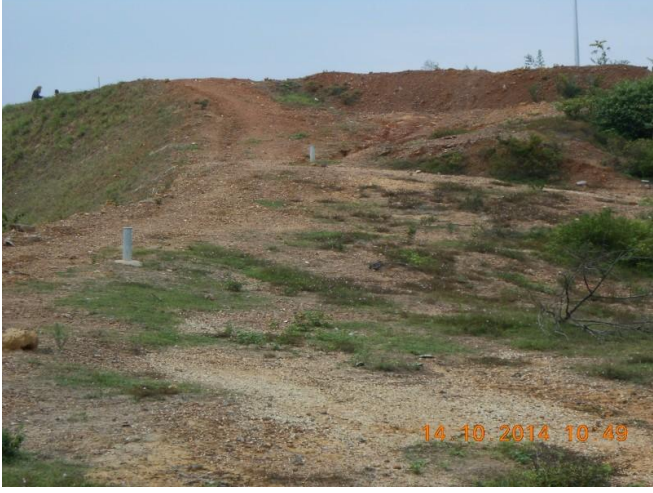
Plate 1b: Exposed slope is observed (RHS u/stream of ST-2-01; Saddle Dam A).

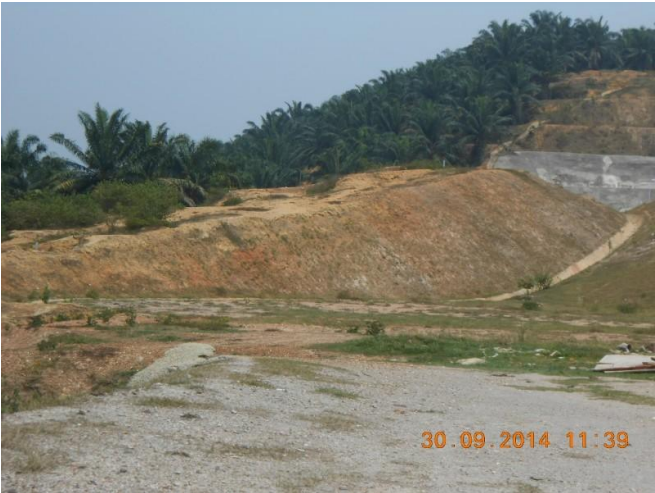
Plate 1c: Exposed slope is observed (LHS u/stream of ST-2-01; Saddle Dam A).

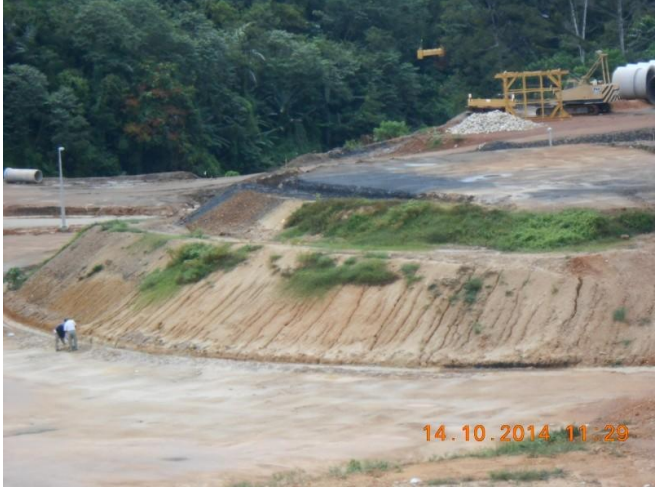
Plate 1d: Exposed slope is observed (Main Dam).

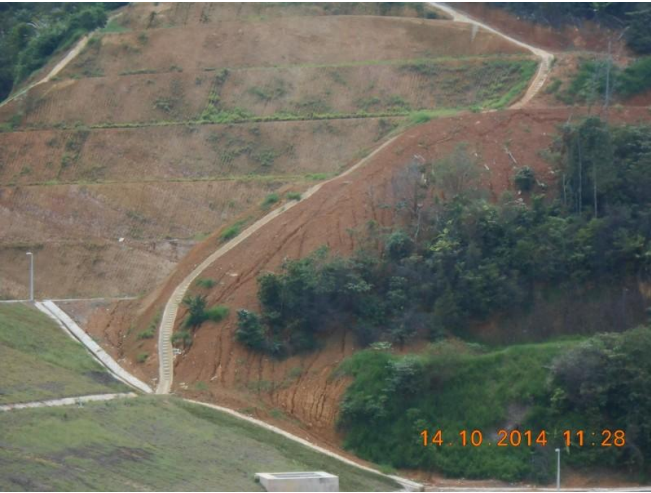
Plate 1e: Formation of gullies is observed (RHS Main Dam).

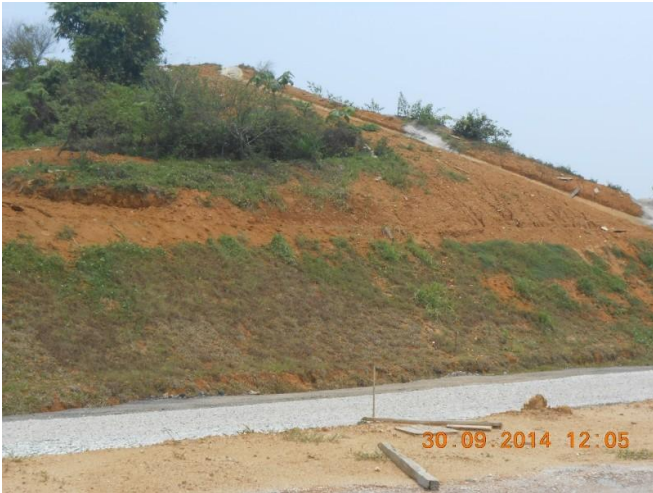
Plate 1f: Exposed slope is observed (d/stream spillway).

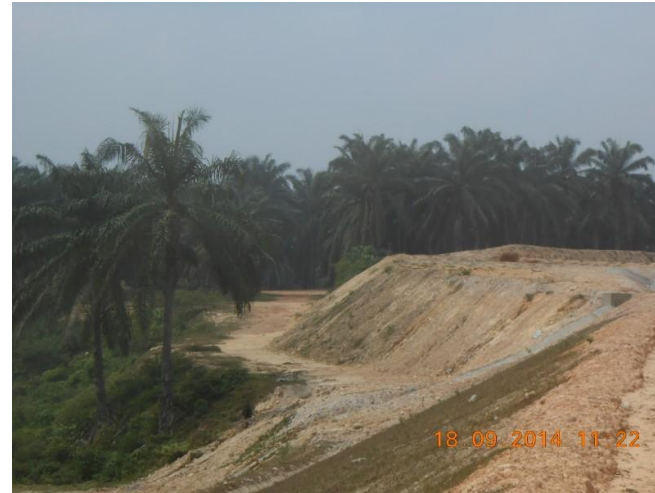
Plate 1g: Exposed slope is observed (LHS relocation road CH 2150).

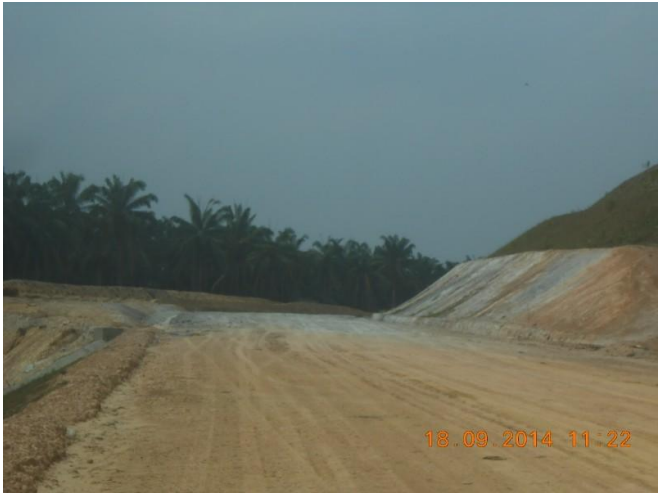
Plate 1h: Exposed slope is observed (LHS & RHS relocation road CH 2150).

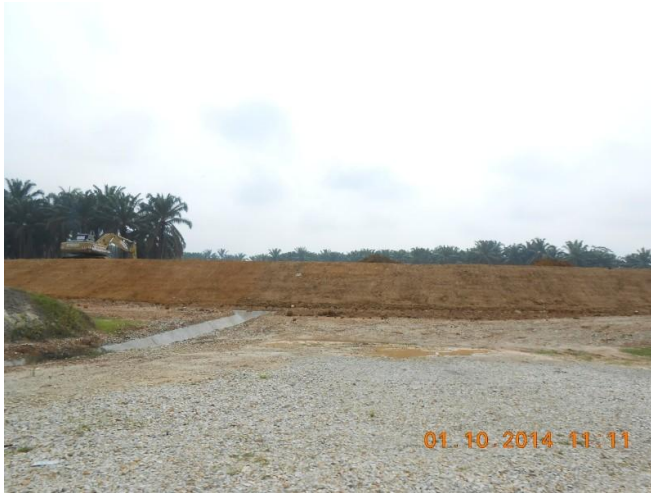
Plate 1i: Exposed slope is observed (LHS CH 2650 relocation road).

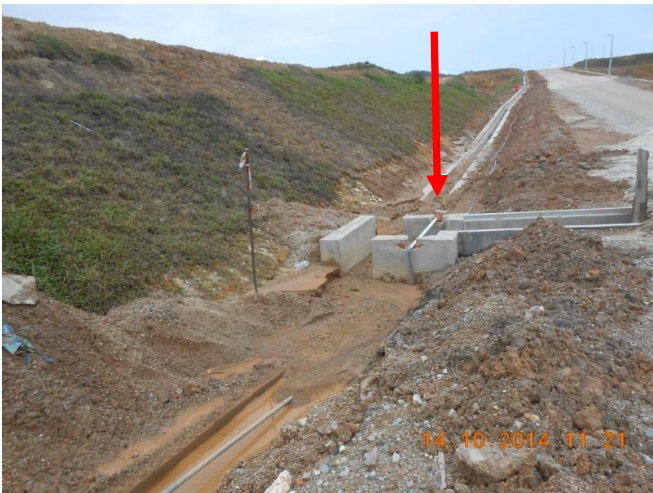
Plate 2a: Silted drain is observed (behind batching plant-access road).

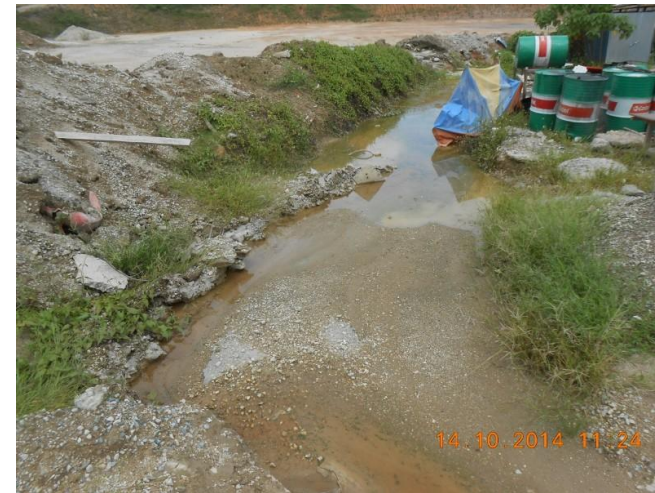
Plate 2b: Silted earth drain has yet to be de-silted (batching plant).

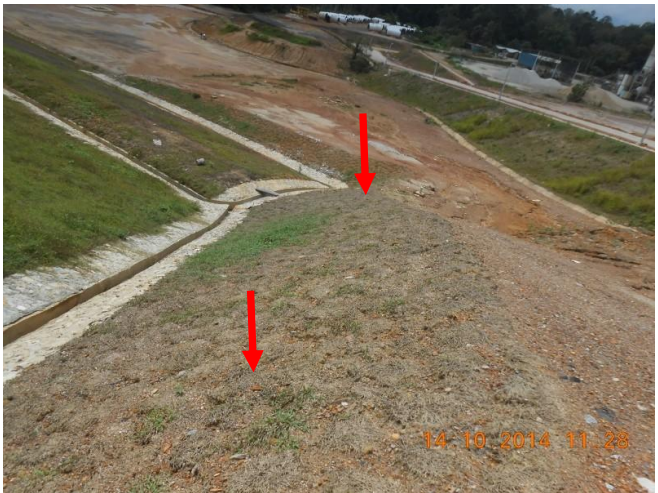
Plate 3a: Turfing has been dead is observed (Main Dam).

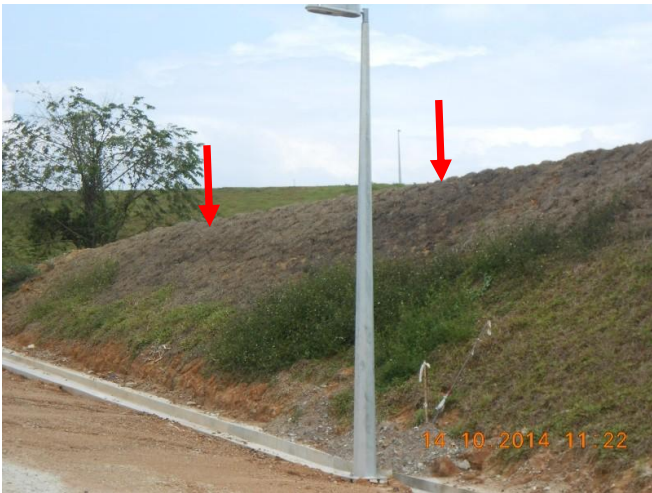
Plate 3b: Turfing has been dead is observed (behind batching plant).

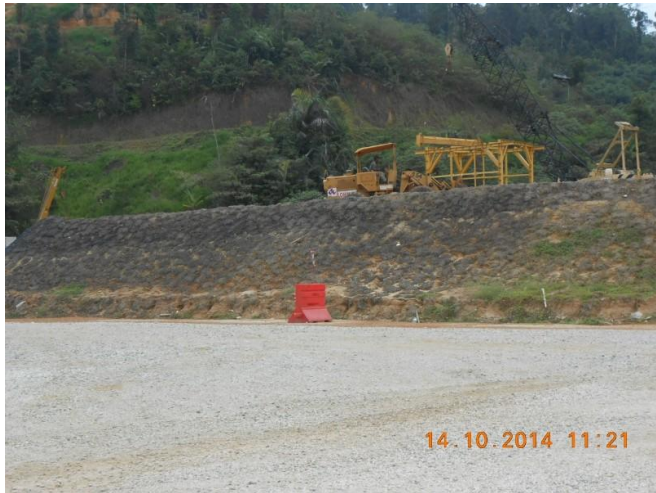
Plate 3c: Turfing has been dead is observed (near to the pipe storage).

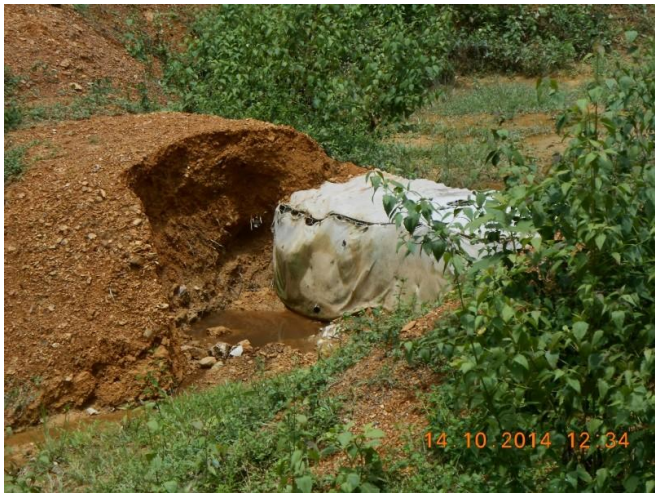
16.	Relocation Road	ST-2-18 CH 3600	✓	-	Installed on: 28 February 2014 Status: Operational	Next Maintenance: 03 October 2014	<u>Observation:</u> - Dry silt trap is observed. - Outlet is observed to be eroded. <u>Suggestions/Recommendations:</u> - To rectify the outlet immediately. - Daily monitoring and regular inspection/maintenance to be carried out after event of heavy downpour.	<u>Observation:</u> - Slightly clear discharge is observed. - Outlet is observed to be eroded. <u>Suggestions/Recommendations:</u> - To rectify the outlet immediately. - Daily monitoring and regular inspection/maintenance to be carried out after event of heavy downpour.	<u>Observation:</u> - Slightly clear discharge is observed. - Outlet gabion is observed to be eroded. <u>Suggestions/Recommendations:</u> - To rectify the outlet immediately. - Daily monitoring and regular inspection/maintenance to be carried out after event of heavy downpour.	X

Plate 4b: Outlet to be eroded is observed (ST-2-18).

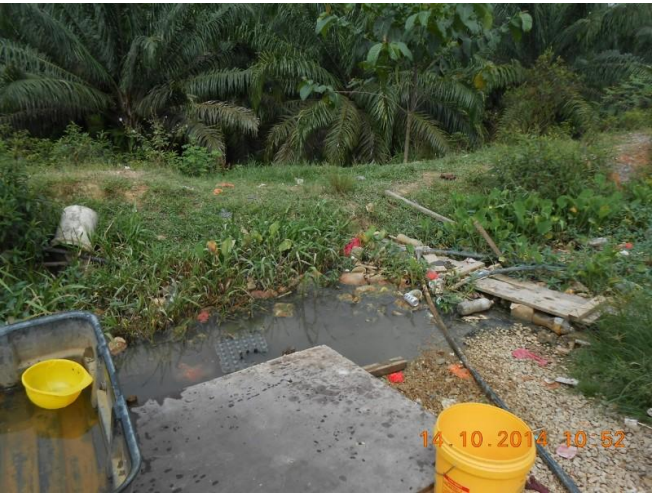
Plate 5a: Solid waste is observed scatter around (workers' camp).

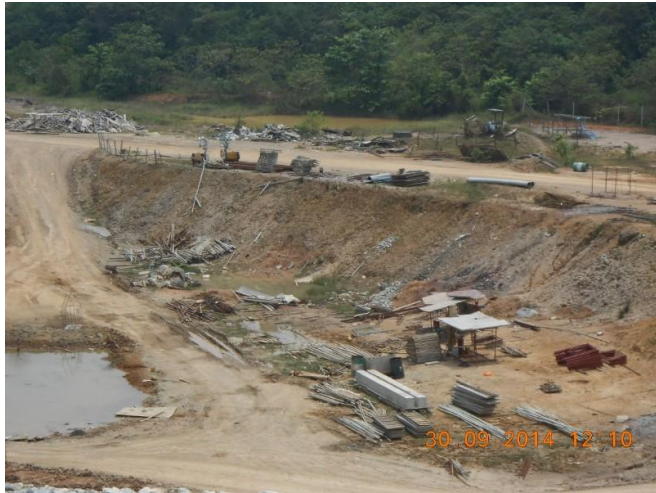
Plate 5b: Housekeeping for construction waste has yet to be carried out (draw-off tower).

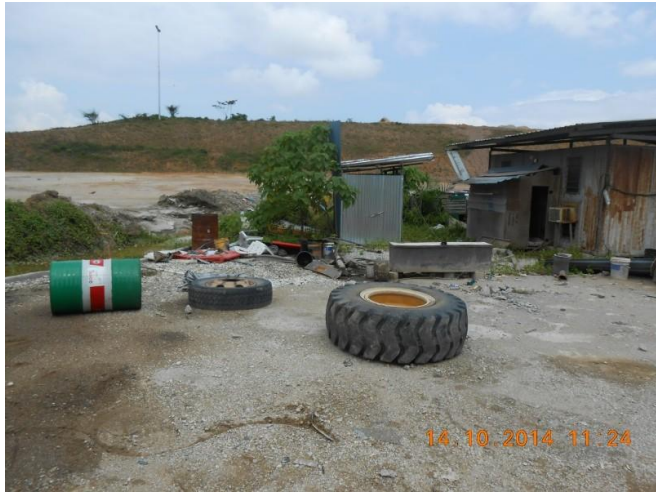
Plate 5c: Poor housekeeping is observed (batching plant).

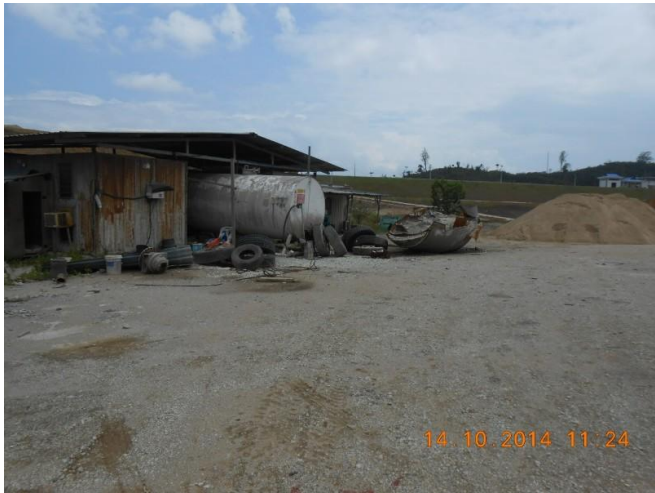
Plate 5d: Poor housekeeping is observed (batching plant).

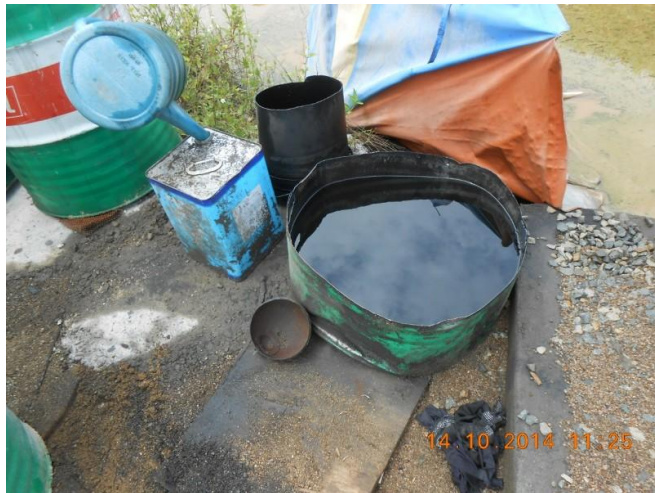
Plate 6a: Poor housekeeping is observed (batching plant).

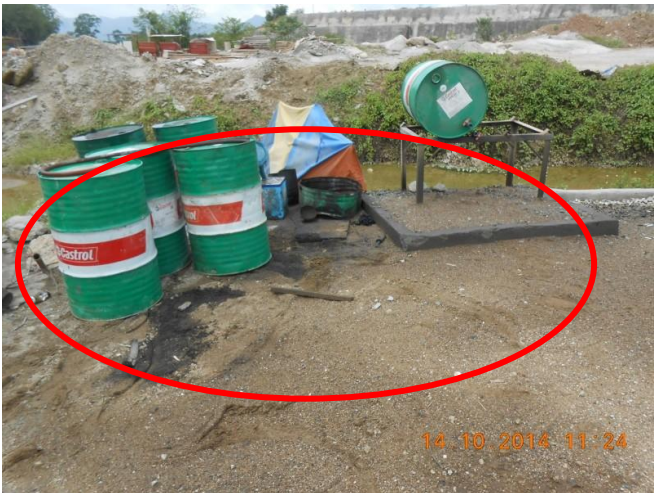
13.	Batching Plant	Oil & Grease; Scheduled Waste (SW)	-	-	<u>Last Maintenance:</u> - 3 June 2013: Repair broken bund <u>Proposed Action / Action Taken:</u> Oil spillage has been collected as SW and the area has been rectified. <u>Next Maintenance:</u> Every day morning	<u>Observation:</u> - Oil spill and contaminated soil has yet to be rectified. <u>Suggestions/Recommendations:</u> - SW to be properly contained, labelled, stored and handled/disposed in accordance to the regulations. - Inventory record to be maintained. X	<u>Observation:</u> - Oil spill and contaminated soil has yet to be rectified. - Poor housekeeping is observed. - Silted earth drain is observed. <u>Suggestions/Recommendations:</u> - To carry out housekeeping and de-silting works immediately. - SW to be properly contained, labelled, stored and handled/disposed in accordance to the regulations. - Inventory record to be maintained. X	<u>Observation:</u> - Oil spill and contaminated soil has yet to be rectified. - Housekeeping has yet to be to be carried out. - Silted earth drain has yet to be de-silted. <u>Suggestions/Recommendations:</u> - To carry out housekeeping and de-silting works immediately. - SW to be properly contained, labelled, stored and handled/disposed in accordance to the regulations. - Inventory record to be maintained. X	X

Plate 6b: Oil spill is observed (batching plant).

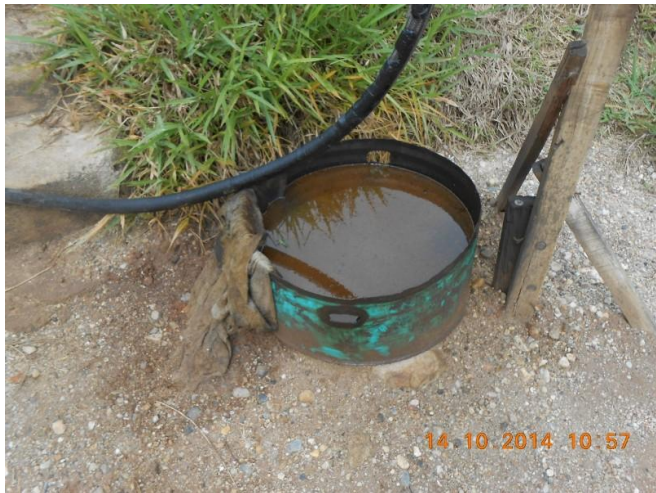
Plate 6c: Contaminated geotextile and oil ponding is observed (workers' camp).

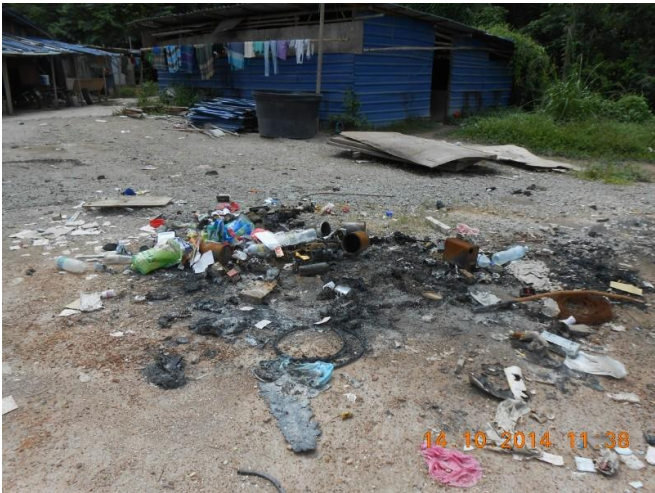
Plate 1a: Remnant of open burning activity is observed (workers' camp near pipe storage).

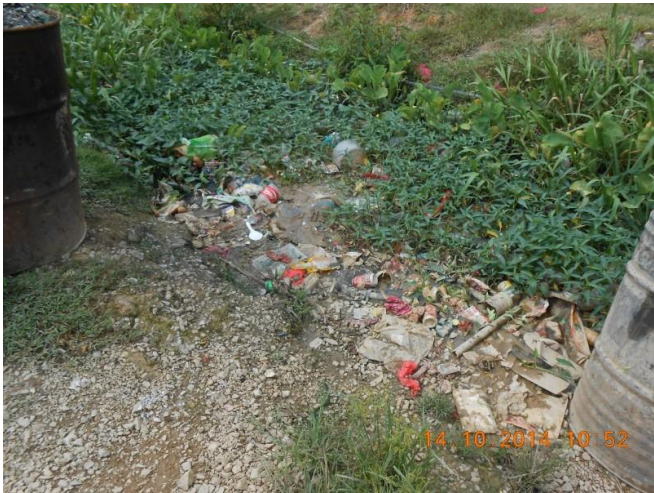
Plate 1b: Poor housekeeping is observed (drain at workers' camp).

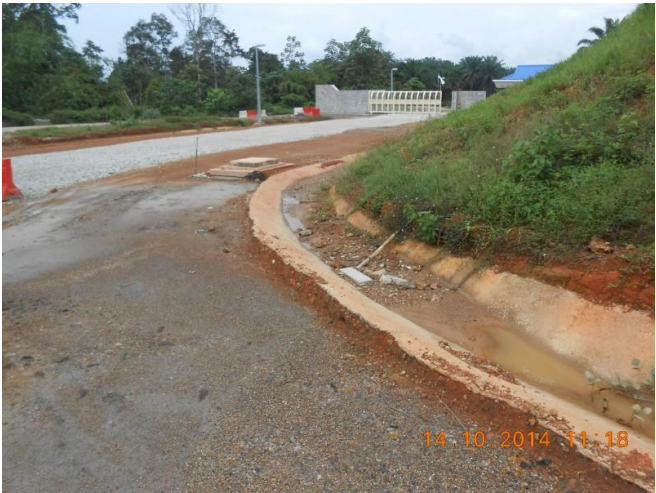
Plate 2a: Silted drain has yet to be de-silted (near main entrance gate).

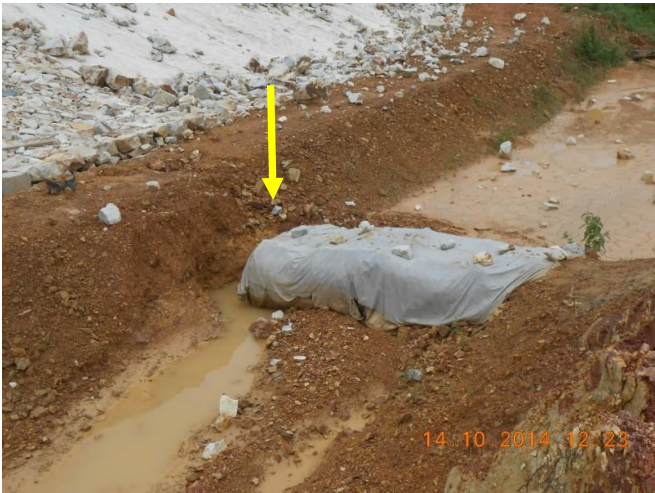
Plate 3a: Gap is observed at gabion wall (ST-2-16).

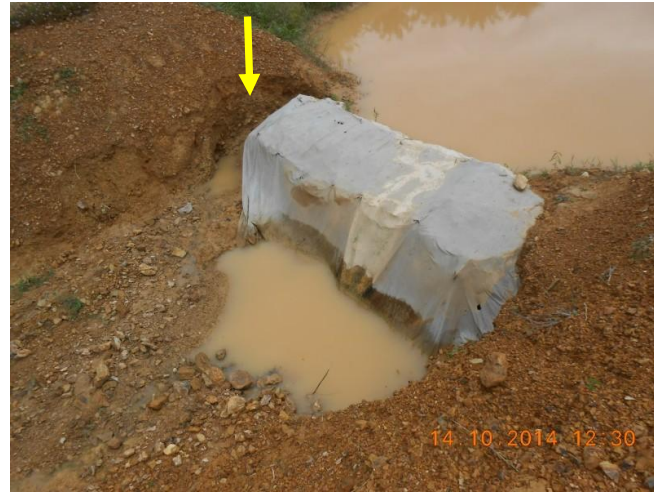
Plate 3b: Gap is observed at gabion wall (ST-2-17).

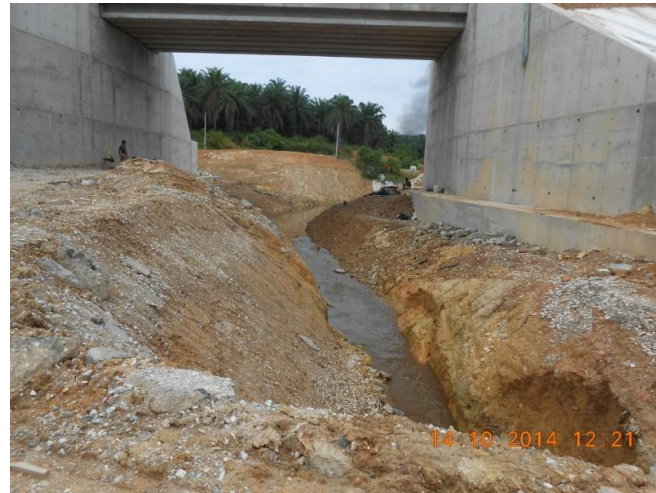
Plate 4a: Exposed slope has yet to be protected (relocation road under bridge).

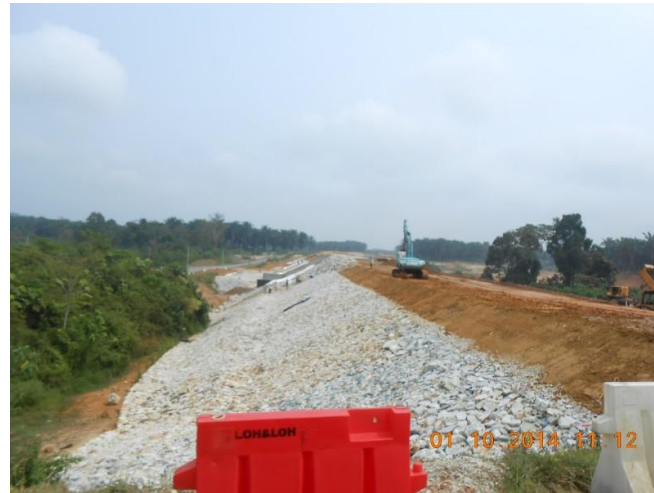
Plate 4b: Exposed slope has yet to be vegetated (relocation road).

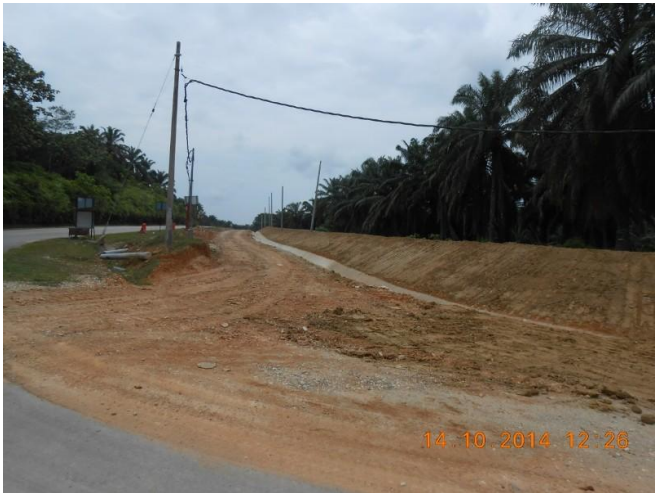
Plate 4c: Exposed slope has yet to be vegetated (relocation road).

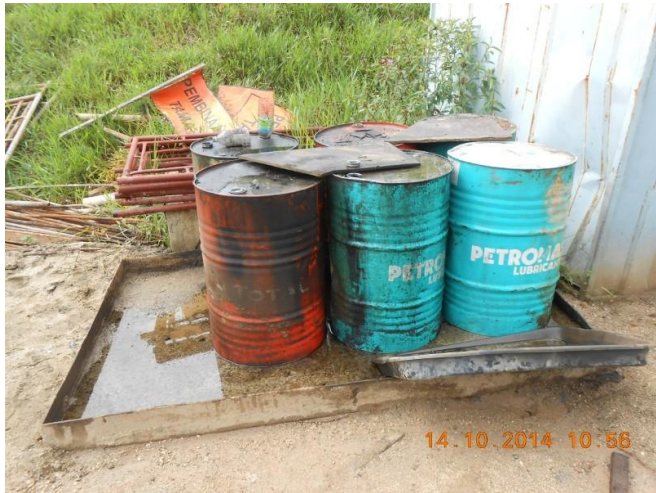
Plate 5a: Schedule waste without labelling is observed (workers' camp).

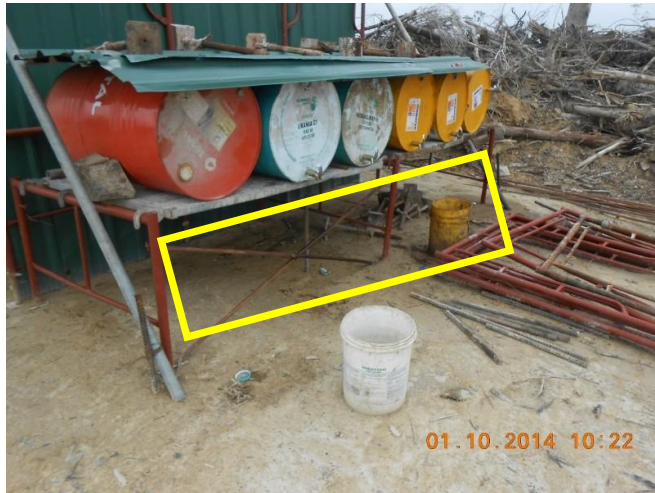
Plate 5b: Oil drums without tray are observed (saddle dam b).

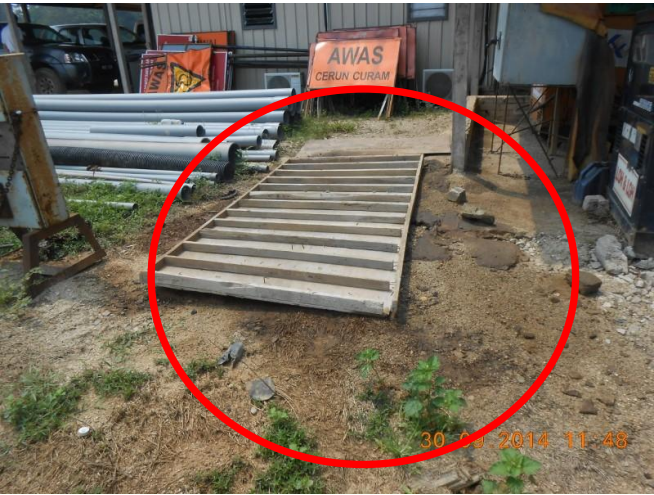
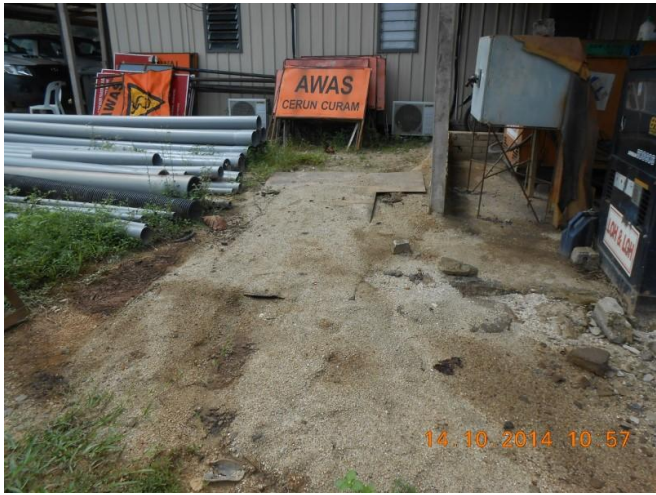
Plate 1a **(Before)**: Oil spill is observed (near genset at site office).

Plate 1a **(After)**: No more oil spill (near genset at site office).

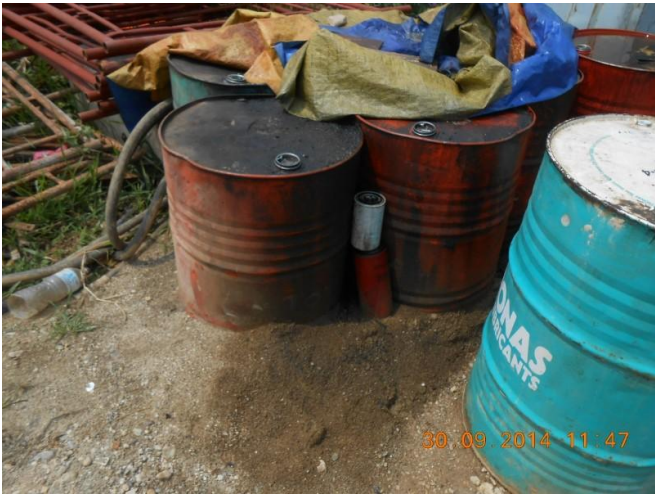
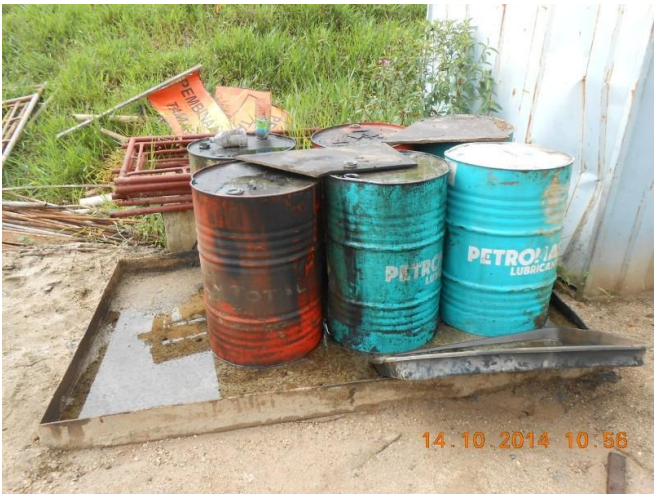
Plate 1b **(Before)**: Contaminated sand is observed in the tray and no labelling (workers' camp).

Plate 1b **(After)**: Contaminated sand has been collected (workers' camp).

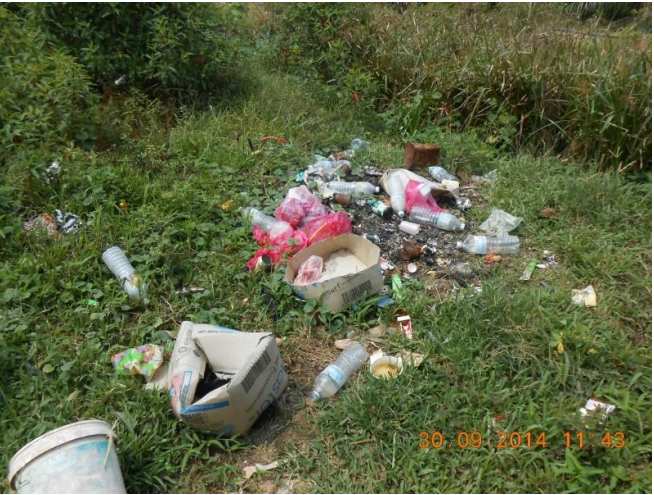
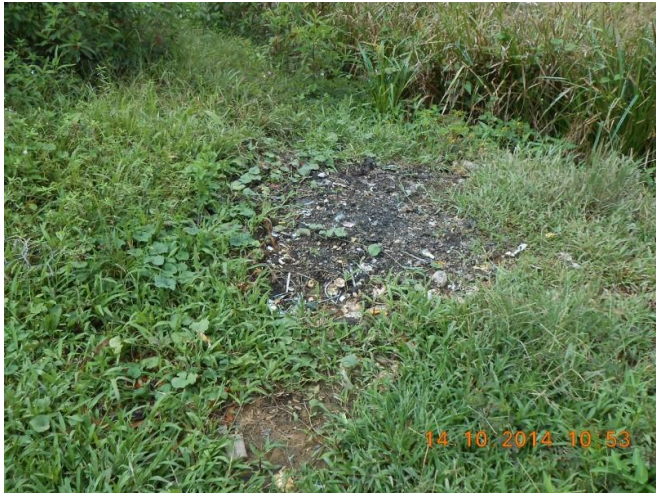
Plate 2 **(Before)**: Remnant of open burning activity is observed (workers' camp).

Plate 2 **(After)**: Remnant of open burning activity has been clean up (workers' camp).

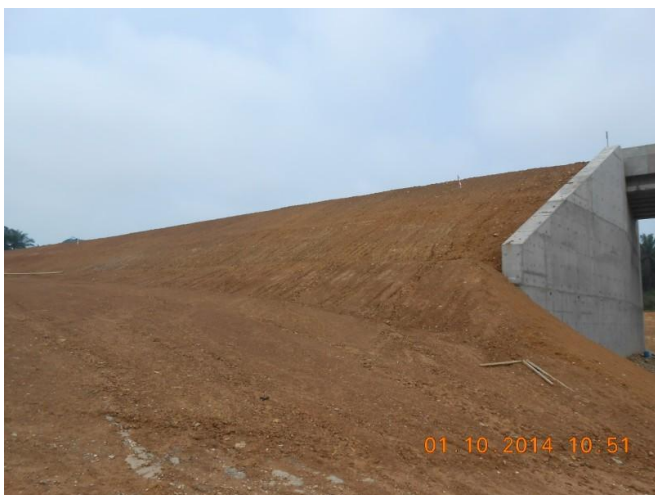
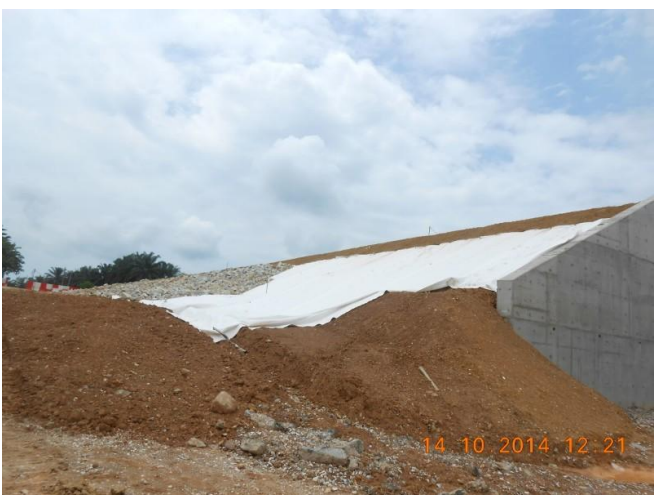
Plate 3a **(Before)**: Exposed slope has yet to be protected (relocation road near bridge).

Plate 3a **(After)**: Riprap works is in progress (relocation road near bridge).

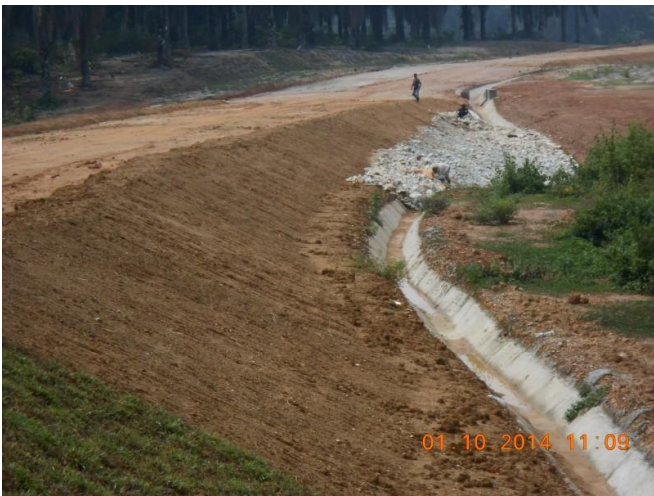
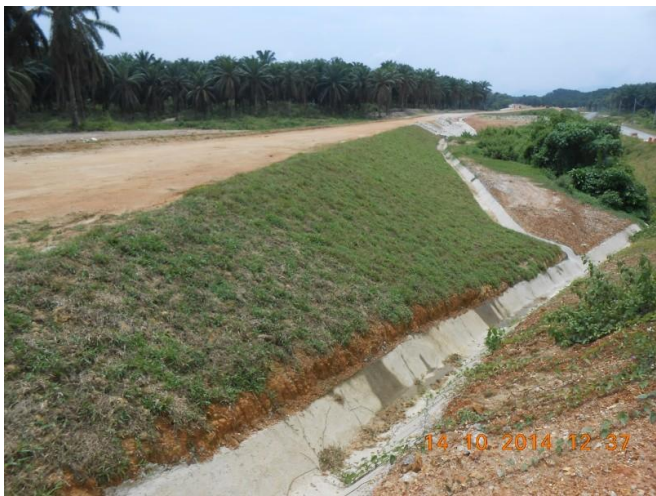
Plate 3b **(Before)**: Exposed slope has yet to be vegetated (relocation road).

Plate 3b **(After)**: Exposed slope has been turfed (relocation road).

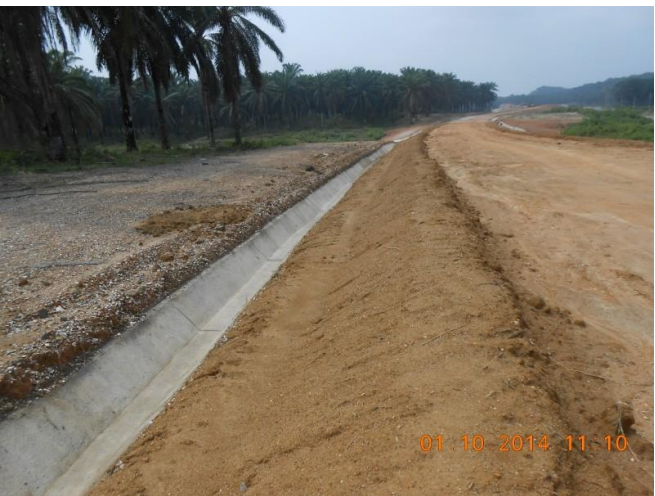
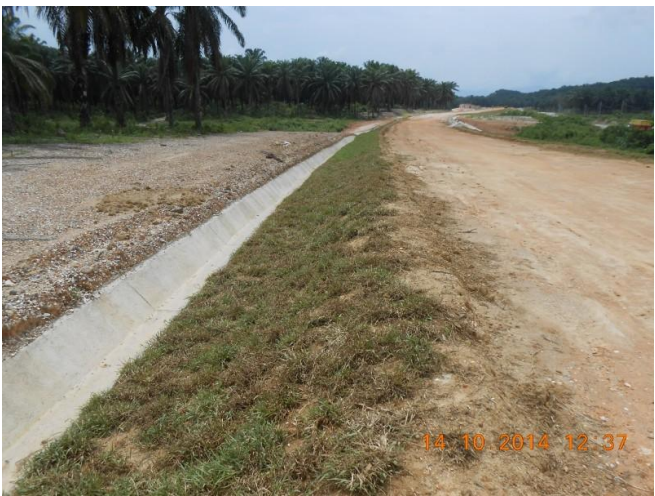
Plate 3c **(Before)**: Exposed slope has yet to be vegetated (relocation road).

Plate 3c **(After)**: Exposed slope has been turfed (relocation road).
