Quality & Metrology Part-Assembly Project

Coventry University Manufacturing Engineering: 156MAM

Jack Farmer (7901797), Omar Mashaly (7604717)

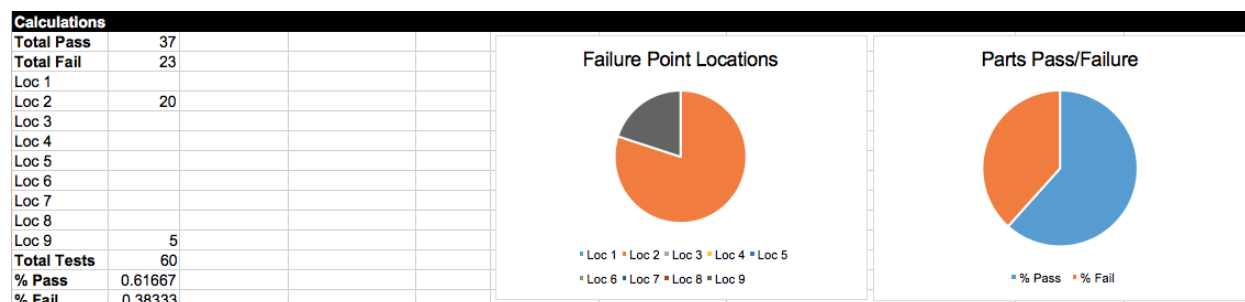
Figure 3.1-4 Summary of data collected from filler inspection

From the data collected over the course of one batch of filler pipes, it was found that only 61.7% of pipes fit in the jig and hence were in tolerance for all dimensions. This is surprising considering supposedly all of the pipes had passed the existing quality check and were ready to be sent to the customer.

As shown in figure 3.1-4, all instances of scrap were caused by locations 2 and 9, and in two occurrences both areas simultaneously. Location 2 is after the first bend, where a dimple appears below the bend (see figure 3.1-5). In theory, this does not affect functionality as pipe is still water tight; but in reality, no longer fits in jig as the area surrounding the dimple is wider. It should be kept in mind that the fuel filler must fit in a small channel inside the car and hence must fit inside the jig. The dimple at location 2 is likely caused by insufficient support inside the pipe whilst bending, where the support is either too small in diameter to support the inside wall of the pipe or is not long enough to support the whole area surrounding the bend.

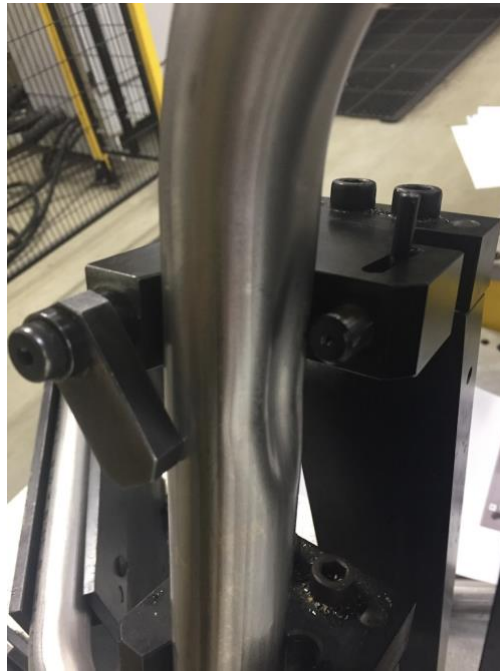
Figure 3.1-5 Dimple at location 2 of filler

An additional failure mode was also added based on findings from data collection. This is for dimples on the pipe bends, as this was a significant issue on parts that were inspected (33% of fillers had a dimple at the same location). This was missing on the existing FMEA.

4	ASP5150	Addison 2 bend	Dimpls next to pipe bend	Pipe may not fit into jig and hence onto vehicle, dimples can cause weakness in pipe increasing possibility of damage	Insufficient support on pipe during bend. Incorrect settings or worn/broken tooling	N/A	9	3	10	270	Jig is to be kept in a controlled environment to ensure calibration and reliability, pipes are checked against jig more frequently (every pipe is tested).	JF, OM	Jig is kept in controlled metrology lab and double visual checks are used to determine if dimples are present. Data is collected and used to check for patterns which could indicate machine faults.	3	3	2	18
5	ASP5150	Sawing	Pipe length cut too short	Too short will result in non-fitment with upper pipe and in vehicle.	Saw fixture tooling worn/broken. Incorrect set-up	SOP is used to guide operators. Skills matrix is used to check operators' ability. 1st off & additional 4 checks in gauge per shift.	7	2	5	70	Every pipe is inspected using the jig to more effectively recognise tooling issues. Saw fixture can then be periodically repaired and calibrated.	JF, OM	Inspection on 100% of pipes. Data is collected to recognise patterns of failure indicating tooling issues.	2	7	2	28

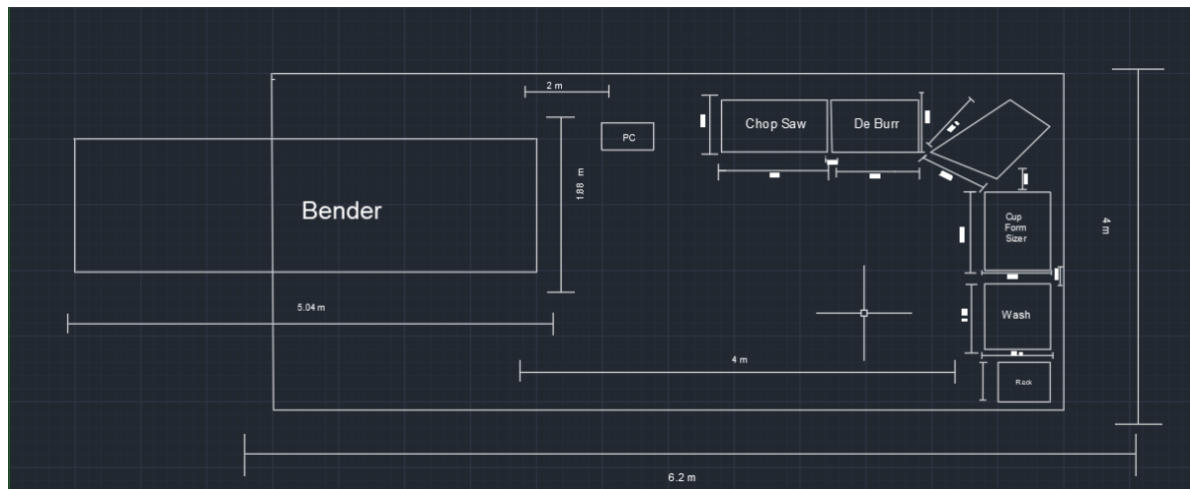
The layout is organised in a rectangular area which includes at the far left as seen on (figure 3.4-1) there is the bender, then right in front of it on the top 2 meters away there is the personal computer which you choose exactly the bends of each fuel filler that is programed on the computer, right beside it there is the chop saw, the De Burr is the next machine, then on the right side there is the cup form sizer, under it is the wash machine and finally there is the rack. All of this area is made in a 6.2 meters length and 4 meters width making the area 24.8 m².

Figure 3.4-1 Current layout of the bender cell

As for how these machines are spread, the quality check for the pipe after each process is not a problem as they check everything visually during the whole process after each station in it. The only problem is that there is not enough equipment to check the quality for each station. This conclusion of the layout was determined by timing the whole process, which is 62 seconds, checked visually, and the area was calculated so that the layout was concluded to be good enough to be used and not changed. These quality themes were discussed before in the key themes of quality.

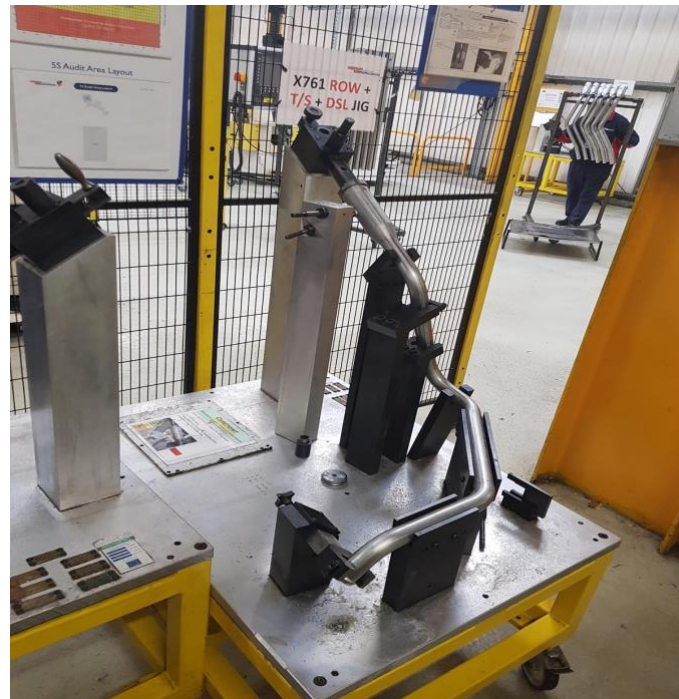
At the end of the entire bending cell, after all processes (the last process being the end forming) the bent pipe is placed in a jig (see figure 4.1-1). The jig is used to check the bend angle, as well as the positioning of the cup form and the end of the pipe. This acts as a visual check - no measurements are taken on the jig. The operator places and removes the pipe from the jig manually.

Figure 4.1-1 Current bending gauge

A copy of the calibration certificate for the jig was obtained (this can be viewed in Appendix 6). The calibration is measured using a FARO control arm. It should be noted that the jig is measured for calibration at the Standard Reference Temperature of $20^{\circ}\text{C} \pm 1^{\circ}\text{C}$. This is in accordance with ISO 1 which defines the reference temperature for 'geometrical product specification and verification' to be 20°C .

However, the area that the jig is kept in, on the factory floor, is not kept at the standard temperature and there are no measures in place to maintain even temperature and humidity. The factory is not insulated for temperature or vibration, hence changes in the outside environment or vibration from machine can directly influence the jig. Therefore, the calibration done on the jig is quickly undone, and any measurements taken cannot be verified to be precise. This may also pose an issue if Unipart aim to achieve UKAS accreditation for their metrology.

Hence it is proposed that 100% of parts are inspected using the jig at the end of the processes in the bending cell, though the jig will be adapted to provide meaningful numerical data. This would be in addition to double visual inspections - details on which processes have visual inspections can be found in the proposed FMEA (appendix 8).

It is proposed that the current jig is retrofitted with digital dial test indicators (DTIs). These would be fitted at 9 locations on the jig (see figure ??). The digital DTIs would be connected to a computer which would allow data to be automatically fed into a collection system. Data from each measurement would be input automatically in a database. This is faster than manual data collection, meaning the increased frequency of inspection would not have as much of a substantial impact on time.

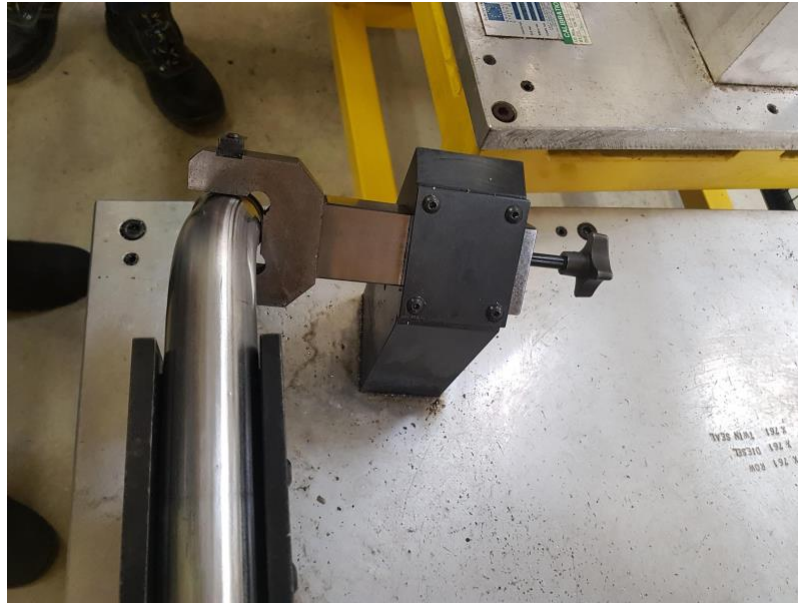
The endform process is the last process of manufacturing the fuel filler, it is the process after cutting the pipe and cleaning the end in the De Burr machine; the end part of the bent and cut pipe is then put in the cup form machine to form the endform of the fuel filler. The machine uses spinning of some round tools to create the endform shape needed. Each endform machine in the factory has its own dimensions on the shape of the endform. After finishing the process, the endform is then inspected visually and then is put in a gauge that checks the whole fuel filler's bend angle, length and width, and the endform (see figure 4.2-1). The cup forming machine and the quality check gauge are suitable.

Figure 4.2-1 Endform test on jig

In order to make the full check of the endform there is a proposal that should not be too expensive. The proposal is to get a small coordinate measuring machine (CMM), which would be small in size. The machine will basically be a small robot which has a small hand with a needle that will move around the endform from the inside and the outside to measure the accurate size of the hole. This will be accurate enough for the endform to be done correctly

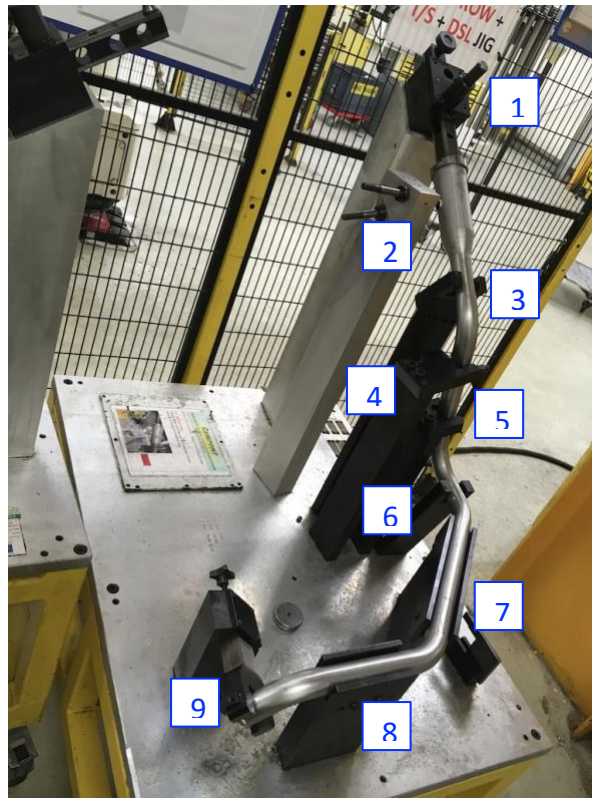
Figure 5.3.1-2 Digital DTI locations

As already mentioned, the data from the DTIs would then be used to generate SPC graphs which can be used for machine fault detection. If the SPC line begins to tend towards the control limits, this can be spotted before parts begin to be out of tolerance and steps can be taken to prevent faulty parts being made.
