HOME INSPECTION EXECUTIVE SUMMARY

Address: 251 N Bristol Ave, Los Angeles, CA 90049
Client: Binsr Demo
Inspector: Binsr
Date: 08/13/2025

This is a supplementary report - refer to full TREC report for complete details

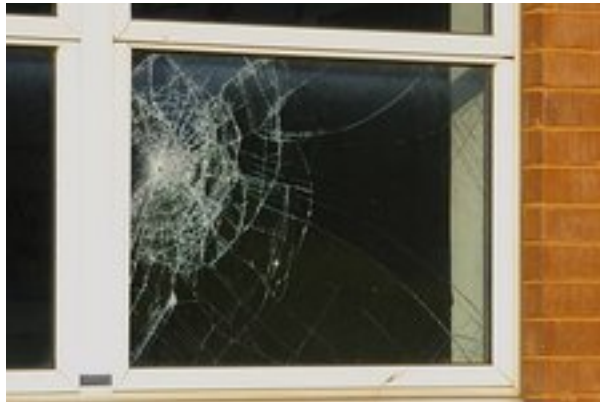
Ground-Level Exterior Structures: Window Systems and Sealing

A glass pane on one or more windows was broken. It is recommended to replace broken windows to restore their intended fu...

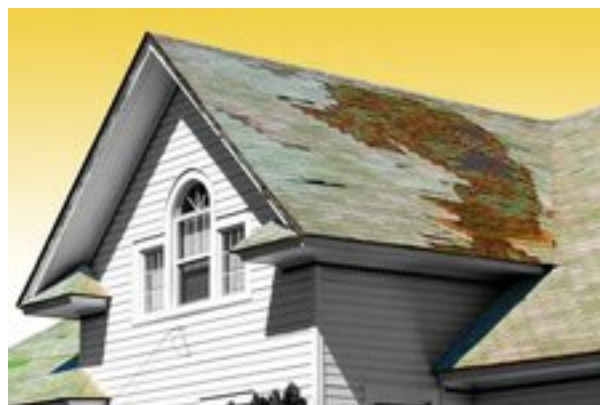
Roofing System Assessment: Overall Roof Condition

Several roof shingles were observed to be broken. This condition may lead to water intrusion and should be addressed pro...

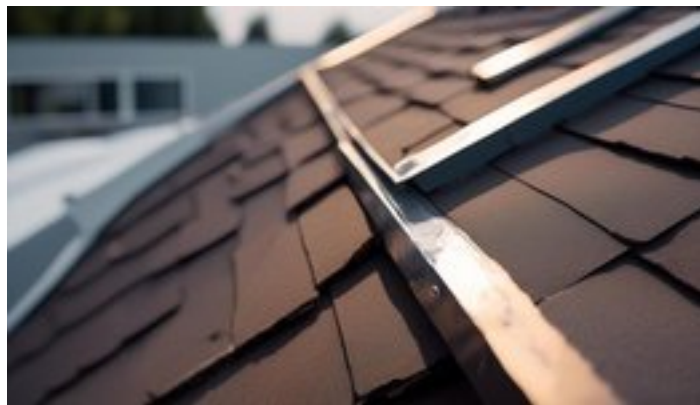
Roofing System Assessment: Roof Flashing Components

Observations indicate the presence of openings or gaps within the flashing or sealant materials. Such breaches can compr...
