Palo Verde Nuclear
Generating Station

Subject: **Palo Verde Nuclear Generating Station (PVNGS) Unit 2**
Docket No. STN 50-529
License No. NPF-51
Licensee Event Report 2012-002-00

Condition Prohibited by Technical Specification Due to Low Pressure Safety Injection System Drain Pipe Leak

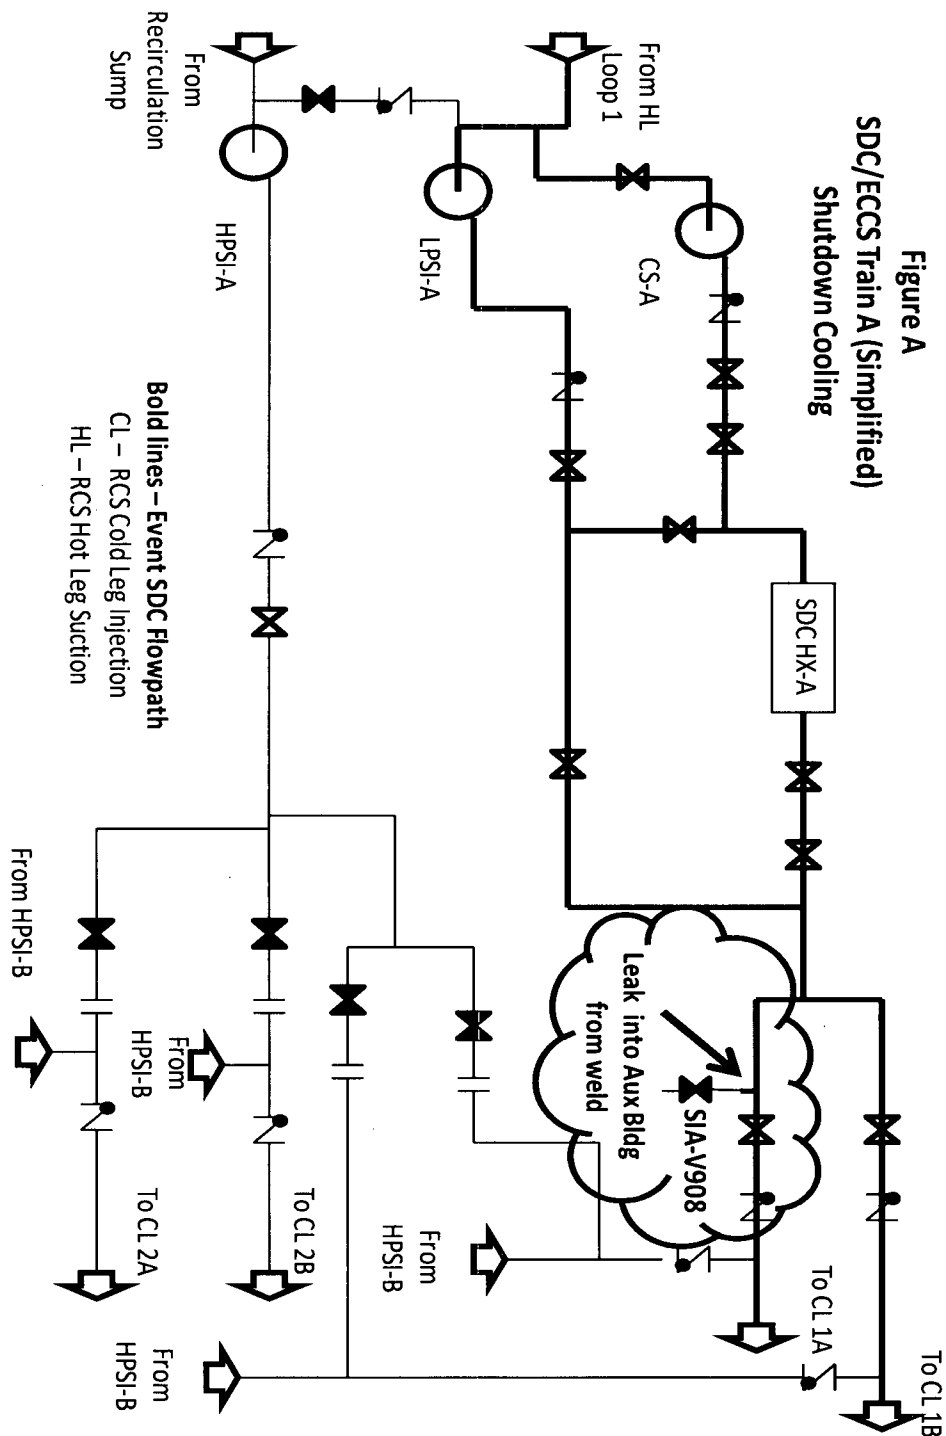
Figure A provides a simplified functional diagram of the Train A SI systems and displays the leak location within the LPSI/SDC system.

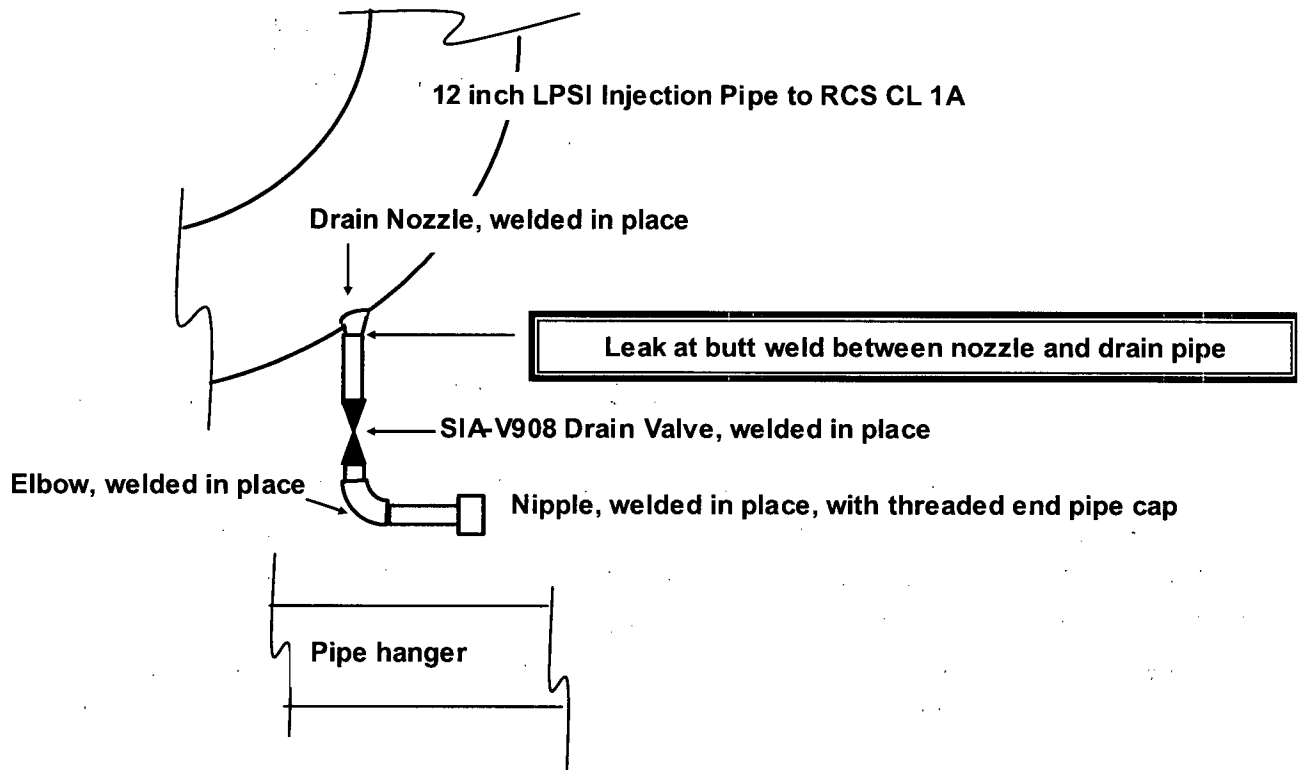
Subsequently, with the piping insulation removed, an examination of the drain pipe upstream of valve SIA-V908 identified a through-wall defect on the weld that attaches the drain pipe to the nozzle on the LPSI cold leg 1A injection pipe. The leak rate was estimated to be approximately 0.25 gallons per minute. Figure B provides a sketch of the drain pipe configuration.

LPSI Header 1A Injection Pipe and Drain Pipe / SIA-V908 Configuration on October 8, 2012

The weld defect resulted from the installation of a temporary drain fitting which was left attached to the pipe nipple downstream of valve SIA-V908 when Train A SDC was returned to service following maintenance in December 1991. Piping thermal growth occurred when SDC was placed in operation which caused the SIA-V908 assembly to contact an adjacent pipe hanger (see Figure B) and act as a restraint to system vibrations that occur during operation. As a result, a defect was initiated in the weld due to abnormally high cyclic stresses induced when the SIA-V908 assembly was restrained by contact with the pipe hanger during SDC operations.

Prior to November 1991, insufficient clearance between valve SIA-V908 and the pipe hanger prevented installation of drain fittings. In November 1991, following installation of a new SIA-V908 valve, the clearance was increased which then allowed the installation of a temporary drain fitting during maintenance activities. The temporary drain fitting was left installed when the system was restored to service in December 1991 and remained until May 1993. During that time, SDC operations resulted in high cyclic stresses being imparted on the weld. In May 1993, the design of the outlet side of valve SIA-V908 was modified to install the current elbow and nipple configuration and correct the interference problem such that no further contact with the adjacent pipe hanger occurred. This design change modified only the outlet side of the valve such that the weld upstream of SIA-V908 (which contained the defect) was not worked on. During the time from May 1993 to October 2012, the defect propagated slowly from high cycle fatigue during normal system operations until the pipe wall was breached during Train A SDC operations in refueling outage 2R17.

To correct the weld defect, the subject drain pipe and valve SIA-V908 assembly was replaced and the weld repaired on October 11, 2012.

To prevent recurrence, procedures will be revised to require that systems with capped pipe ends be returned to their design configuration with fittings removed and pipe caps tightened when maintenance activities are completed.
