Subject: Docket No. 50-482: Licensee Event Report 2011-003-00, "Diesel Generator Declared Inoperable Due to Inadequate Reinstallation of Pipe Connection Resulting in Excessive Governor Oil Coolant Leak"

1. FACILITY NAME
WOLF CREEK GENERATING STATION2. DOCKET NUMBER
05000 4823. PAGE
1 OF 7

Diesel Generator Declared Inoperable Due to Inadequate Reinstallation of Pipe Connection Resulting in Excessive Governor Oil Coolant Leak

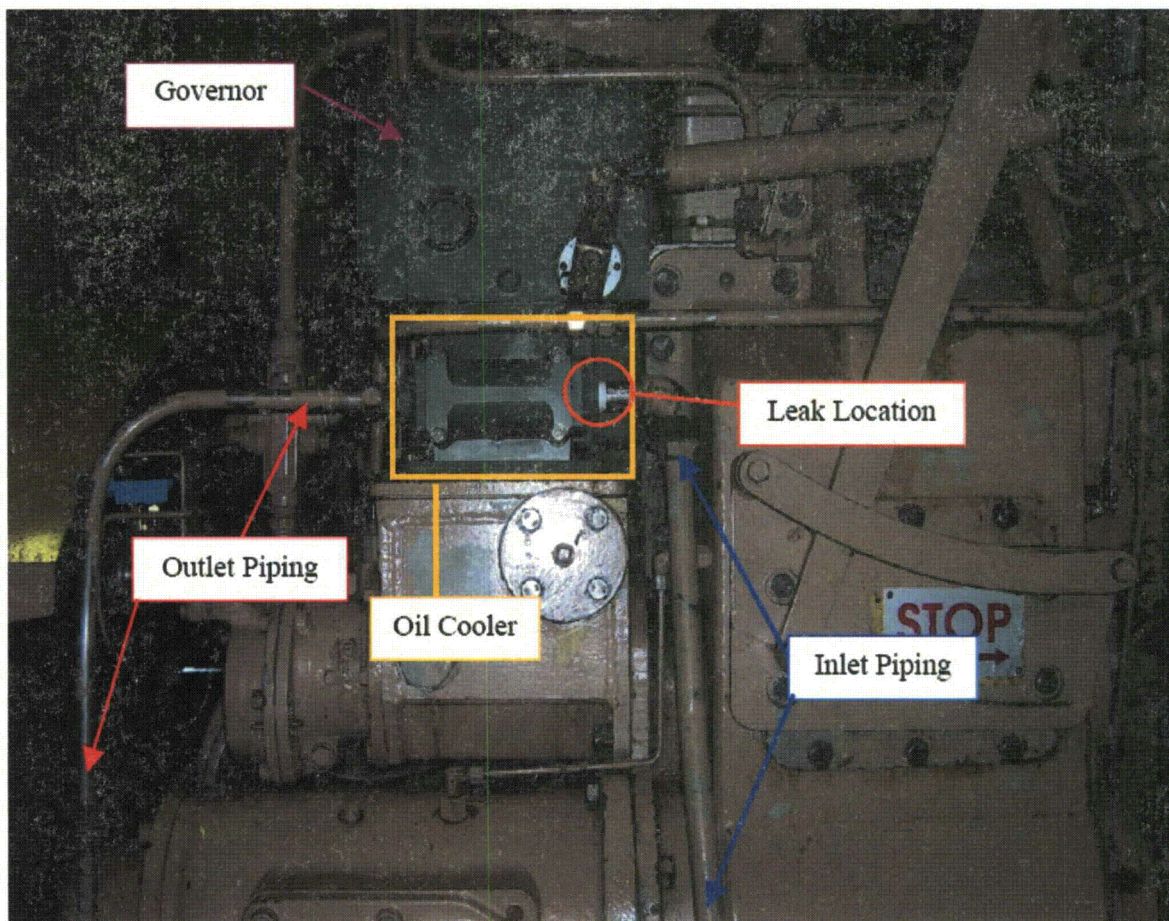
Figure 1

Work Order 11-338729-000 was generated to correct the leak. Upon disassembly, it was noted by the Wolf Creek Nuclear Operating Corporation (WCNOC) mechanic and documented in the work order, the pipe nipple at the inlet of the governor oil cooler was hand tight. As is common on National Pipe Threads (NPT), Neolube 100, a sealing paste, had been used on the pipe threads. Upon visual inspection, the threads of both the oil cooler inlet flange and the pipe were in good condition. There was no physical damage that would prevent the connection from sealing properly. The components were reassembled and the connection remained leak free during the subsequent reperformance of the 24 hour run (STS KJ-011A) on March 12-13, 2011.

While the pipe was found hand tight, the threads were fully engaged such that a rigid connection was established. This was confirmed prior to disassembly, noting no pipe movement occurred with the application of external force. This indicates, while the threads were not tight and sealed against leakage, the piping was restrained from movement. The pipe was restrained such that no further tightening or loosening could occur without disassembling other components (See Figure 1).

Work Order 11-338729-000 was generated to correct the leak. The components were reassembled on March 12, 2011 and the "A" DG was restored to operable status at 1815 CDT on March 12, 2011 following completion of post maintenance testing. The connection remained leak free during the subsequent reperformance of the 24 hour run (STS KJ-011A) on March 12-13, 2011.
