Subject: **Palo Verde Nuclear Generating Station (PVNGS)**
Unit 3
Docket No. STN 50-530
License No. NPF 74
Licensee Event Report 2013-001-00

Enclosed please find Licensee Event Report (LER) 50-530/2013-001-00 that has been prepared and submitted pursuant to 10 CFR 50.73. This LER reports a degraded principal safety barrier and a condition prohibited by Technical Specifications that resulted from leakage on one reactor vessel bottom-mounted instrument nozzle assembly.

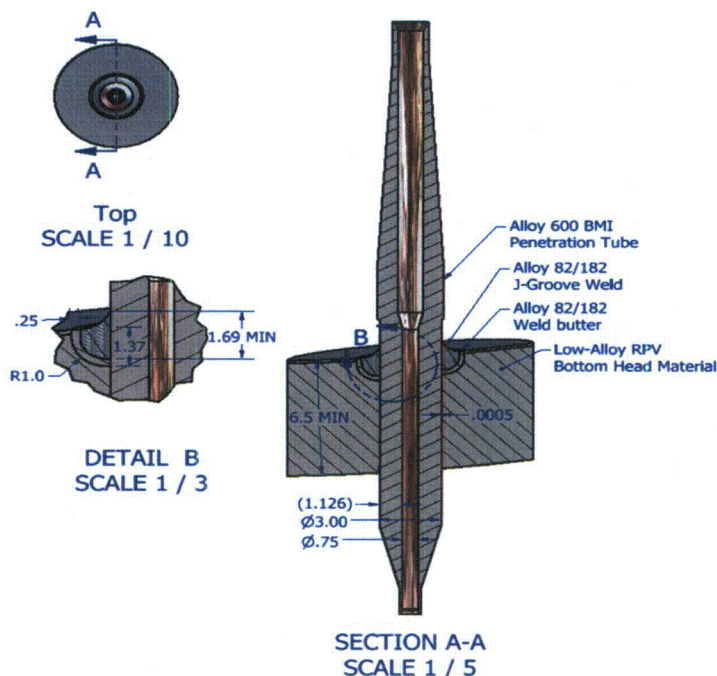
Figure 1- Illustration of a BMI Nozzle Assembly Including Location of Welds

The BMI nozzle assemblies in the reactor vessel lower head are fabricated from Alloy 600 and are internally connected to the vessel lower head with J-groove welds made from Alloy 82/182 (see Figure 1). These materials have known susceptibility to primary water stress corrosion cracking (PWSCC). Stresses that make Alloy 600 nozzle tubes and their Alloy 82/182 J-groove attachment welds susceptible to cracking are inherently induced by the welding of the nozzle tube to the inside surface of the reactor vessel lower head during

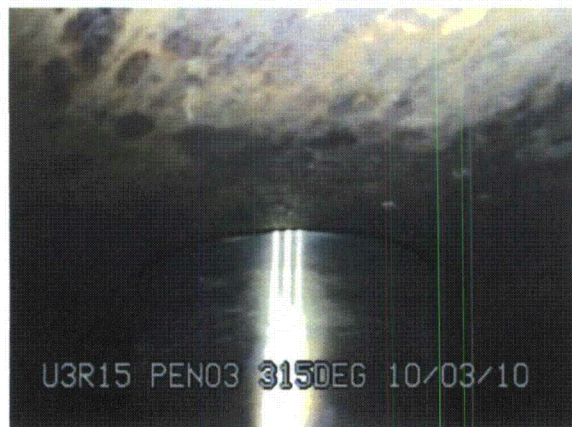
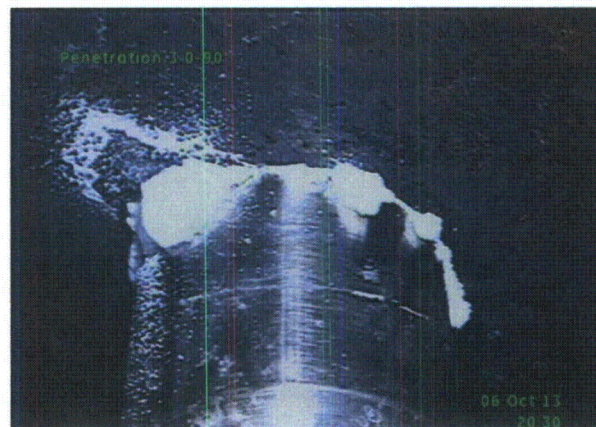
Figure 2 - Photos of Unit 3 BMI Nozzle 3

At approximately 2100 on October 6, 2103, during a scheduled visual examination of the reactor vessel BMI nozzle assemblies, white residue was discovered at the annulus region of BMI nozzle 3 (see Figure 2). The BMI visual examinations were performed using remote controlled video and photographic equipment to meet the in-service inspection requirements of 10 CFR 50.55a(g)(6)(ii)(E) and ASME Code Case N-722-1.

A sample of the residue was taken and analyzed for chemical and isotopic properties on October 8, 2013. Analysis confirmed the sample contained boron and lithium, with a chemical content consistent with RCS coolant. A gamma isotopic analysis was performed which found the leak to be active at the time of plant shutdown based, in part, on the presence of short-lived radionuclides in the residue. These results confirmed the residue was the result of RCS pressure boundary leakage.

On October 23, 2013, Arizona Public Service (APS) and vendor personnel completed volumetric NDE of BMI nozzle 3. The NDE included two time-of-flight diffraction ultrasonic (UT) examinations in both the axial and circumferential beam directions, a single 45 degree shear examination in the downward-looking direction, a 0 degree examination, and an eddy current examination (ECT) of the inside surface of the nozzle tube. APS, Westinghouse, and Electric Power Research Institution (EPRI) personnel independently reviewed the results of the NDE activities and concluded the source of the boron residue was a group of axially (lengthwise) oriented cracks that likely originated in the J-groove attachment weld of the nozzle tube to the vessel.

In addition to the UT and ECT examinations, a leak test was performed by pressurizing the BMI nozzle 3 annulus area on the bottom of the reactor vessel with helium and inspecting the inside of the vessel for emerging gas bubbles. Gas bubbles were observed rising from a location outside the nozzle tube in the J-groove weld at the tube interface. The leak test confirmed the origin of the leak.

The probable cause of the BMI nozzle 3 leakage was a near-surface weld flaw that came in contact with RCS water. The flaw initiation point was likely caused by a BMI J-groove weld defect that occurred during reactor vessel fabrication and was undetected by penetrant testing. The metallurgical analysis will focus on how the near-surface weld flaw then became exposed to the primary water environment and resulted in PWSCC.

To restore the reactor vessel pressure boundary, a half-nozzle repair of BMI nozzle 3 replaced the lower portion of the BMI nozzle assembly and moved the RCS pressure boundary from the J-groove weld inside the reactor vessel to a new J-groove weld outside the reactor vessel. As shown below in Figures 3 and 4, the new J-groove weld joins a new Alloy 690 bottom half-nozzle to an Alloy 52M ambient temperature temper bead weld pad deposited on the outer diameter of the reactor vessel bottom shell. The temper bead weld pad is addressed in ASME Boiler and Pressure Vessel (B & PV) Code Case N-638-4, which is conditionally accepted in Regulatory Guide 1.147, *Inservice Inspection Code Case Acceptability*, ASME Section XI, Division 1, Revision 16. The temper bead weld pad
