102-06904-DCM/DFH
June 24, 2014

Subject: **Palo Verde Nuclear Generating Station (PVNGS)**
Unit 3
Docket No. STN 50-530
License No. NPF 74
Licensee Event Report 2013-001-01

Leakage on Reactor Vessel Bottom-Mounted Instrumentation Nozzle 3

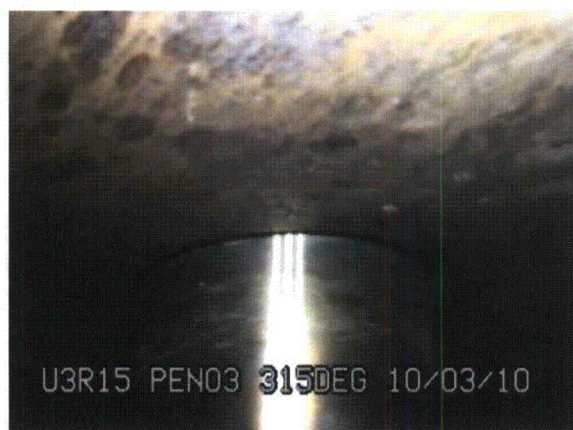
Year 2010

At approximately 2100 on October 6, 2103, during a scheduled visual examination of the reactor vessel BMI nozzle assemblies, white residue was discovered at the annulus region of BMI nozzle 3 (see Figure 2). The BMI visual examinations were performed using remote controlled video and photographic equipment to meet the in-service inspection requirements of 10 CFR 50.55a(g)(6)(ii)(E) and ASME Code Case N-722-1.

Upon discovery, the lead engineer for the PVNGS BMI inspection activity was notified and responded to the site to evaluate the condition. Qualified engineering personnel conducted a review of the photographic images and reviewed photographic records of past visual examinations of the Unit 3 BMI nozzle 3. At 0219 on October 7, 2013, engineering personnel determined the white residue was most likely boric acid resulting from RCS pressure boundary leakage.

Figure 2 - Photos of Unit 3 BMI Nozzle 3

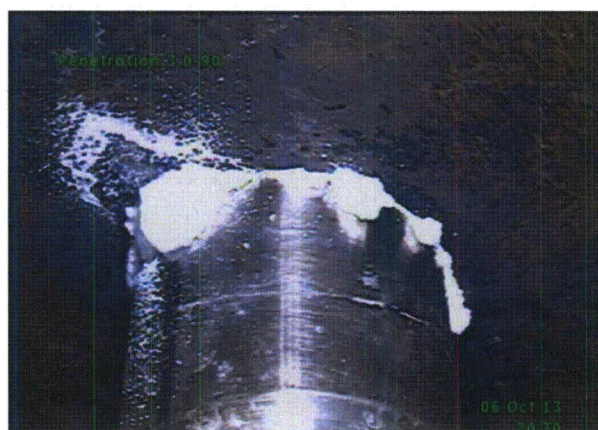
Year 2013

A sample of the residue was taken and analyzed for chemical and isotopic properties on October 8, 2013. Analysis confirmed the sample contained boron and lithium, with a chemical content consistent with RCS coolant. A gamma isotopic analysis was performed which found the leak to be active at the time of plant shutdown based, in part, on the presence of short-lived radionuclides in the residue. These results confirmed the residue was the result of RCS pressure boundary leakage.

On October 23, 2013, Arizona Public Service (APS) and vendor personnel completed volumetric NDE of BMI nozzle 3. The NDE included two time-of-flight diffraction ultrasonic (UT) examinations in both the axial and circumferential beam directions, a single 45 degree shear examination in the downward-looking direction, a 0 degree examination, and an eddy current examination (ECT) of the inside surface of the nozzle tube. APS, Westinghouse, and Electric Power Research Institution (EPRI) personnel independently reviewed the results of the NDE activities and concluded the source of the boron residue was a group of axially (lengthwise) oriented cracks that likely originated in the J-groove attachment weld of the nozzle tube to the vessel.

The laboratory analysis of the boat sample concluded the cracking observed in the boat sample is consistent with PWSCC. The laboratory results suggest a weld void became wetted at some point during service, which enabled the concentration of environmental constituents that promoted PWSCC in the weld and nozzle materials. There was no evidence of circumferentially-oriented cracking found in the nozzle material.

The cause of the pressure boundary leakage was axial cracking in a sub-surface BMI nozzle J-groove weld flaw that extended into the nozzle to a length exceeding the J-groove weld leg thickness. The laboratory analysis of the boat sample suggests the weld flaw became wetted at some point during service which enabled concentration of environmental constituents that promoted PWSCC in the weld and nozzle materials. Leakage occurred once the axial cracking extended below the J-groove weld root.

To restore the reactor vessel pressure boundary, a welded pad/half-nozzle repair of BMI nozzle 3 replaced the lower portion of the BMI nozzle assembly and moved the RCS pressure boundary from the J-groove weld inside the reactor vessel to a new J-groove weld outside the reactor vessel. As shown below in Figures 3 and 4, the new J-groove weld joins a new Alloy 690 bottom half-nozzle to an Alloy 52M ambient temperature temper bead weld pad deposited on the outer diameter of the reactor vessel bottom shell. The temper bead
