Subject: Licensee Event Report (LER) 2013-002-00
Waterford Steam Electric Station, Unit 3 (Waterford 3)
Docket No. 50-382
License No. NPF-38

Licensee Event Report 2013-002-00

1. FACILITY NAME					2. DOCKET NUMBER				3. PAGE						
Waterford 3 Steam Electric Station					05000 382				1 OF 8						
4. TITLE															
Emergency Feedwater System Flow Control Valve Fails To Close Due To Valve Positioner Failure

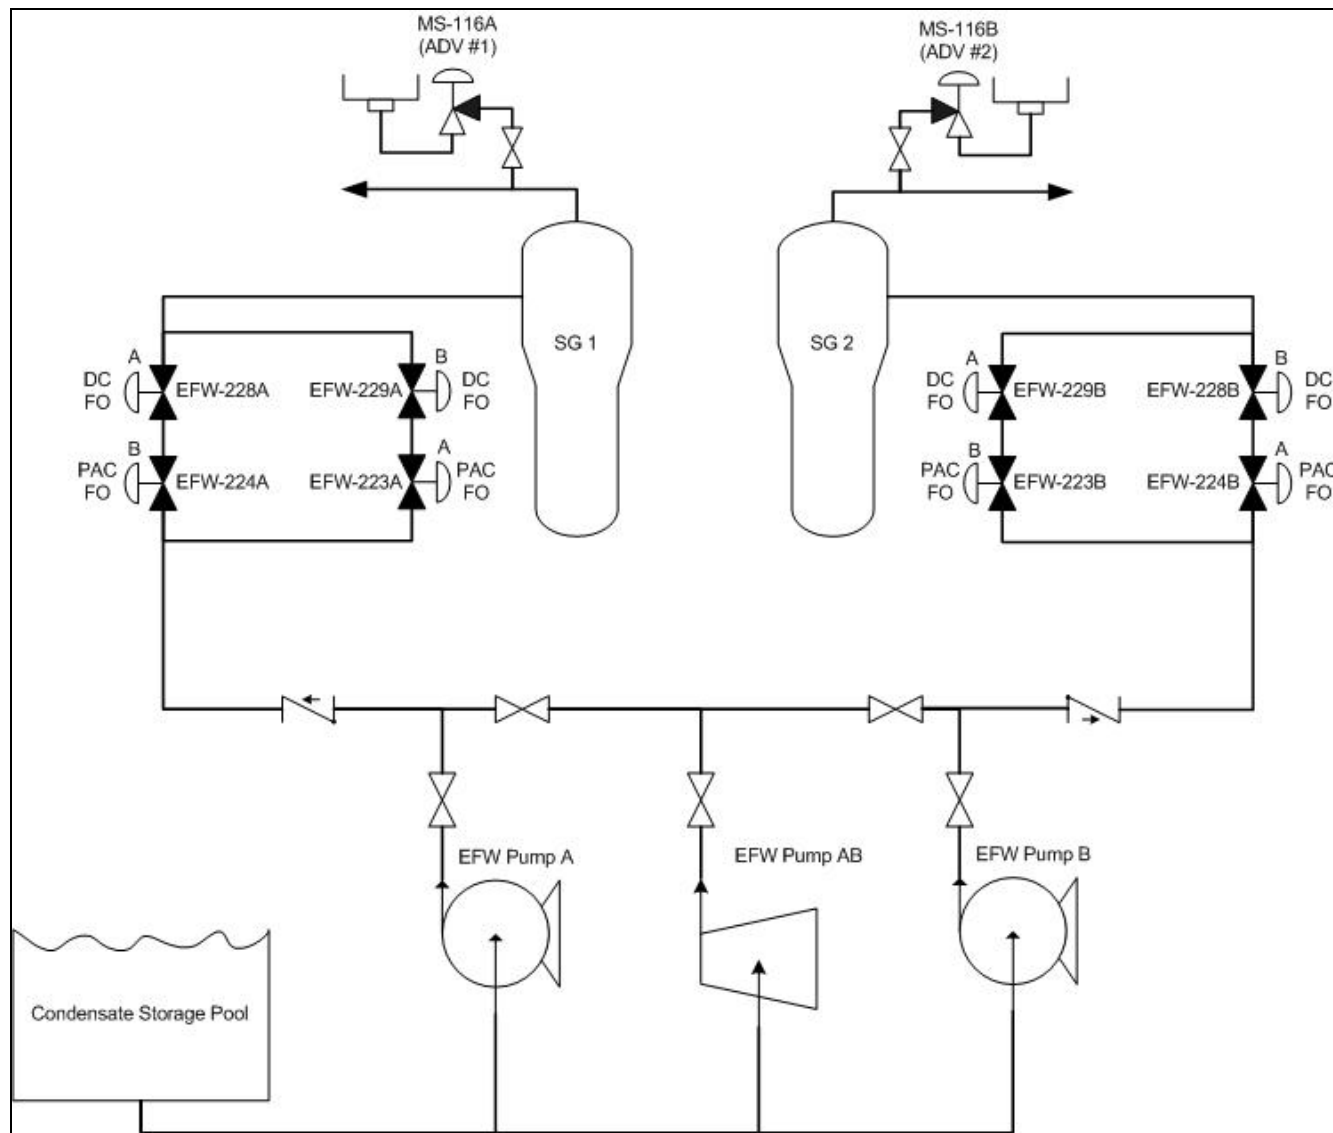
Figure 1: Emergency Feedwater System Basic Flow Diagram

Following the reactor trip, actuation EFAS-1 was received due to SG 1 level decreasing below setpoint. At this time the EFW pumps started, both SG 1 EFW isolation valves opened, and both SG 1 EFW flow control valves received a permissive to open (see Figure 1). EFW flow to SG 1 varied by several hundred gallons per minute (Point ID C26229). Control Room operators noted that EFW-223A (EFW to SG1 Backup Flow Control Valve) level controller output on panel CP-8 was oscillating rapidly from 10% to 50% and EFW flow to SG 1 was oscillating rapidly from 500 GPM to maximum flow. In addition, controller output for EFW-224A (EFW to SG1 Primary Flow Control Valve) [FCV] was noted to be stable.

Due to the rising SG 1 level, EFW-223A controller output was driven to the close position. At this time EFW flow was stable at approximately 280 GPM (approximately 200 GPM from EFW-224A and 80 GPM leaking by EFW-223A). Also due to the rising SG 1 level, EFW-224A was driven to the closed position. With a zero EFW flow demand signal, SG 1 level continued to rise (Point ID's A11106 / A11120) due to a 120 GPM EFW flow rate.

While Operations was resetting the EFAS actuation, EFW-228A (EFW to SG 1 Primary Isolation Valve) [FCV] was closed and EFW Flow to SG 1 did not change. However, when EFW-229A (EFW to SG 1 Backup Isolation Valve) [FCV] was closed, EFW Flow to Steam Generator 1 went to zero GPM. This

demonstrated that valve EFW-223A was not fully closed with an active close demand.
