**Subject: Palo Verde Nuclear Generating Station (PVNGS)  
Unit 3  
Docket No. STN 50-530  
License No. NPF 74  
Licensee Event Report 2008-001-01**

Attached, please find Licensee Event Report (LER) 50-530/2008-001-01, which supplements a previously reported manual reactor trip when removing a degraded Control Element Drive Mechanism Motor Generator set from service. This supplement is being submitted to report a change to the root cause of the event and the associated corrective actions described in the initial report.

LICENSEE EVENT REPORT (LER)  
CONTINUATION SHEET

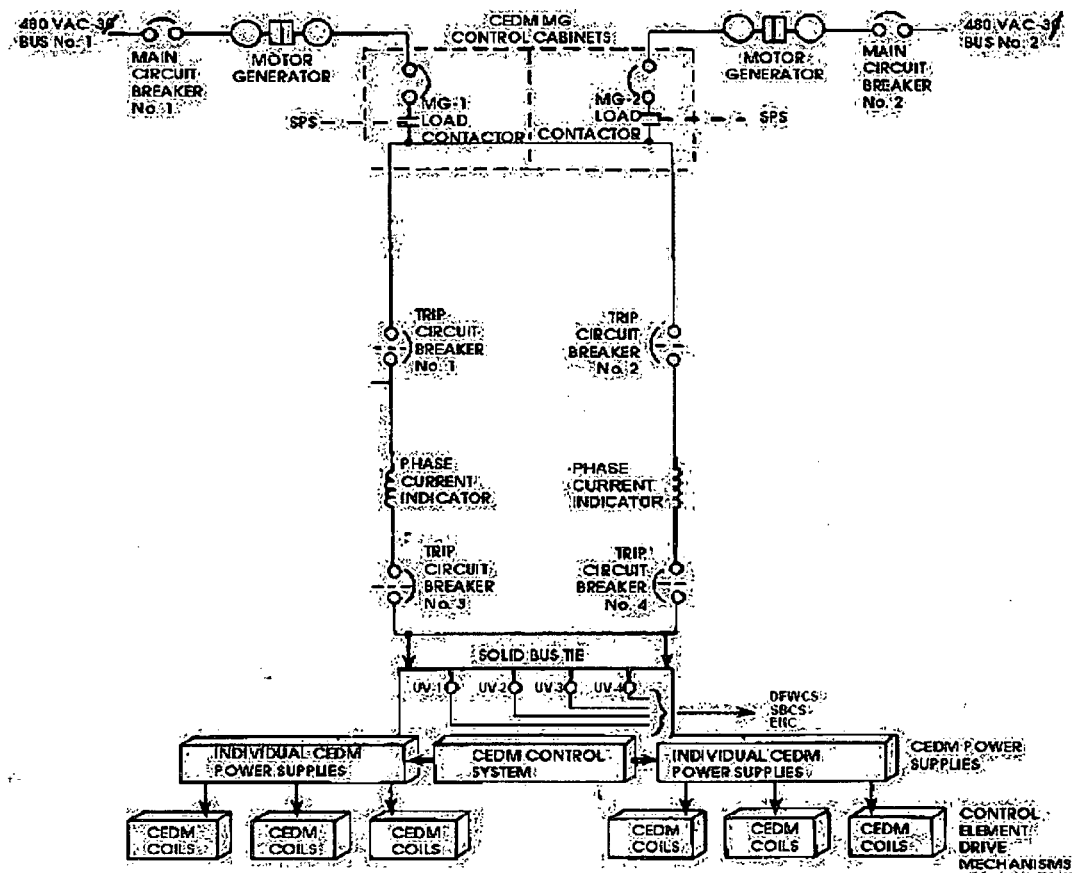
## **CEDM Bus Simplified**

The two MG sets are connected in parallel to a common bus to supply 240 VAC, 3 phase power through two parallel sets of two reactor trip circuit breakers (see drawing on the last page). These four breakers and their controls make up the reactor trip switchgear (RTSG) (EIS Code: AA). The output from the RTSG is directed through circuit breakers for subgroups of CEAs and downstream individual CEA circuit breakers (EIS: 52) and then through power switch assemblies containing silicon controlled rectifiers (SCRs) converting the 3 phase, AC power to a smoothed DC output. This smoothed DC output is then divided and distributed throughout the CEDM cabinets for ultimate delivery to the CEDM coils for all 89 CEAs.
