Subject: **Palo Verde Nuclear Generating Station (PVNGS) Unit 2**
Docket No. STN 50-529
License No. NPF-51
Licensee Event Report 2012-002-01

4. TITLE Condition Prohibited by Technical Specification Due to Low Pressure Safety Injection System Drain Pipe Leak
--

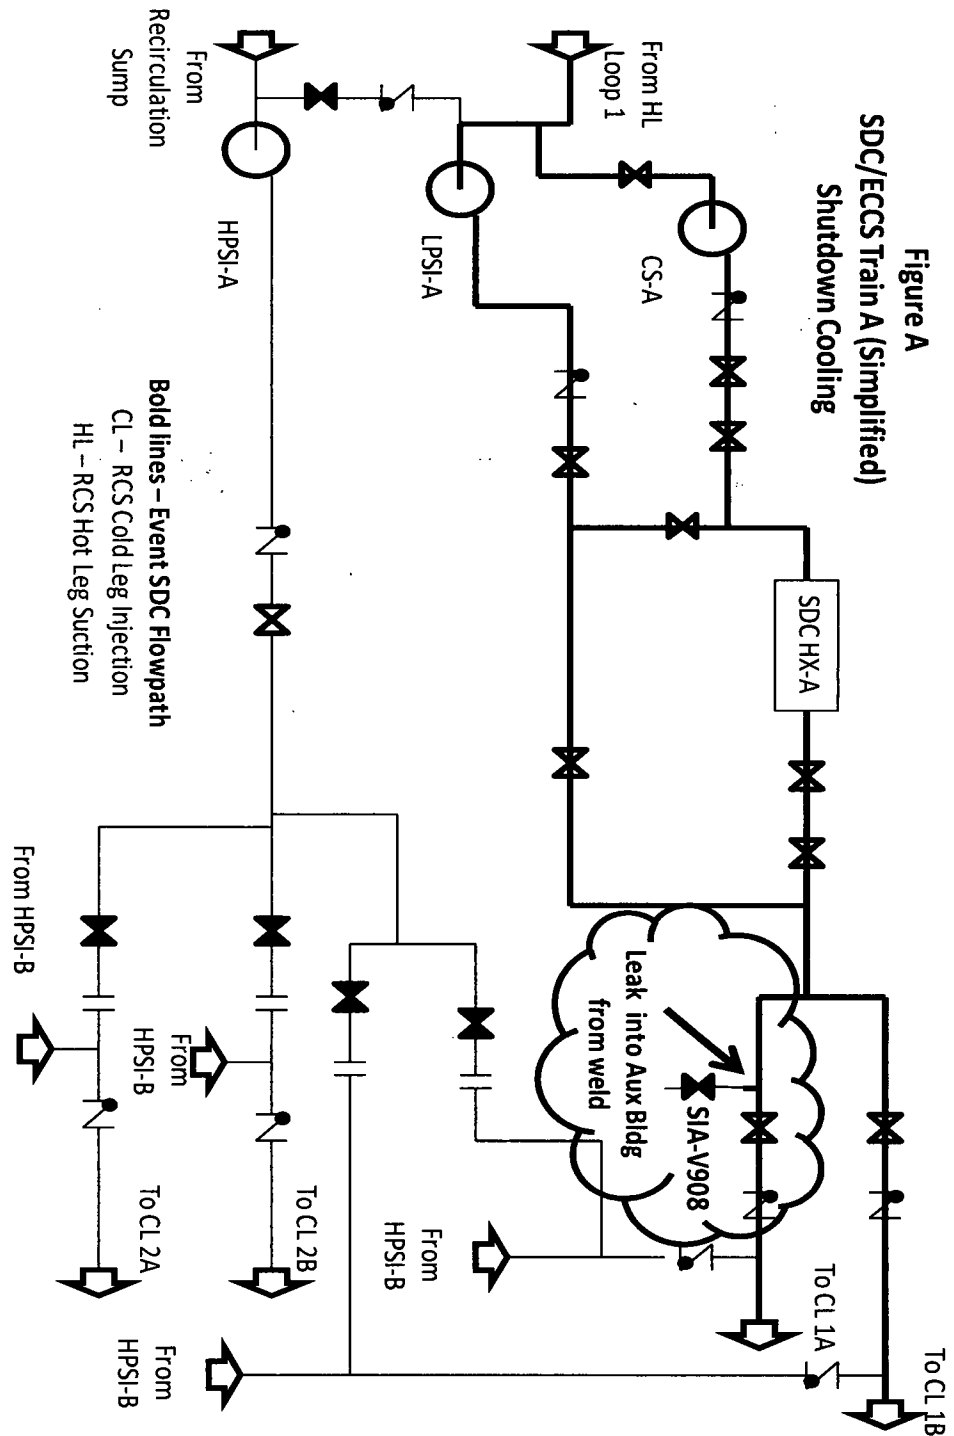
Figure A provides a simplified functional diagram of the Train A SI systems and displays the leak location within the LPSI/SDC system.

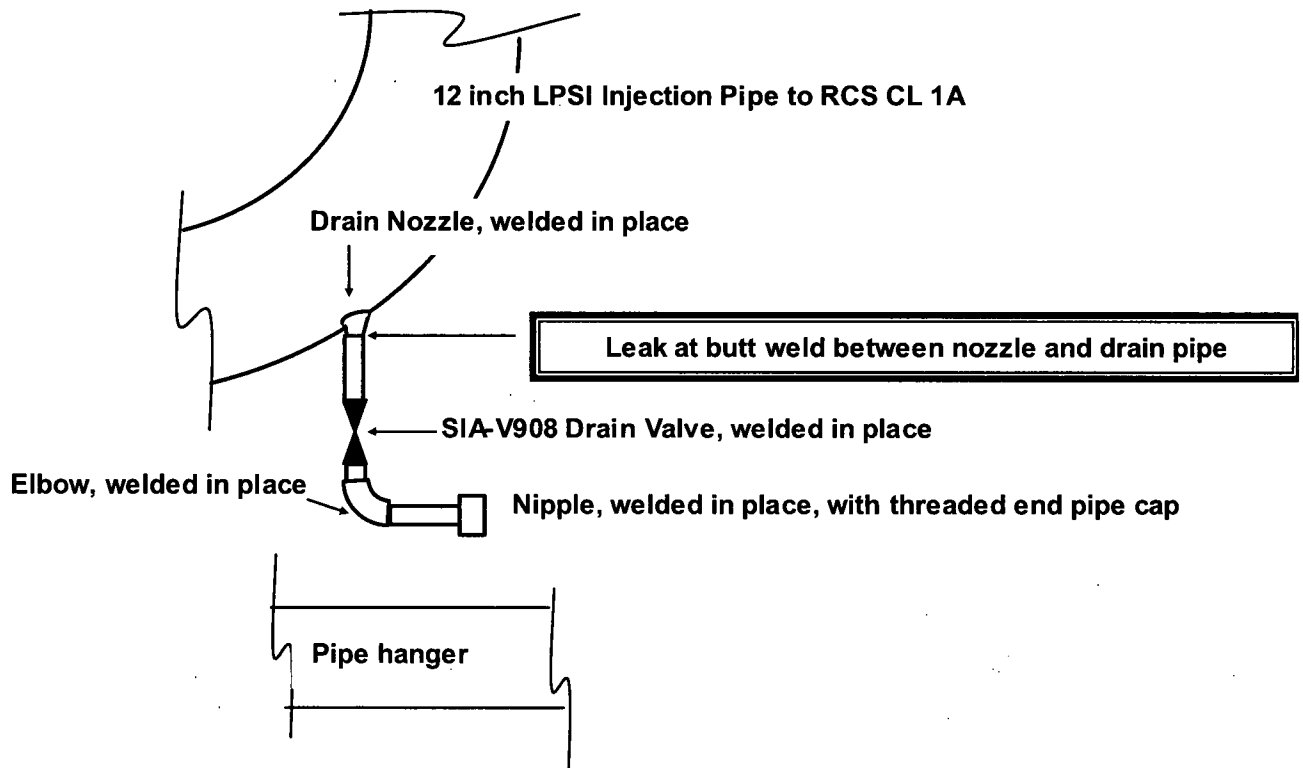
Subsequently, with the piping insulation removed, an examination of the drain pipe upstream of valve SIA-V908 identified a through-wall defect on the weld that attaches the drain pipe to the nozzle on the LPSI cold leg 1A injection pipe. The leak rate was estimated to be approximately 0.25 gallons per minute. Figure B provides a sketch of the drain pipe configuration.

LPSI Header 1A Injection Pipe and Drain Pipe / SIA-V908 Configuration on October 8, 2012

The weld defect resulted from the installation of a temporary drain fitting which was left attached to the pipe nipple downstream of valve SIA-V908 when Train A SDC was returned to service following maintenance in December 1991. Piping thermal growth occurred when SDC was placed in operation which caused the SIA-V908 assembly to contact an adjacent pipe hanger (see Figure B) and act as a restraint to system vibrations that occur during operation. As a result, a defect was initiated in the weld due to abnormally high cyclic stresses induced when the SIA-V908 assembly was restrained by contact with the pipe hanger during SDC operations.

May 1993. During that time, SDC operations resulted in high cyclic stresses being imparted on the weld. In May 1993, the design of the outlet side of valve SIA-V908 was modified to install the current elbow and nipple configuration and correct the interference problem such that no further contact with the adjacent pipe hanger occurred. This design change modified only the outlet side of the valve such that the weld upstream of SIA-V908 (which contained the defect) was not worked on. During the time from May 1993 to October 2012, the defect propagated slowly from high cycle fatigue during normal system operations until the pipe wall was breached during Train A SDC operations in refueling outage 2R17.

The cause of this event was determined to be inadequate guidance to ensure temporary fittings on safety-related fluid systems were removed prior to placing the system in service.

To correct the weld defect, the subject drain pipe and valve SIA-V908 assembly was replaced and the weld repaired on October 11, 2012.

To prevent recurrence, procedures were revised to require that systems with capped pipe ends be returned to their design configuration with fittings removed and pipe caps tightened when maintenance activities are completed.
