WOLF CREEK

Subject: Docket No. 50-482: Licensee Event Report 2008-002-01,
Technical Specification Allowed Outage Time Exceeded due to
Room Cooler Leak

WOLF CREEK GENERATING STATION

Technical Specification Allowed Outage Time Exceeded due to Room Cooler Leak

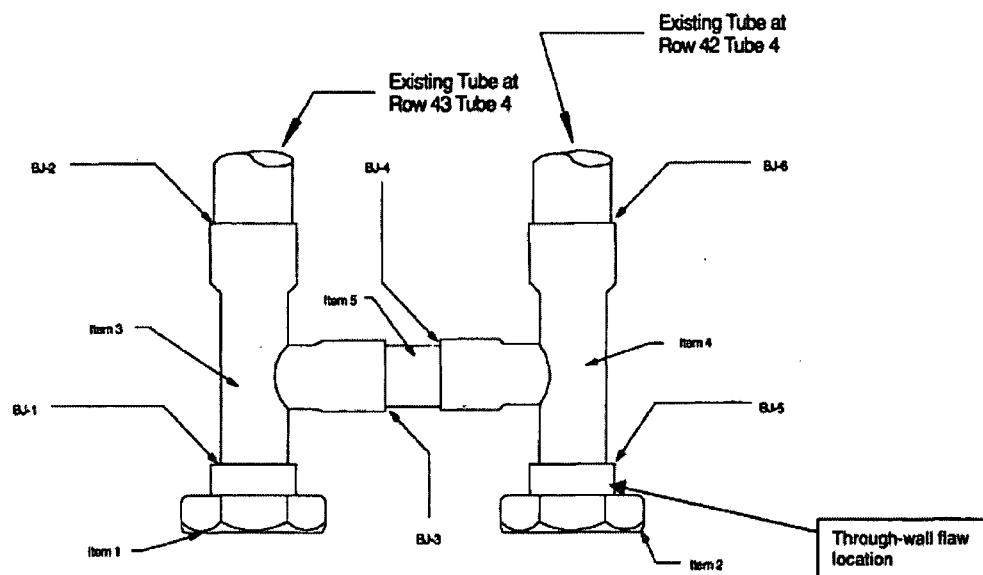
Room Cooler H-Bend Assembly

At 1420 hours on February 13, 2008, water was identified coming from the drip pan for the "A" Centrifugal Charging Pump (CCP) (EIS Code: P) room cooler. At 1550 hours, after the removal of the outer cover panel of the room cooler, a leak was identified on a room cooler H-bend assembly. The "A" CCP room cooler and "A" CCP were declared inoperable. TS 3.5.2, Condition A / Required Action A.1 was entered with a 72 hour Completion Time to restore the inoperable train ("A" CCP) to OPERABLE status. Additionally, Condition B / Required Action B.2 of TS 3.8.1 was entered with a Completion Time of 4 hours to declare the required feature(s) supported by the inoperable DG inoperable when its required redundant feature(s) is inoperable (i.e., 4 hours to declare the "B" CCP inoperable). When the "A" CCP was declared inoperable, entry into Condition B / Required Action B.2 of TS 3.8.1 was required as discussed in the TS Bases.

The H-Bend assembly arrangement is composed of two tees joined together (see sketch below), and a threaded nut on one end of each tee. All of this is brazed together into a solid unit. An end plug (not shown) threaded into each nut and sealed by an o-ring completes the assembly.

The "A" CCP room cooler is original installed plant equipment. The apparent degradation mechanism is flow-induced erosion in the H-Bend area. This failure mechanism has been seen on other room coolers that utilize H-Bends for connecting the circuits.

Flow erosion is a slow wear mechanism that degrades the H-Bends over a long period of time. This component has been in service for about 23 years and, other than maintenance outages, this component maintains continuous flow through the tubes. The continuous flow plus the length of service suggests that this is normal aging and not an accelerated degradation event.

The "A" CCP Room Cooler was isolated to repair the H-Bend leak. The repair activities replaced the defective H-Bend and returned the CCP Room Cooler to operable status.

The original room coolers included the use of H-Bend returns soldered to CuNi alloy tubes. The long-term plan to replace all CuNi coils with up-graded stainless steel components by the end of the first quarter of 2009 has been completed. The replacement room coolers have been re-designed which eliminated the H-bends and improved the tube material. The first of the new coils were installed in 1999.
