**UNITED STATES
NUCLEAR REGULATORY COMMISSION**
REGION IV
612 EAST LAMAR BLVD, SUITE 400
ARLINGTON, TEXAS 76011-4125

December 15, 2011

Subject: COLUMBIA GENERATING STATION - NRC SPECIAL INSPECTION REPORT
05000397/2011008

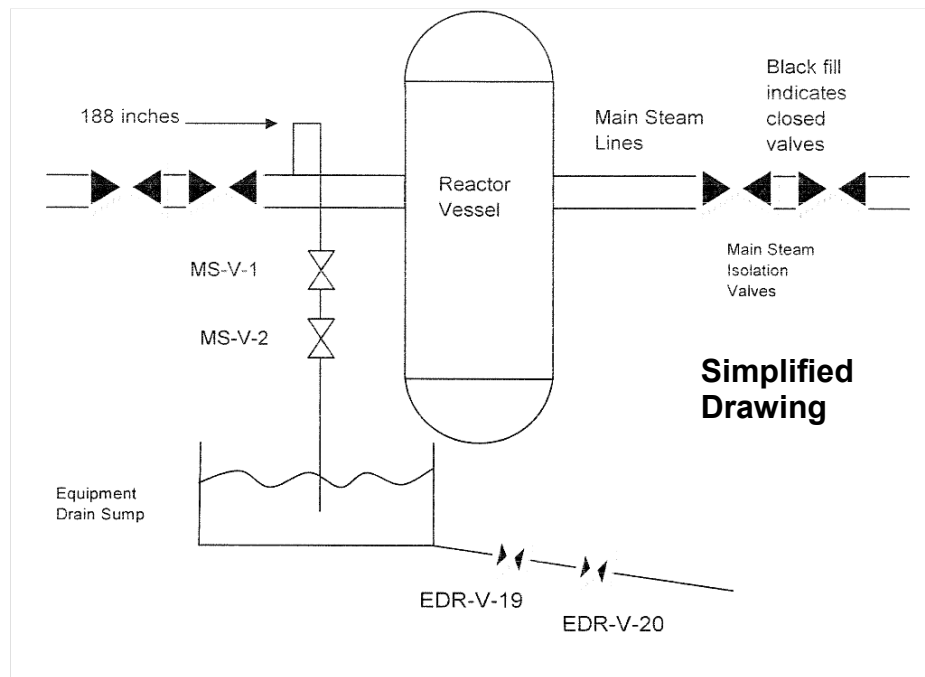
1. **April 11, loss of 4000 gallons through two main-steam drain valves during vessel fill:**

From May 5 to 6, 2007, operators were filling the reactor vessel to prepare to remove the reactor vessel head. Operators failed to close main steam line drain valves MS-V-1 and MS-V-2 during the fill evolution. The failure to take effective corrective measures for this event led to the subsequent loss of inventory event described below. Both events were discussed previously in NRC Inspection Report 05000397/2011003. An inadequate procedure contributed to both events.

1. April 11 event – operators inadvertently drained 4000 gallons of reactor coolant inventory through valves MS-V-1 and MS-V-2 to the equipment drain sump. Operators failed to follow OI-9 Steps 11.1 and 13.2.4, in that: 1) operators failed to know the status of plant equipment at all times; and 2) during prior outages, operators had failed to resolve procedure problems prior to commencing similar work.

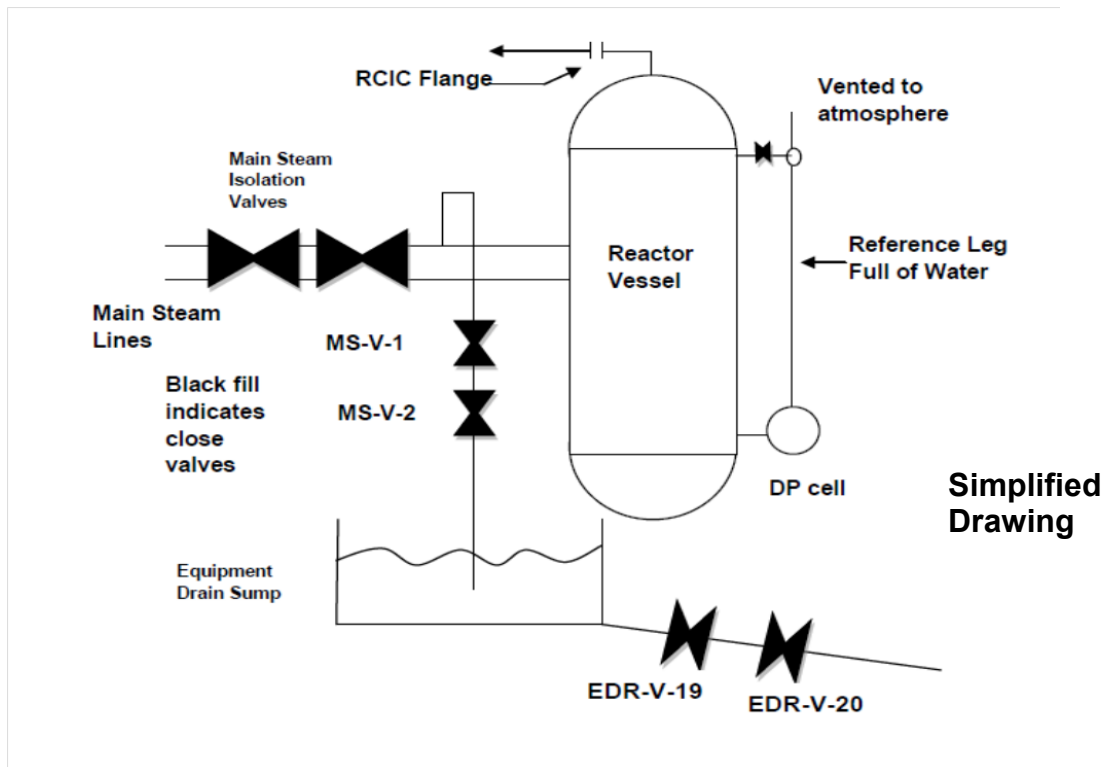
2. **July 28-30. loss of accurate reactor pressure vessel level indication for approximately 40 hours:**

- 3:15 p.m. While maintaining reactor vessel level constant, operators identified a flow mismatch between the control rod drive system and the reactor water cleanup system. As part of normal control rod drive operations, water will enter the reactor vessel. To maintain reactor vessel level constant, operators must drain water out of the reactor vessel through the reactor water cleanup system. The in-flow and out-flow should have been the same, but operators noted that less water was flowing through the reactor water cleanup letdown path. Operators suspected that water was leaking out through valves MS-V-1 and MS-V-2 to the equipment drain sump.

- 10:36 a.m. MS-V-1 was closed. Reactor vessel level indication started to slowly increase.
- 10:38 a.m. Operators noted that flow from the equipment drain sump decreased from approximately 30 gallons per minute to less than 1 gallon per minute. Operators had confirmed that water was leaking from the reactor vessel to the equipment drain sump through valves MS-V-1 and MS-V-2.

2. July 28 to 30 event - reactor vessel level instruments were inaccurate and operators inadvertently drained approximately 4300 gallons of water from the reactor vessel. Operators failed to follow OI-9 Steps 4.2.2, 11.1, 11.2.1, and 13.2.5 because 1) operators did not understand the task and were not aware of the expected results prior to proceeding; 2) operators did not know the status of plant equipment at all times; 3) operators used verbal instructions to control work, versus procedures, work orders or tags; and 4) operators failed to stop the activity when the procedure was found to be inadequate or unclear and failed to correct the procedure prior to proceeding. In addition, during past outages, operators had worked around the deficient procedure and had failed to get it changed.

1. Revision of the noted procedures to provide appropriate direction. The procedures were revised to require that an alternate vent path be provided prior to closing the reactor core isolation cooling system head flange.
 2. Create a new system operating procedure for reactor shutdown level control strategies.
- “Loss of Reactor Protection System Channel B and Automatic Isolation of Shutdown Cooling,” dated 10/31/2011
 1. Columbia Generating Station did not take a proactive approach to replacing the older style logic boards.

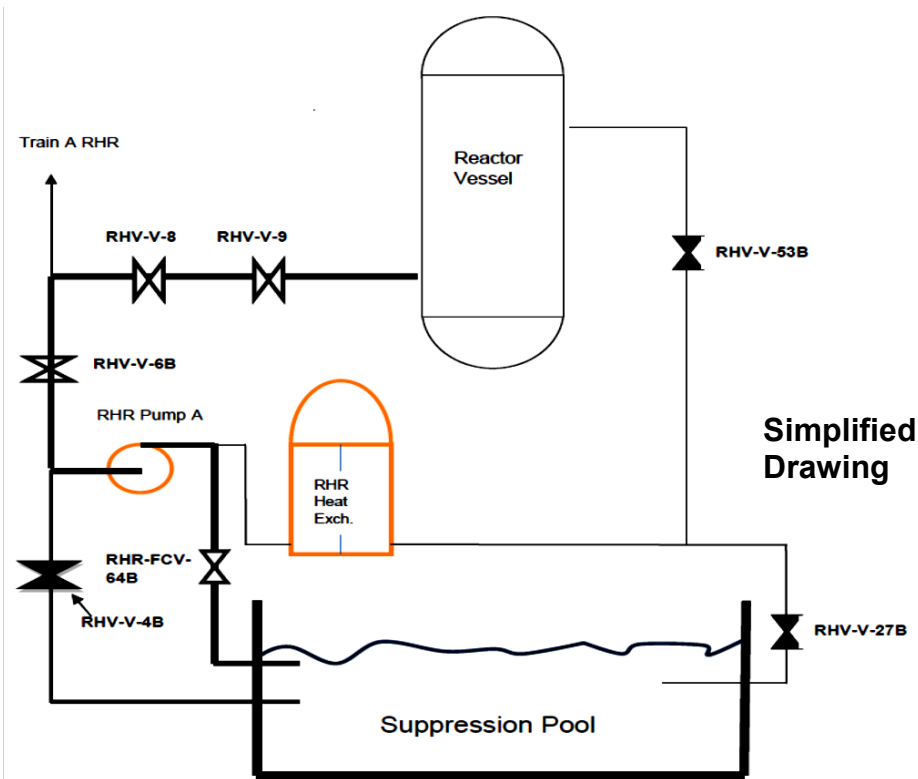
3. **September 10, loss of reactor pressure vessel inventory to the suppression pool through the residual heat removal minimum flow valve:**

The operator failed to implement Procedure SOP-RHR-STBY, Step 5.2.1, which specified, in part:

3. September 10 event - operators failed to follow procedures and drained reactor coolant to the suppression pool. Operators failed to follow OI-9 Step 18.2.9.c and Section 14, in that: 1) operators started work prior to conducting a pre-job brief; and 2) the peer check for the evolution did not perform an adequate peer check.

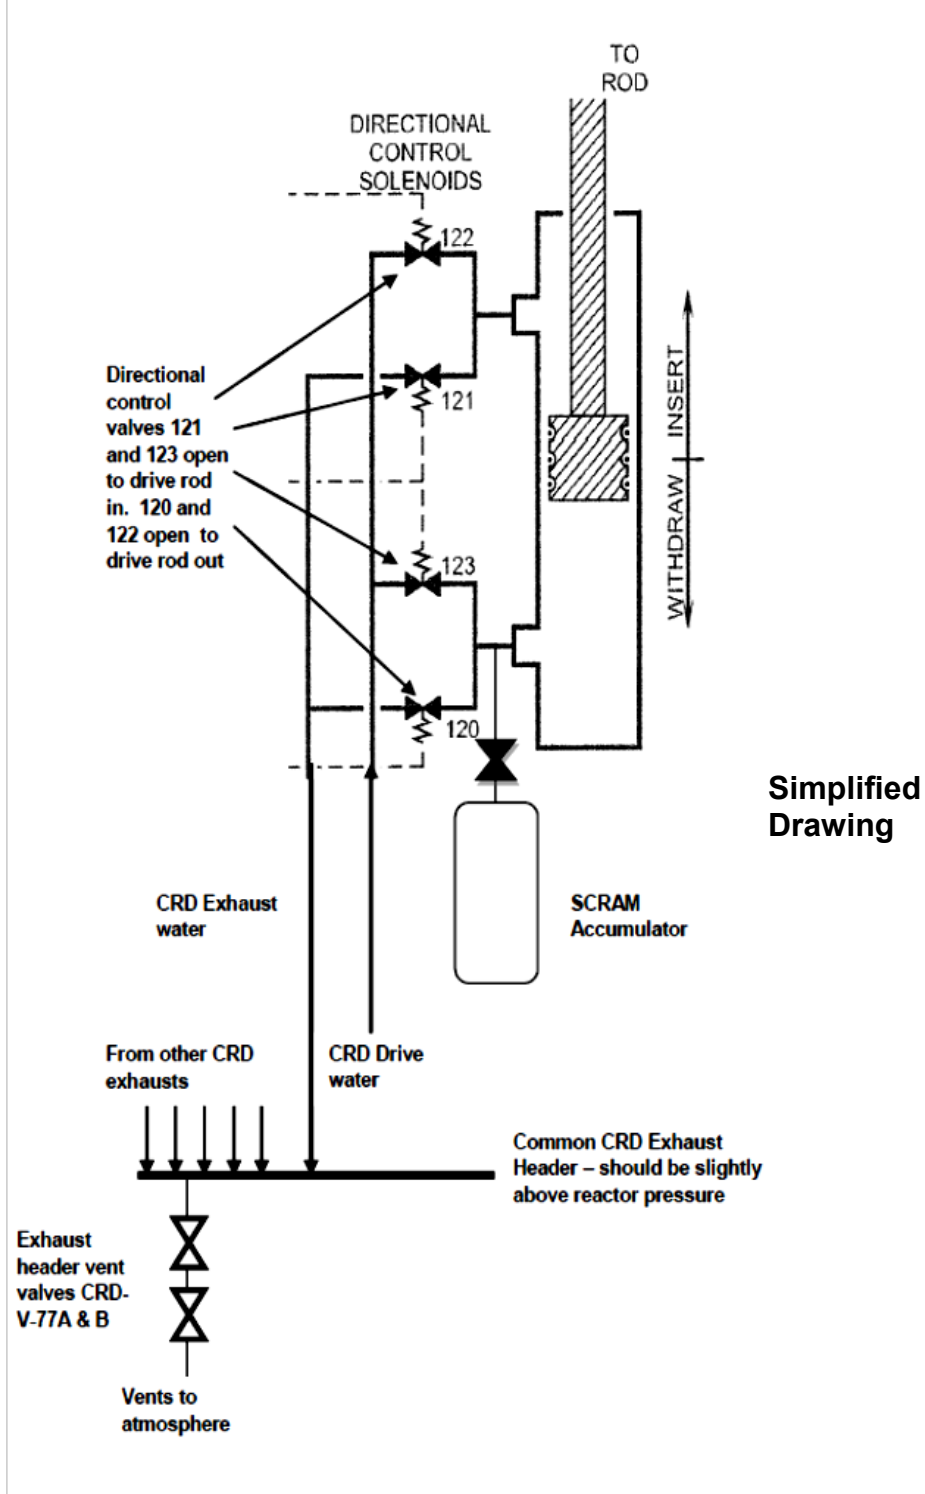
4. Sept 15, failure to properly coordinate control rod drive surveillances:

This step was initialed by a reactor operator as complete. Contrary to this requirement, the operator did not adequately review the open surveillance log or the clearance order log for potential conflicts. Operators had improperly assumed that, because they were performing a reactor hydrostatic test, the control rod drive system had been restored to its normal valve lineup.

Note: The NRC team determined that, at the time of the control rod malfunction, postmaintenance testing on control rod drive 14-51 was already satisfactorily completed. Based on this, it was not reasonable for the operators to have assumed that the control rod malfunction was caused by the directional control valve maintenance. Further, no directional control valve problem could have caused this control rod to insert rapidly into the core in response to a manual insert signal.

In response to the control rod 18-51 malfunctions, operators determined that a potentially generic problem existed and they started to look for the problem. Operators then discovered that the valves to the control rod drive exhaust header were in the improper configuration.
