Subject: Docket No. 50-482: Licensee Event Report 2011-002-00, "Diesel Generator Declared Inoperable Due to Inadequate Installation of a Fuel-Rack Control Pin"

LICENSEE EVENT REPORT (LER)

1. FACILITY NAME
WOLF CREEK GENERATING STATION2. DOCKET NUMBER
05000 4823. PAGE
1 OF 5

Diesel Generator Declared Inoperable Due to Inadequate Installation of a Fuel-Rack Control Pin

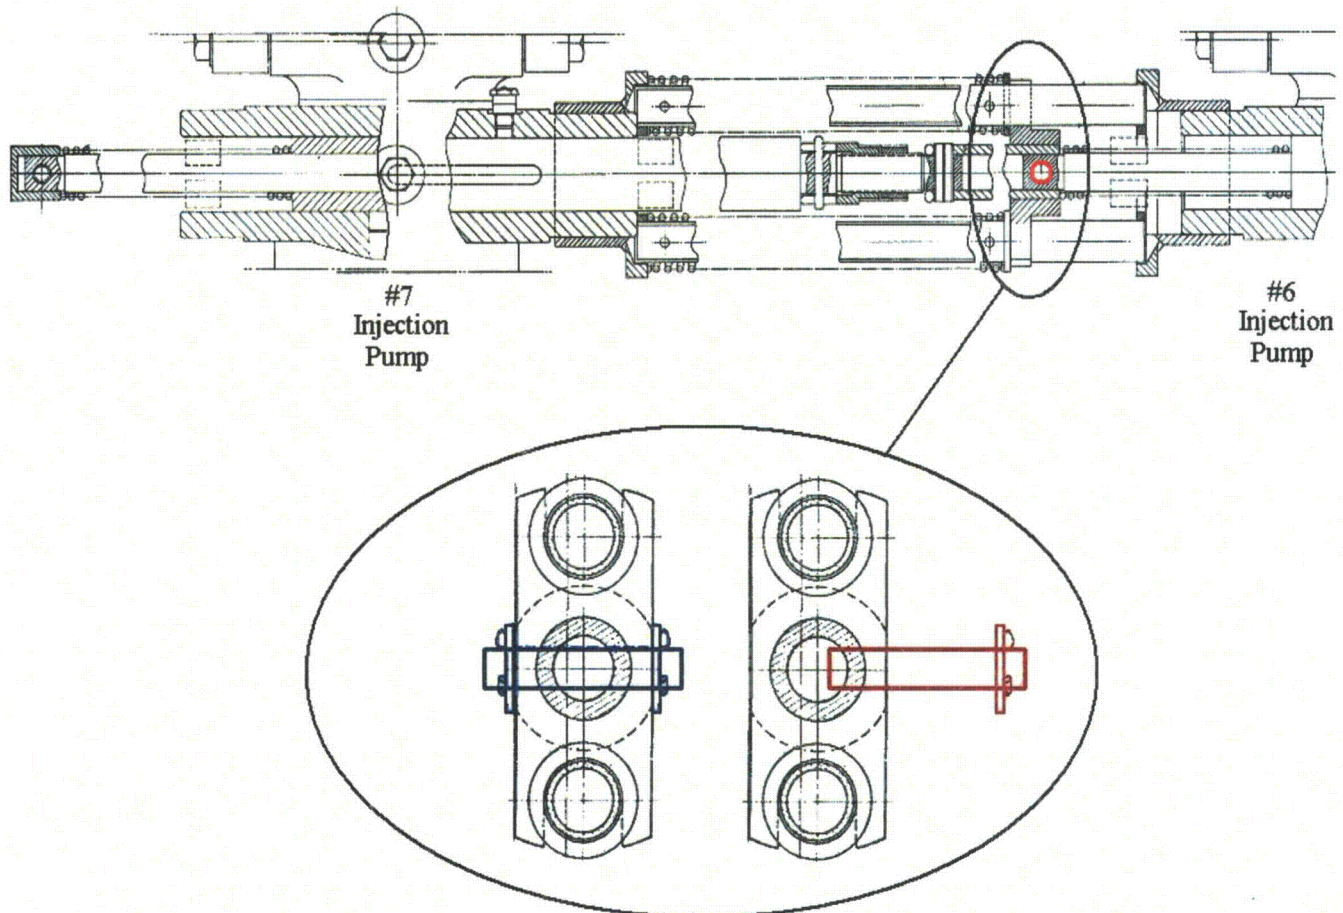
As shown in Figure 1 on page five of five, this control pin passes through the fuel rack to connect the injector pumps for the number six and number seven cylinders on the "A" DG. The DG governor [EIS Codes: EK, 65] moves the fuel rack as necessary to control engine power output. The other fuel-rack control pins on the "A" and "B" DGs were inspected and found to be properly installed and secured by cotter pins. One cotter pin on the "B" DG was found with one of the two legs broken but it still properly secured the fuel-rack control pin. This cotter pin on the "B" DG was replaced on March 7, 2011.

Detachment of this fuel-rack control pin and fuel racks could result in the number seven cylinder and injector pump running at more than 100 percent of rated load. Overload conditions on one cylinder could potentially damage the "A" DG. With this control pin detached, the number seven cylinder fuel injector pump also may not move to the no-fuel position when the DG governor moves to shut down the DG.

WCNOC and vendor maintenance personnel replaced the fuel injection pump for the number six cylinder on December 3, 2010. That date is considered to be when the cotter pin was not properly installed in the fuel-rack control pin between the number six and number seven cylinders on the "A" DG.

The immediate cause of this event is inadequate installation of a fuel-rack control pin and failure to properly secure a fuel-rack control pin with a washer and cotter pin after replacement of a fuel injection pump for the "A" DG by WCNO and vendor maintenance personnel on December 3, 2010. A root-cause evaluation of this condition and an evaluation of the adverse impacts of a detached fuel-rack control pin on a DG in the stand-by condition, after an engine start and during extended operation are in progress. A supplemental report will be submitted to discuss the cause(s) and circumstances of this human performance-related root cause in accordance with 10 CFR 50.73(b)(2)(ii)(J).

Figure 1 – PC2.5 A-Bank Injection Pump Linkage Illustration
(Blue - Pin Properly Installed, Red – Representative of "As Found" Pin Partially Installed)

The fuel-rack control pin between the number six and number seven cylinders was properly installed and properly secured with a new washer and cotter pin on February 23, 2011. The other fuel-rack control pins on the "A" and "B" DGs were then inspected and found to be properly installed and secured by cotter pins. One cotter pin on the "B" DG was found with one of the two legs broken but it still properly secured the fuel-rack control pin. This cotter pin on the "B" DG was replaced on March 7, 2011.
