Why Windows 10 had difficulty connecting to a ESP32DevKitV1 board that was embedded with a ESP32D0WDQ6(revision1) chip?

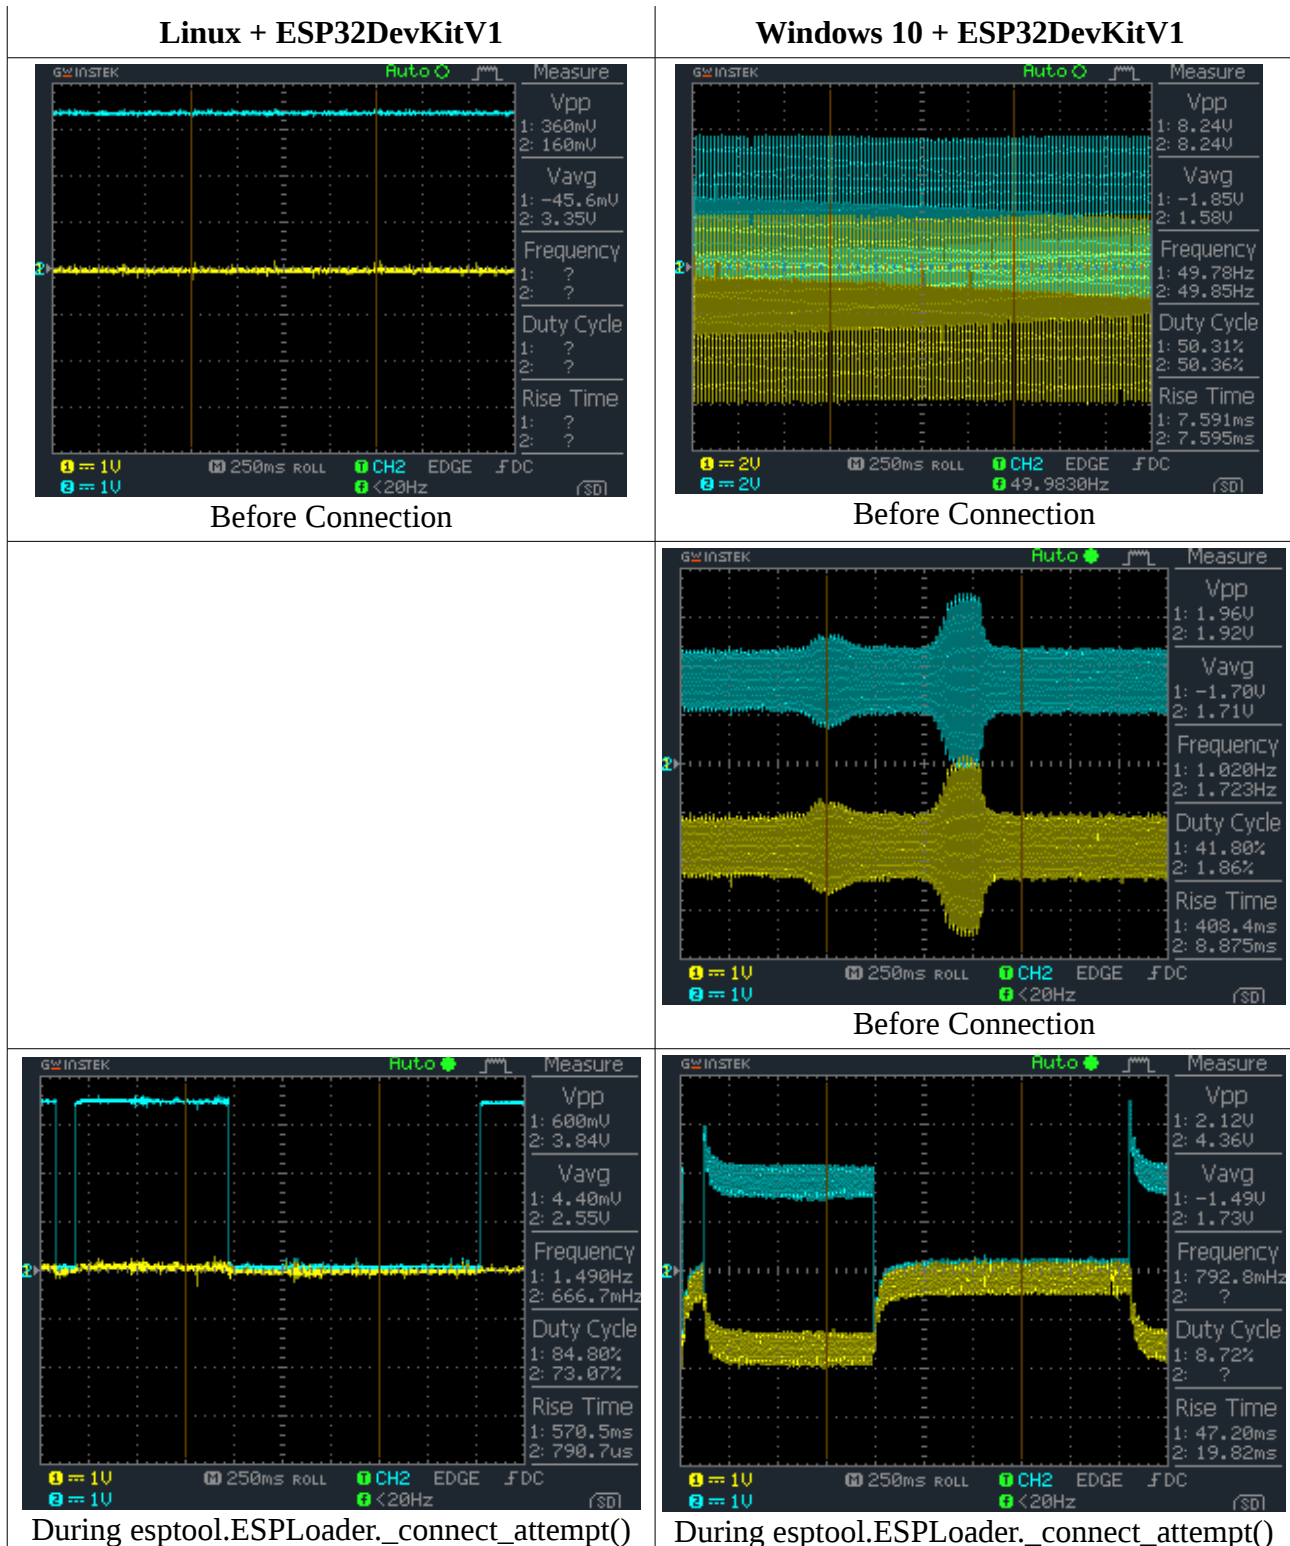
EN == Blue color curve; GND == Yellow color curve

Voltages at the EN and GND pins of the ESP32 board when connected to a Windows 10 system were highly noisy and more importantly did not perform to ESP32 specifications. These voltage failings did not occur when a Linux system was used.
