## Why Windows 10 has difficulty connecting to a ESP32DevKitV1 board that was embedded with a ESP32D0WDQ6(revision1) chip?

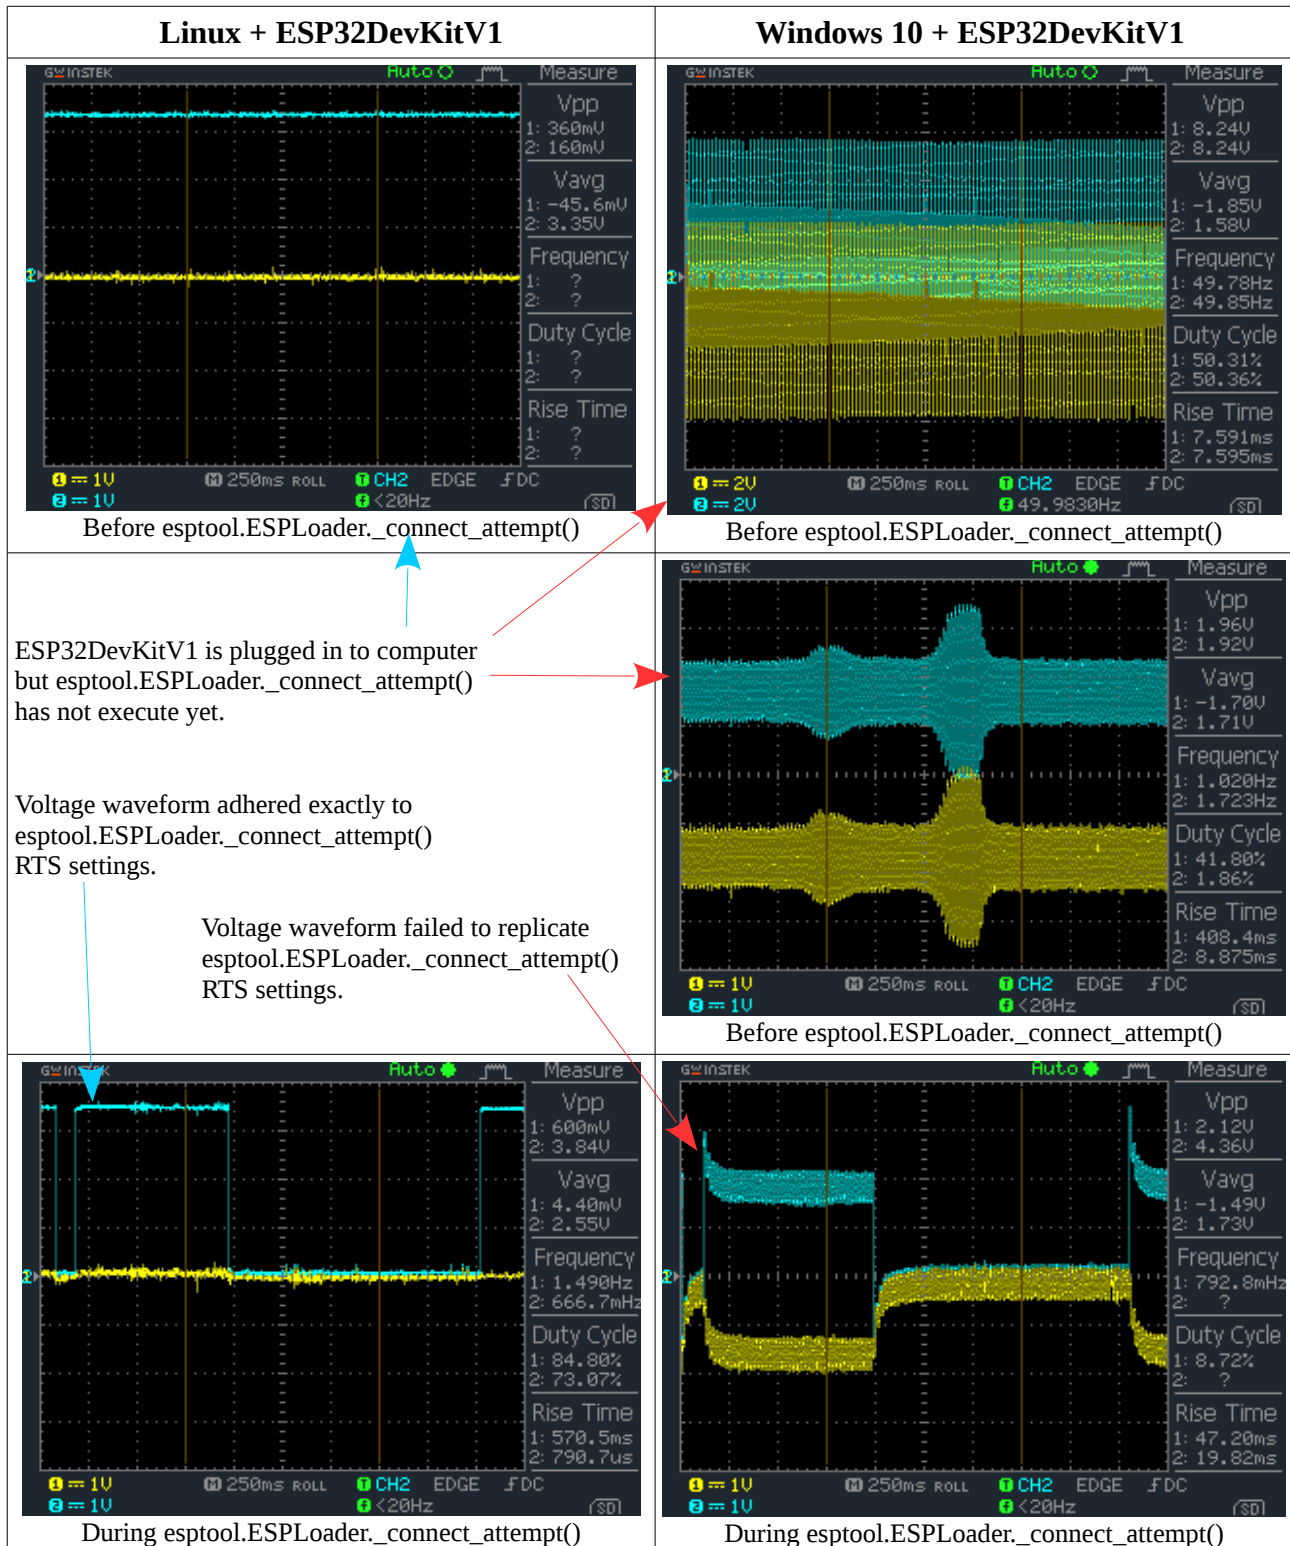
EN == Blue color curve; GND == Yellow color curve

The voltages at the EN and GND pins of the ESP32 board, being derived from a Windows 10 system, were highly noisy. The measured voltage waveform did not conform to ESP32 specifications and `esptool.py` RTS settings. These voltage failings were not observed at the EN and GND pins of the same ESP32 board when it was plugged in, and when it was subsequently connected, to a Linux system.
