Why Windows 10 has difficulty connecting to a ESP32DevKitV1 board that was embedded with a ESP32D0WDQ6(revision1) chip?

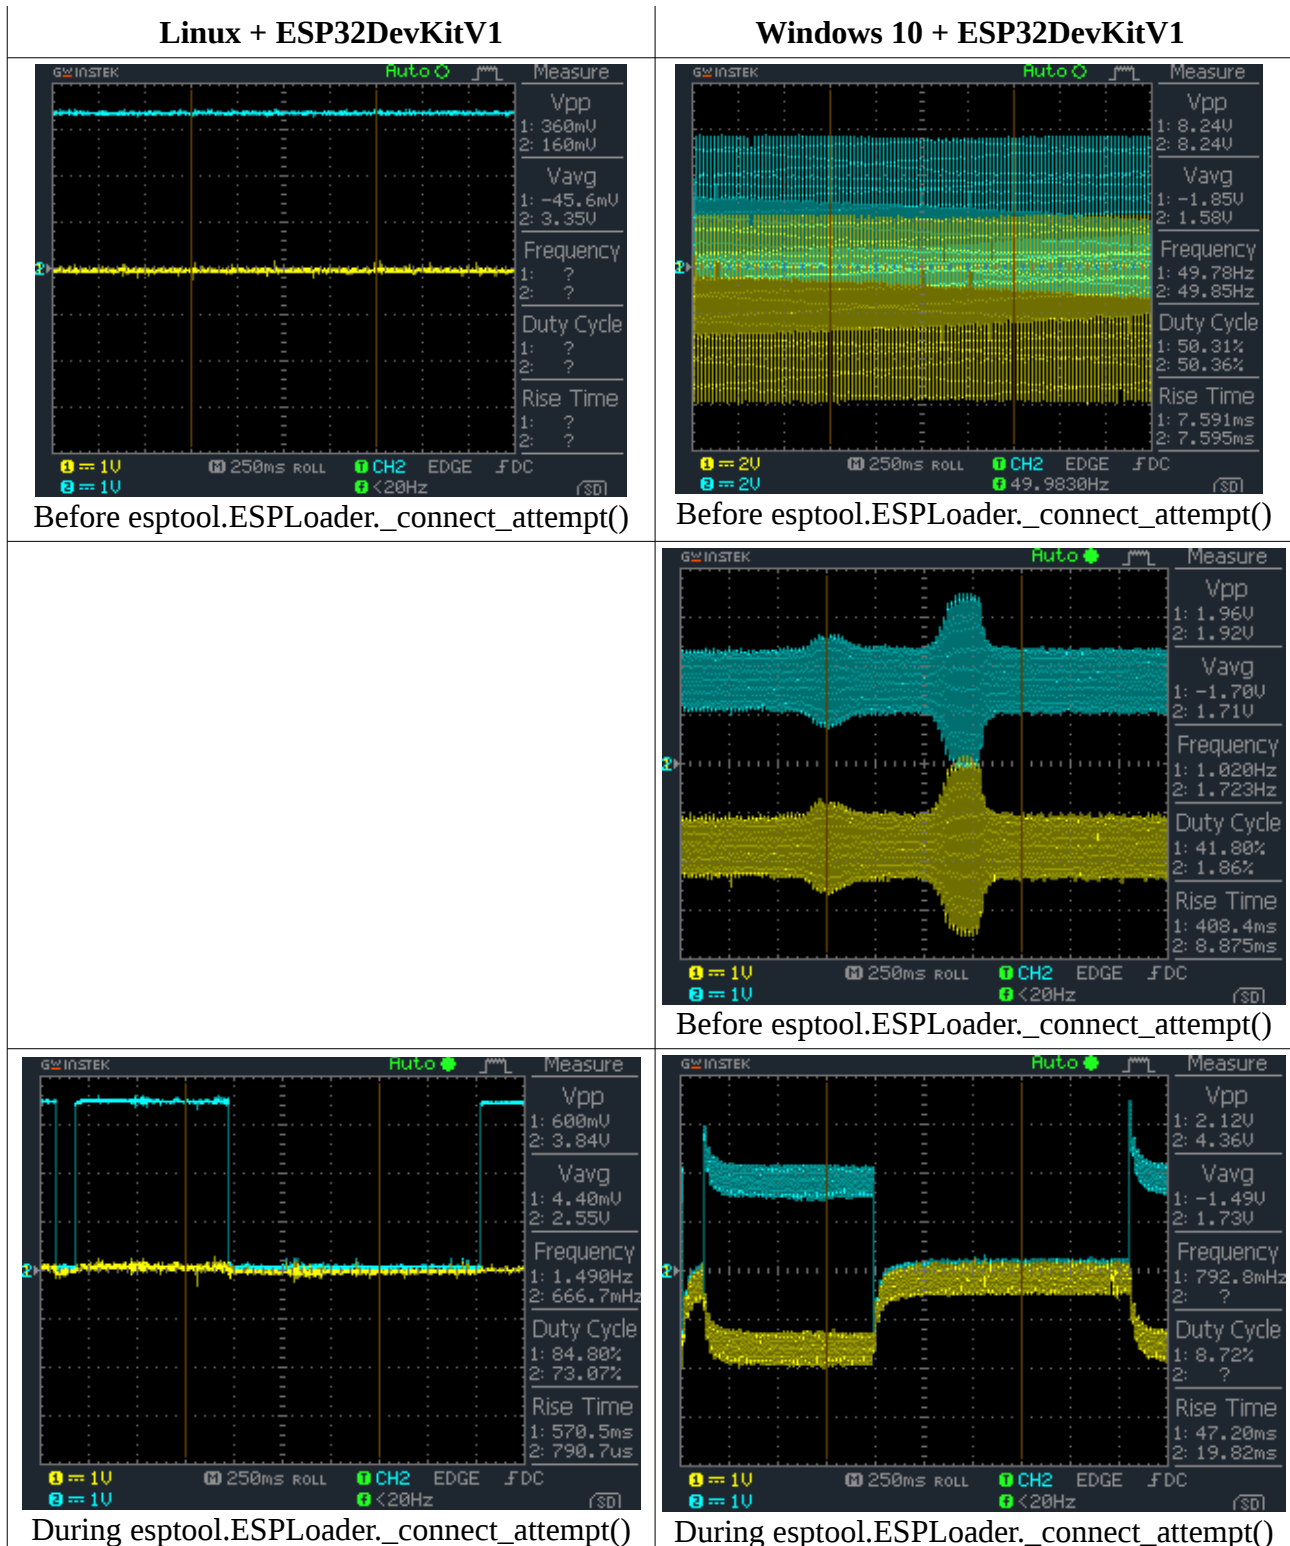
EN == Blue color curve; GND == Yellow color curve

Voltages at the EN and GND pins of the ESP32 board when connected to a Windows 10 system were highly noisy and more importantly did not perform to ESP32 specifications. These voltage failings did not occur when a Linux system was used.
