## Why Windows 10 has difficulty connecting to a ESP32DevKitV1 board that was embedded with a ESP32D0WDQ6(revision1) chip?

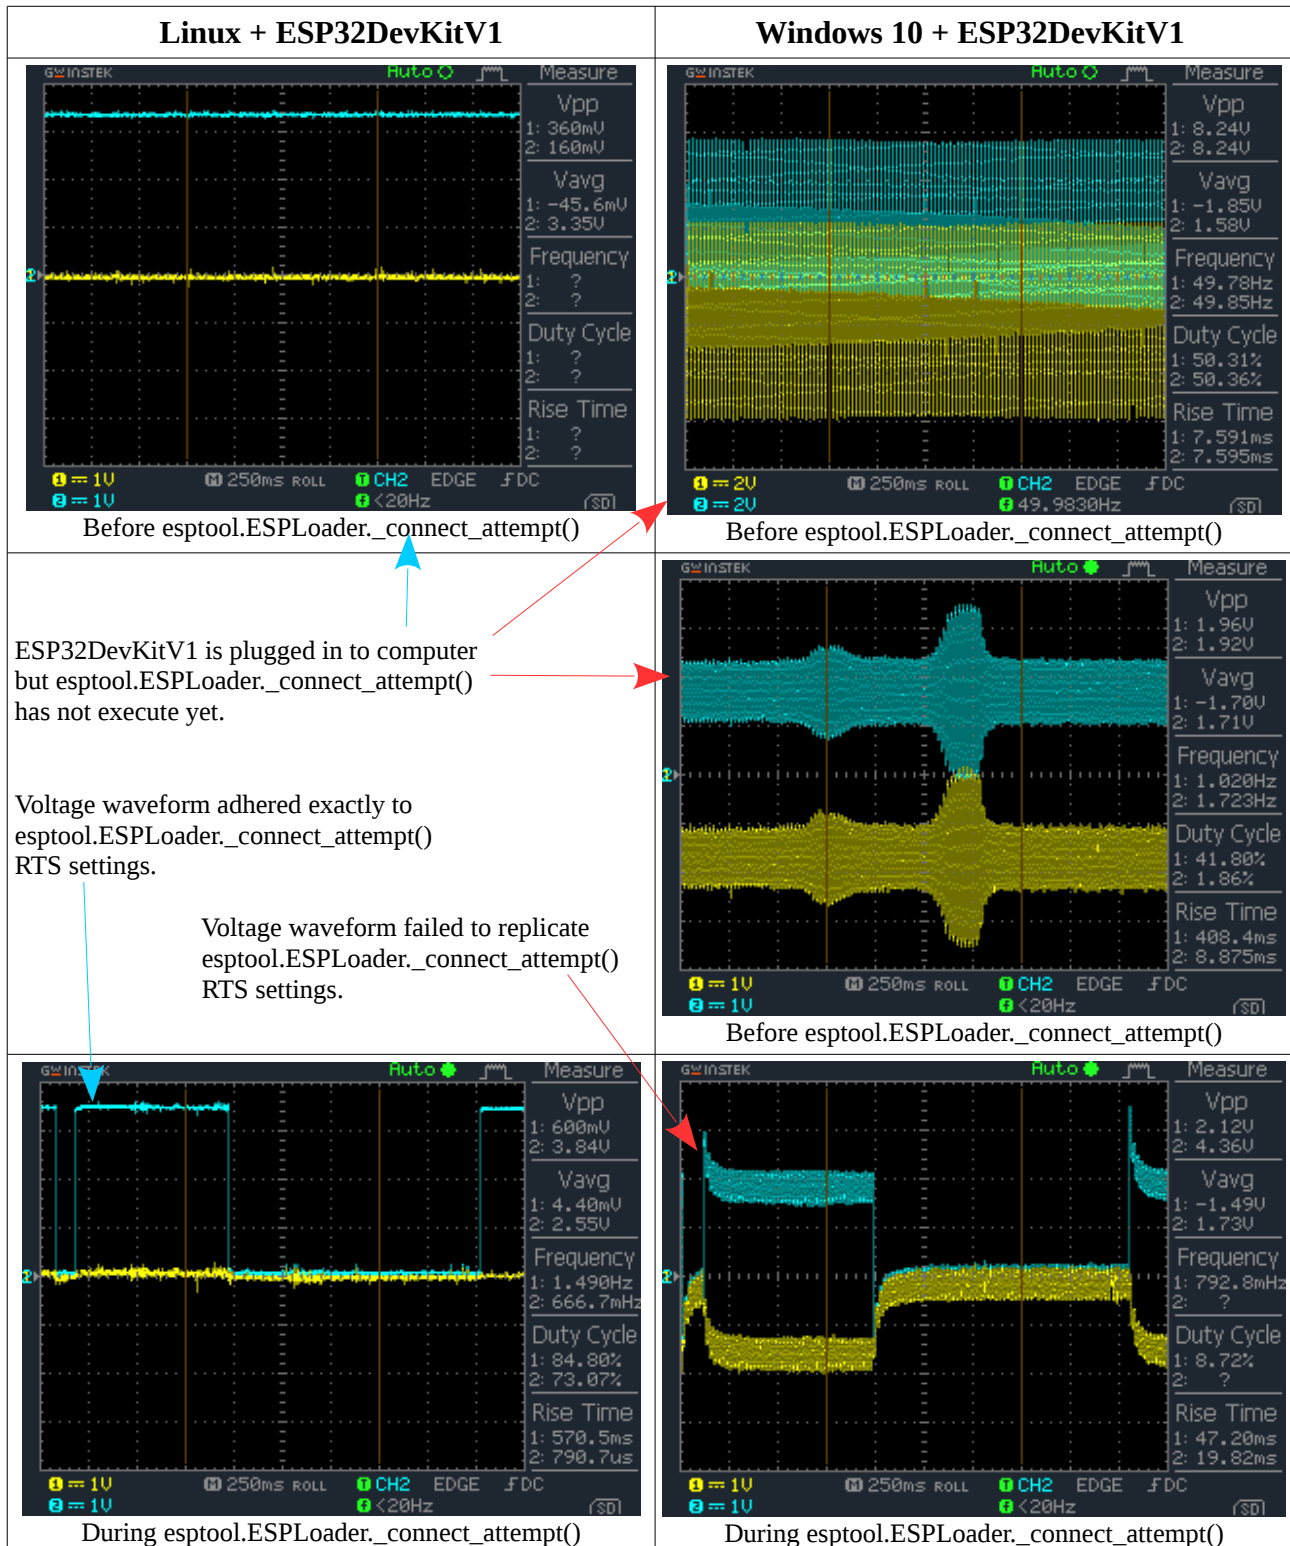
EN == Blue color curve; GND == Yellow color curve

The voltages at the EN and GND pins of the ESP32 board, being derived from a Windows 10 system, were highly noisy. The measured voltage waveform did not conform to ESP32 specifications and `esptool.py` RTS settings. These voltage failings were not observed at the EN and GND pins of the same ESP32 board when it was plugged in, and when it was subsequently connected, to a Linux system.

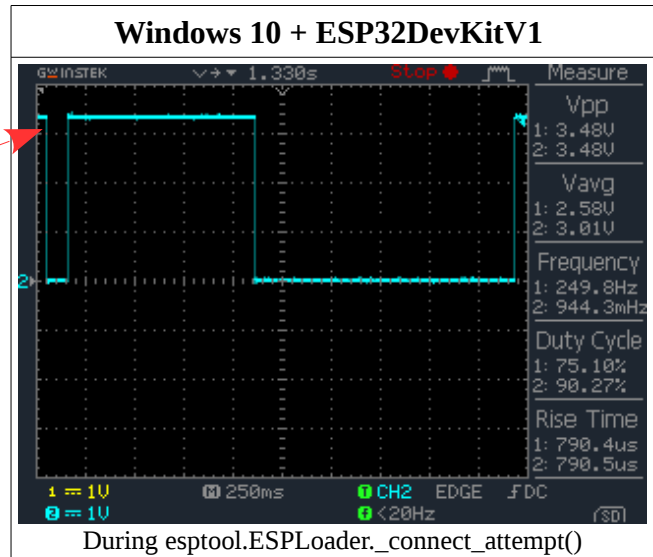
Voltage waveform adhered exactly to  
`esptool.ESPLoader._connect_attempt()`  
RTS settings.

To irradicated the failings that I had observed earlier, I discovered that I had to ensure that the ground on the oscillascope's probe was connected to the GND pin of the ESP32 board. Below shows the cleaned-up voltage signal from the EN pin of the ESP32 board when connected to the Windows 10 system.
