Draft Technical Summary Report

Results from I76 Viaduct Vibration Survey

PennDOT District No. 6

August 2016

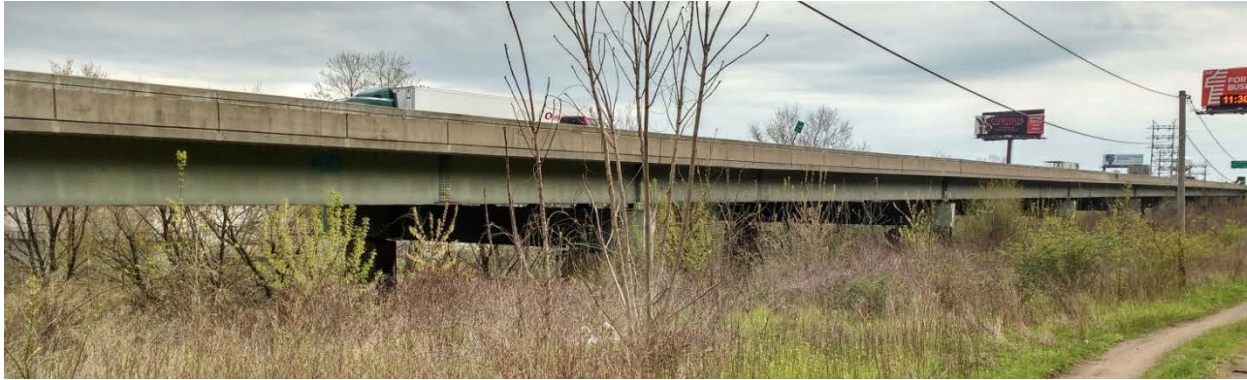
Photo of bridge elevation

Visually, the deck appears to be in good condition, with no major cracking visible. Minor damage was observed in some regions of the center concrete barrier. The girders appeared in excellent condition. No major rusting was observed, and the girders appeared well maintained. The access hatches on many of the box girders had been left open. Any ill effects from this could not be immediately observed. The piers exhibited very little efflorescence and virtually no spalling. Repairs had been performed on several piers, where an embedded drainage pipe had rusted and caused a portion of concrete to spall off.

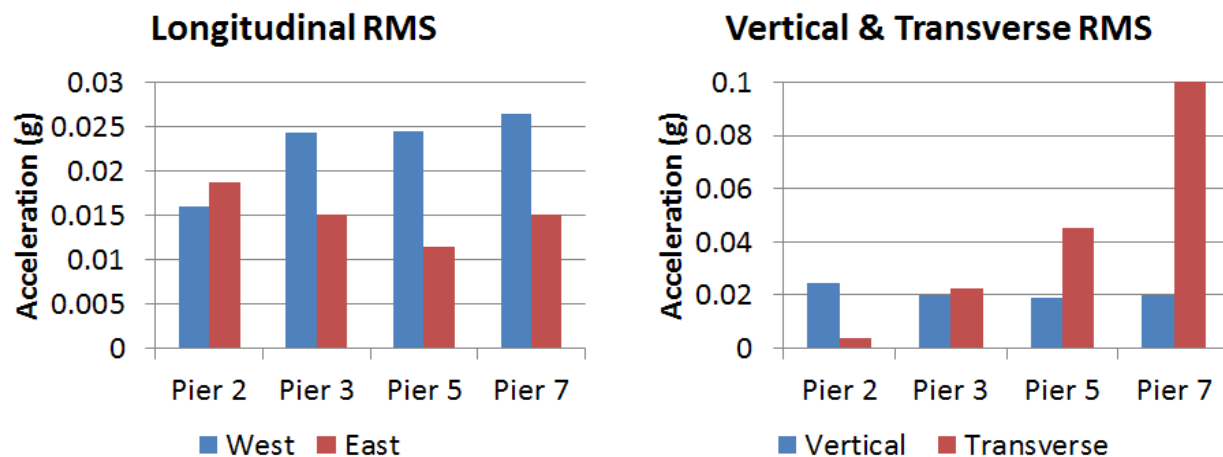
The acceleration of these members due to traffic was recorded in an effort to determine the spans with the highest levels of vibration. The cross girders all experienced similar levels of vertical and longitudinal acceleration, while the cross girder at pier 7 experienced much higher transverse acceleration.

Plot of Root Mean Square of Acceleration during Preliminary Survey

As a result, spans 7 and 8 were chosen for the in depth investigation.

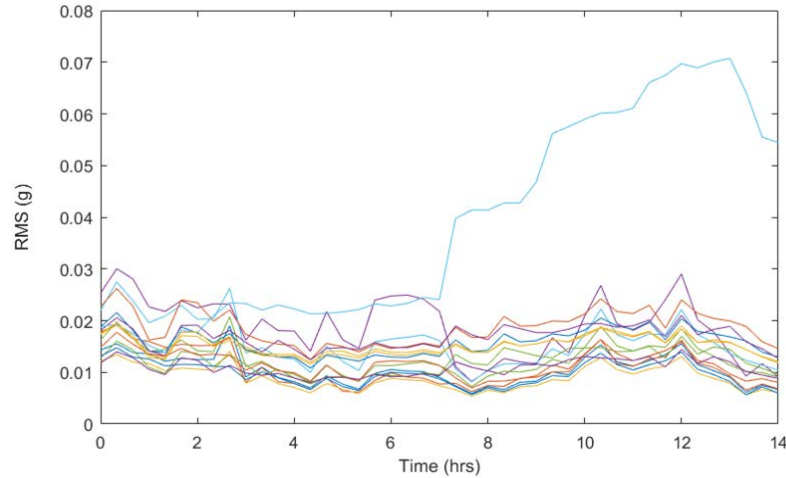
RMS of Superstructure DOF over Time

As can be seen from the above plot, the superstructure experiences relatively steady vibration and it increases toward the latter half of the total record. This time corresponds to the period between 12:00 PM and 3:30 PM. The maximum RMS values for the superstructure range from 0.015 to 0.07 g. In contrast, the RMS values for the pier accelerometers did not exceed 0.003 g. This is due to the effectiveness of the bearings, isolating the pier from superstructure vibrations, and the comparatively large axial stiffness of the piers which limits (and effectively prevents) vertical pier acceleration: the direction for which the superstructure experiences the greatest vibration.

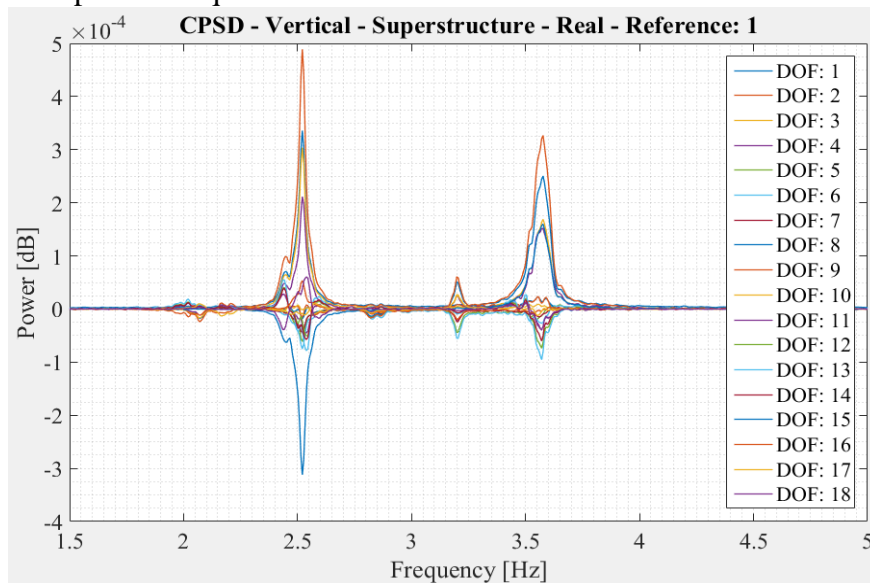
Cross Power Spectral Density of Superstructure DOFs

Several modes of vibration were found at frequencies below 5 Hz. The image above shows the power of each frequency. The peaks in the plots are poles where a mode of vibration is occurring, and for this structure, a natural frequency. In some instances, poles are at very similar frequency and the separate peaks cannot be easily distinguished. This is due to the geometry of the structure (high degree of symmetry) and the fact that there are essentially two identical bridges adjacent to one another. The main modes identified by this effort consisted of bending and torsional modes. For these modes, the mid-span degrees of freedom are experiencing the greatest acceleration. The shapes of several of these modes are displayed below.

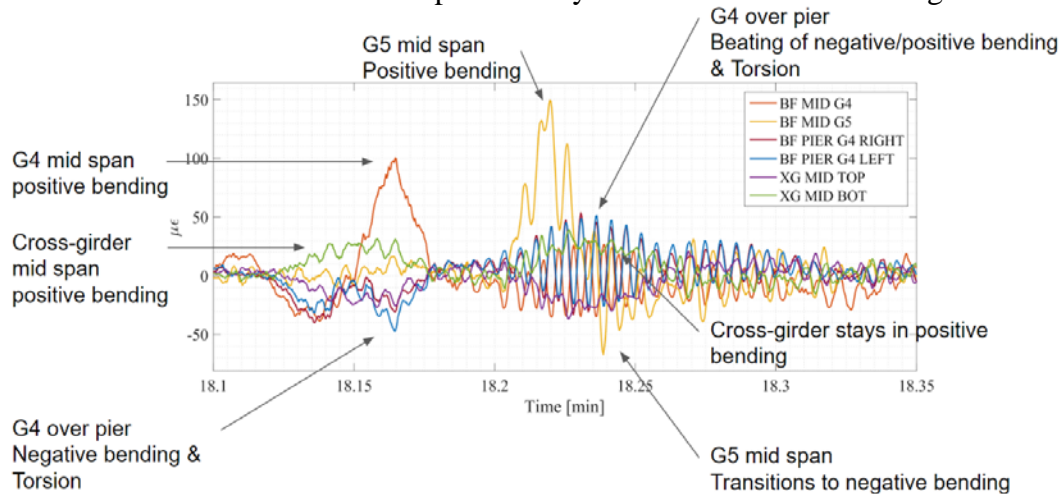
Strain Response

Strain levels in excess of 100 microstrain (3 ksi) were not uncommon, and occasional responses as high as 6 ksi were recorded in the bottom flange of longitudinal girders at mid-span. The interior girders (supported at the center of the box girder) experienced the highest responses. A low pass filter was applied to the data to remove the data associated with frequencies above 1.5

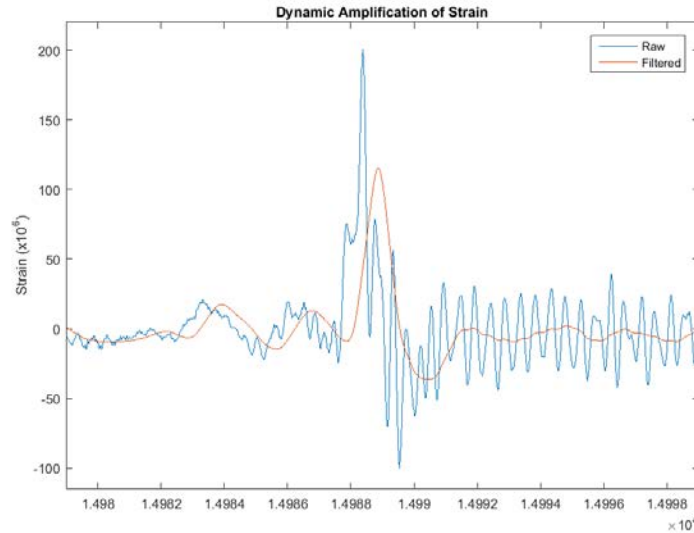
The strain data plotted above has been filtered to show only the static response. The additional strain due to the vibration of the bridge is neglected. However, the portion of strain due to the dynamic response (vibration) of this structure is significant. The plot below is during a large event. The static response accounts for over 100 microstrain, but the vibration of the structure causes the total response to exceed 200 microstrain. For this event, an amplification of the static response by approximately 75% is observed. In comparison, the amplification applied for bridge design is only 33% or less.

Dynamic Amplification of Strain

This level of amplification is on the upper end of what researchers and transportation organizations have measured. However, the fact that the high amplification occurs regularly and even with large events, makes the nature of this bridge's response quite novel.
