Test Structure Description

Description The viaduct was first constructed in 1952. The superstructure was replaced in 1986, while reusing the original piers and foundations. The structure runs along the banks of the Schuylkill River and carries the Schuylkill Expressway (I-76) with a total of four lanes of traffic. Bridge users have reported experiencing unusually high levels of vibration while on the structure. ### Network The bridge is located on a major highway and carries more than 57,000 vehicles a day with 4% truck traffic. The bridge spans an access road and a railroad (spans 9 & 10). Testing of this bridge will not require access in the vicinity of the railroad.

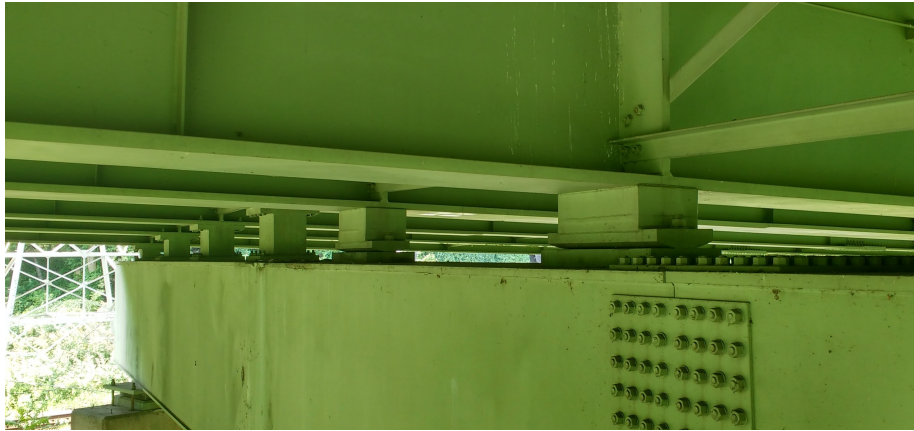
Visually, the deck appears to be in good condition, with no major cracking visible. Minor damage was observed in some regions of the center concrete barrier. The girders appeared in excellent condition. No major rusting was observed, and the girders appeared well maintained. The access hatches on many of the box girders had been left open. Any ill effects from this could not be immediately observed. The piers exhibited very little efflorescence and virtually no spalling. Repairs had been performed on several piers, where an embedded drainage pipe had rusted and cause a portion of concrete to spall off.
