Case Study: Deterioration due to Structural Response

Bridge Introduction

The system is composed of two adjacent bridges, each a four-span, steel, multi-girder bridge with a cast-in-place deck. The bridge serves more than 100,000 vehicles per day and serves as a major link to the George Washington Bridge.

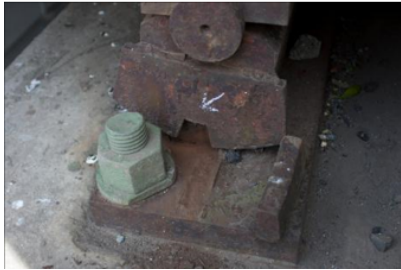
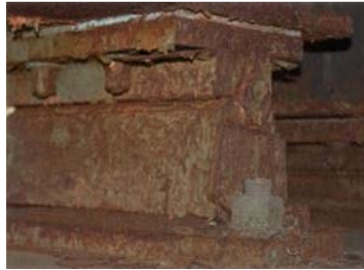
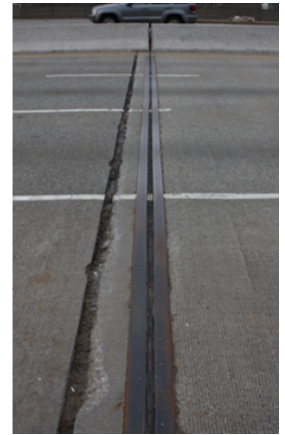
- The bridge exhibited fatigue cracks in the girder webs at the wind bracing connections. The exterior bearings were heavily corroded.

- One bearing had a broken pintel allowing it to rotate (about it's vertical axis). Deteriorated joints permitted water to drain on top of the pier caps and bearings.
- The pier cap exhibited a large crack.
- Soil erosion had led to approach settlement, resulting in a bump at the bridge entry. Large traffic induced vibrations were reported.

- Wind bracing did not contribute to structural stiffness or strength capacity. They were, however, the cause of fatigue cracks and should therefore be removed.
- The corroded bearings were not significantly affecting bridge performance, but their ability to maintain bridge stability in the future is uncertain. FE simulations showed that any bearing replacements should be able to accommodate bi-directional movement.
- The large crack in the piercap can be attributed to improper rebar detailing. Dynamic amplification also contributed, and provides explanation for why the crack appeared only on one piercap, when improper rebar detailing could be found on other piercaps.
- The perceived excessive vibrations can be attributed to the bump at the beginning of the bridge caused by approach settlement.

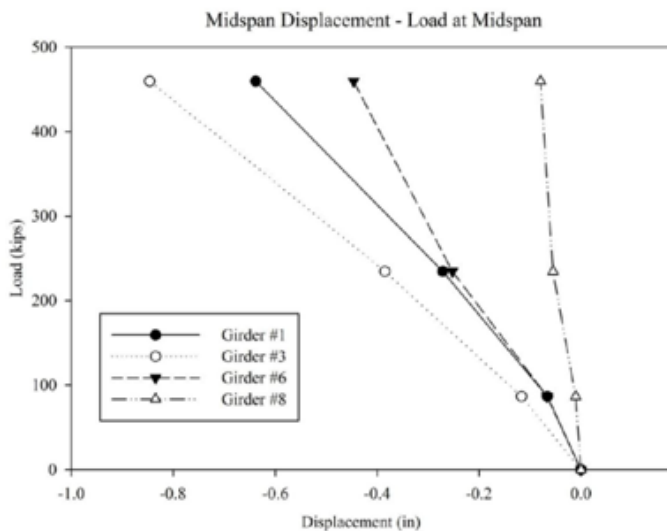
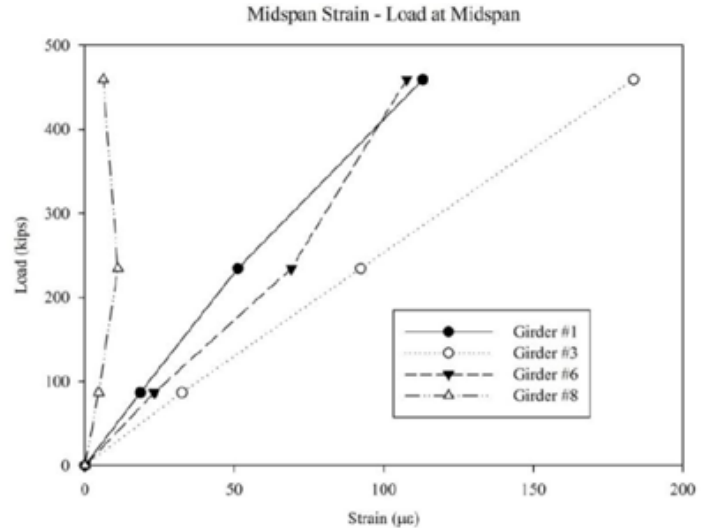
The data gathered during the dynamic test was used to identify the bridge's natural modes of vibration. During operational monitoring bridge vibrations with relatively large amplitudes (peak acceleration of 0.4g) were recorded, thus corroborating inspectors' reports of excessive vibrations.

An FE model was leveraged in order to further understand the causes of the piercap crack. Dynamic simulations showed that the asymmetric geometry of the span resulted in an asymmetric first mode of vibration for which the region over girder #1 experiences greater deformation than the other side. Under normal traffic conditions, the

moving vehicles excite the mass of the bridge, causing it to vibrate. This vibration amplifies the bridge response. It is therefore postulated, that due to the asymmetric nature of the bridge's geometry, the induced bridge vibration causes asymmetric dynamic amplification, and in this case resulted in forces transmitted to the piercap in excess of its available capacity, ultimately leading to a crack.
