## Case Study: Steel Multi-Girder Bridge

### Bridge Introduction

## Case Study: Deterioration due to Structural Response

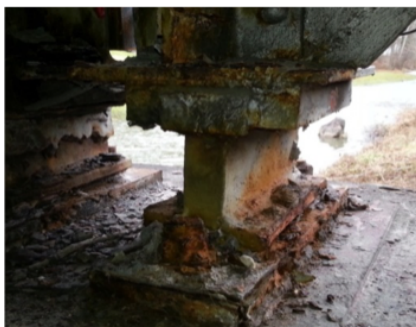
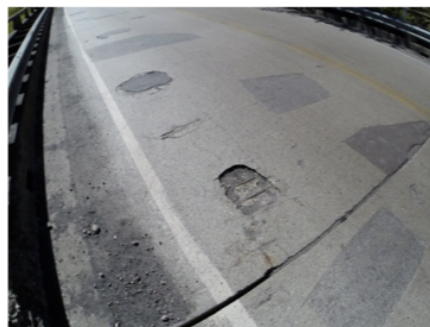
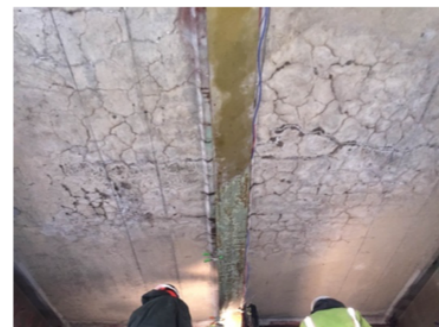
Several bearings were heavily corroded. In these areas, the bottom flanges of the girders also showed considerable corrosion, as already indicated in past inspection reports. This corrosion was likely due to the failure of deck seals in the expansion joints. Furthermore, a bearing on the northern exterior span over the pier was observed to have lost connection to the superstructure. While this “floating” bearing was not a threat to bridge stability, it was indicative of the significant corrosion of the bearing system. The hammerhead piers exhibited signs of efflorescence and some cracking and spalling beneath the bearings. There were also areas on the ends of the hammerhead that have had repairs performed as evidenced by new concrete.

The deck showed signs of shear failure where concrete had broken off as deep as the top layer of reinforcement. Several regions also evidenced deck repairs and patching. It is postulated that the failure of the deck was, in part, due to the braking forces from trucks as they came to a stop at the stop sign at the end of the bridge. It is also possible that the 7” deck as indicated in construction drawings is insufficient to provide durability and adequate reinforcement cover. The underside of the deck had spider web cracking and some efflorescence.

- In spite of the evident deterioration, the structure is capable of carrying legal load levels as evidenced by the successful proof-level load test. The load posting can be removed.
- The conservatism of the structure can be attributed to its ability to effectively distribute load as revealed by the bridge responses during the load test and through the use of refined FE modeling.
- The deterioration of the structure, while not immediately threatening to its capacity, is a concern for the ongoing health of the bridge if allowed to continue. Repair of the deck and deck seals and corroded bearings was therefore recommended.
