Excessive Vibrations: I-76 Case Study

Example Case Study - I-76 Pencoyd Viaduct

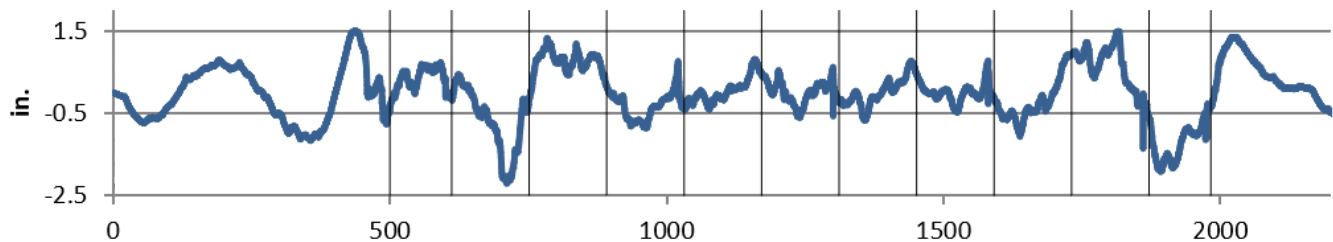
Measured Profile (East Bound, Right Lane)

- The profile of the bridge is such that it causes large vibrations in the test vehicle, especially at higher speeds, consequently increasing the loads felt by the structure and exciting the bridge’s natural modes of vibration.

- The problem can be alleviated by grinding the deck smooth to remove the problematic profile.

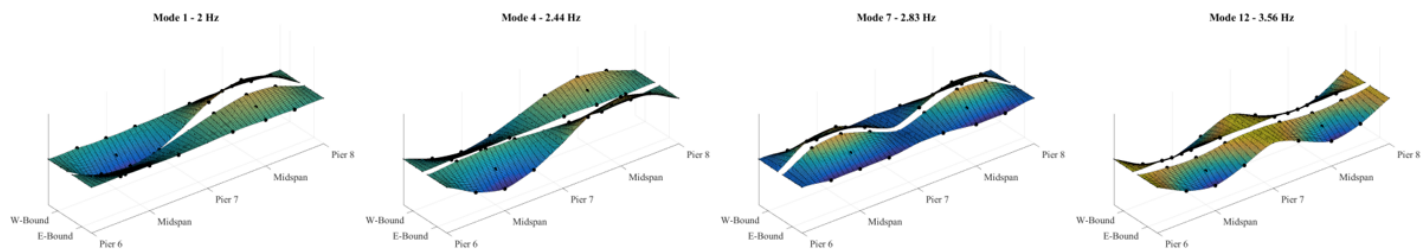
The focused operational monitoring revealed that the bridge was experiencing high magnitude acceleration at low frequencies and strains in the bottom flange that frequently exceeded 100 microstrain. Vertical acceleration of nearly 0.25 g was recorded. Modal processing identified 18 modes of vibration, 13 of which fell between 2 and 4 Hz.

This vibration corresponds to approximately $\frac{1}{2}$ " of displacement which places this bridge in the category of "very disturbing" according to human comfort criteria (Reiher and Meister, 1931). The strain in the deck was extrapolated at midspan and the negative-moment region, revealing events that resulted in strain in excess of 100 microstrain – levels for which long term fatigue cracks begin to form. Dynamic amplification of approximately 75% was estimated by filtering out content greater than 1.5 Hz.

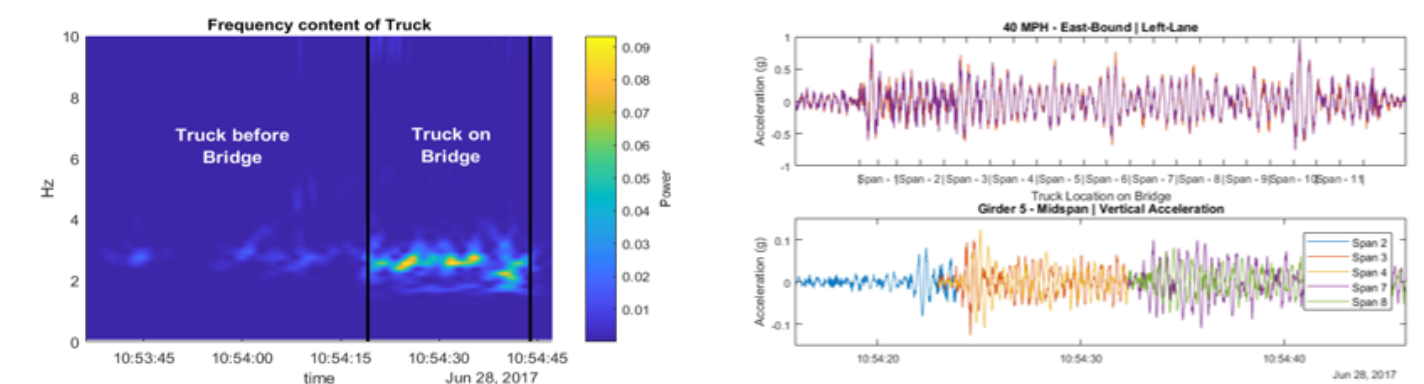
The load test revealed that the bridge induced vibration in the truck, and the truck caused significant vibrations in the bridge. These results indicated that the bridge vibrations were the result of a coupled system (vehicle-bridge) and the interaction must be considered in FE simulations.

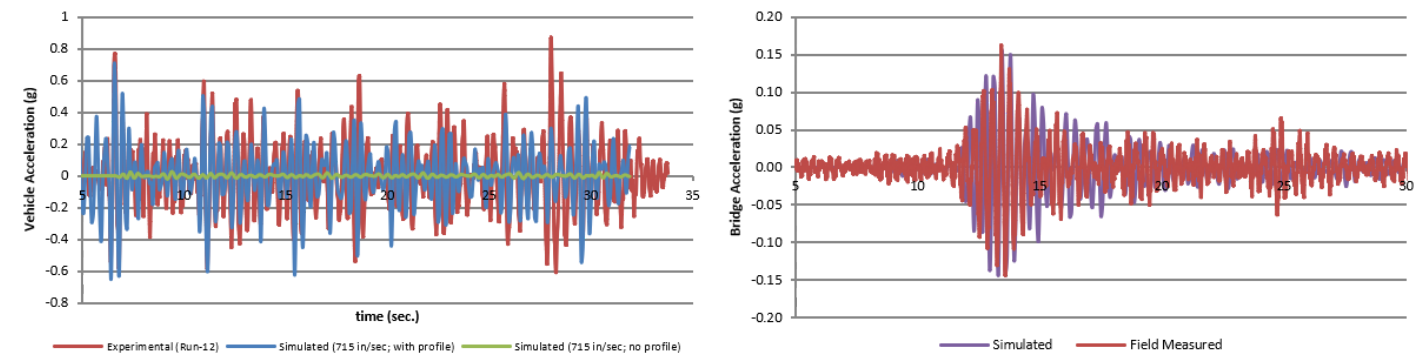
Simulations were performed in which a sprung-mass model of the truck was traversed across an element-level model of the bridge. These simulations did not come close to matching the experimental results until the profile was included in the simulations. The graph below compares the simulation with the profile included with what was recorded in the field and with a simulation that does not include the profile.

The simulations are consistent with the field measurements and indicate that the roadway profile is responsible for the excessive vibrations.
