### **3.2 Selection of the IBS Test Bridge**

### **3.3 Overview of the Structure (Review of Design Drawings)**

### **3.4 Overview of Current Condition (Review of Inspection Reports)**

### **3.6 On-site Observations (Initial Field Visit)**

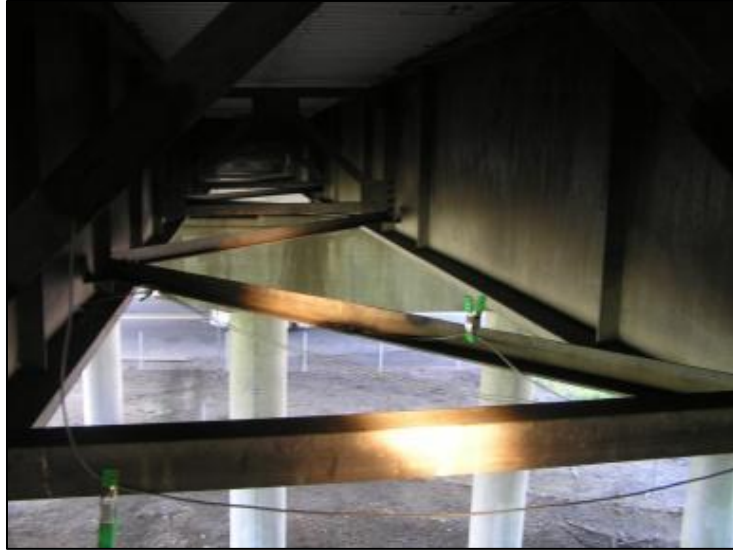
The bridges contain diagonal wind braces (Figure 3-3) between the fascia and first interior girders on every span which are connected via a 'Category E' gusset-to-girder web detail, discussed in Section 3.4. The diaphragms are a standard truss-type composed of four single angles connected to the girders with bolted connections and gusset plates (Figure 3-4).

**Figure 3-3 - Typical Wind Bracing for Fascia Girders**

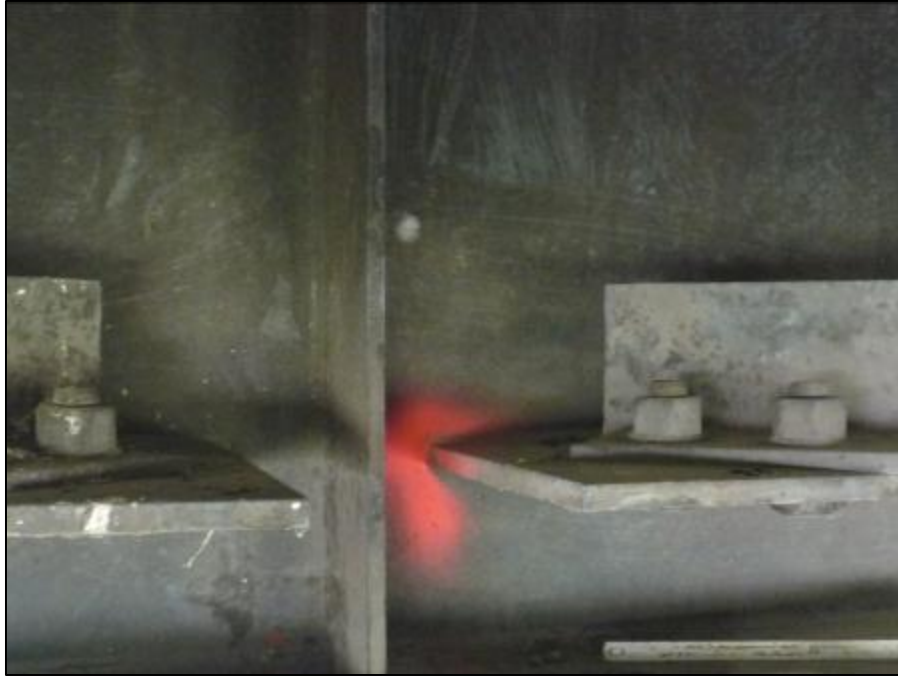
**Figure 3-5 - Wind Brace Connection**

According to the most recent inspection report available, the structures had an overall rating of 5 (Fair) due mainly to the condition of the superstructure. The inspection report pays particular attention to a series of fatigue cracks, which are present at the location of wind bracing-to-girder connections. These 'Category E' fatigue details, shown in Figure 3-5, have resulted in a total of 86 fatigue cracks, of which over 40 have propagated into the web. These 40 cracks were arrested by drilling a hole at the tip of the crack and inserting a bolt in the hole. Through the use of dye penetrant testing, it was determined that the arrested cracks have not progressed past where the hole was drilled.

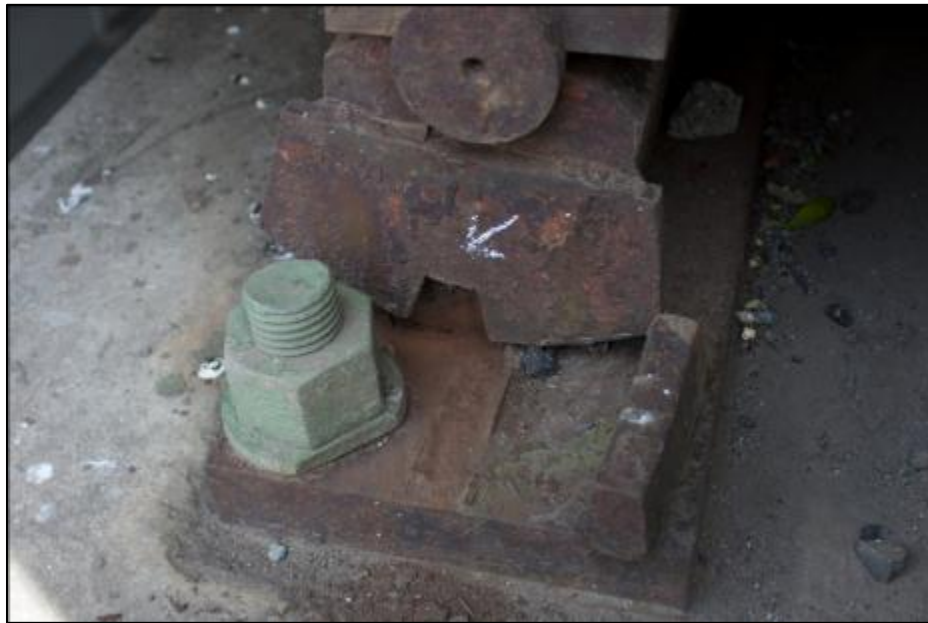
Bearing condition varied significantly across the structure with some bearings exhibiting almost no corrosion or deterioration, while others appear so deteriorated that replacement

may be required. In particular, the fascia bearings showed extensive corrosion, and in one case a fully cracked pintel was observed (Figure 3-8) that allowed the bearing to rotate about its vertical axis.

**Figure 3-8 - Fully Cracked Pintel**

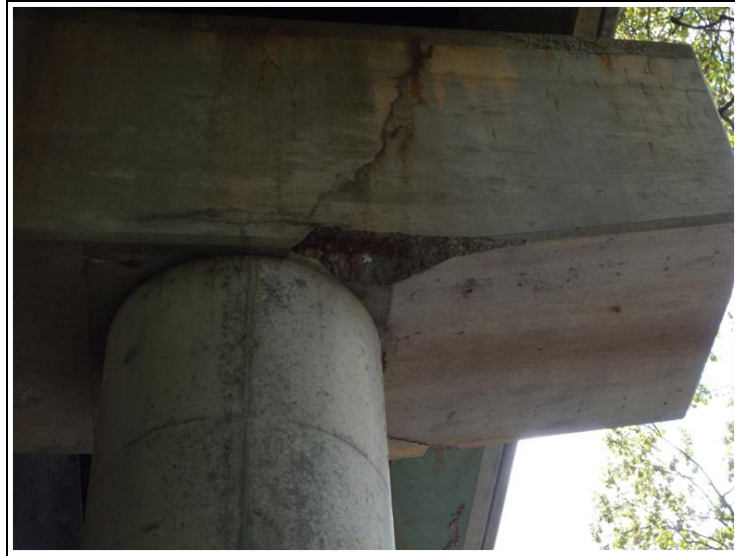
In addition, the majority of the joints were either filled with debris or bulging up into the roadway. Examination of the piercaps showed that most joints allowed water to drain directly through on top of the pier. In addition, the pier between SB1 and SB2 had a very large vertical crack between the bearings for Girder #1 and Girder #2 (Figure 3-9). There

**Figure 3-9 - Crack in SB Pier 1**

large single crack noticed in the pier cap, which likely indicates poor reinforcement details (due to the lack of distributed cracking). While the computed rating factors indicate that the bridge does not have a capacity issue, they do not provide any information about the potential for continued fatigue crack propagation, local bearing instabilities, or localized failures due to poor reinforcement details.

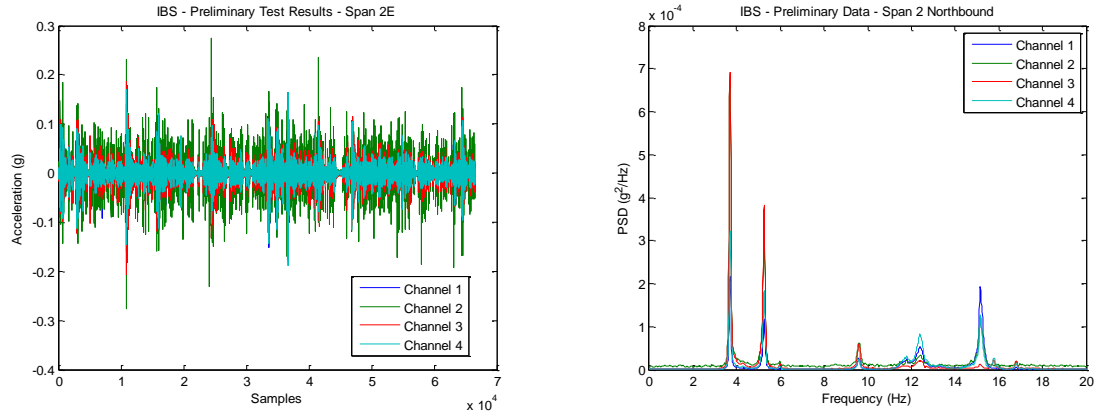
Figure 3-10 and Figure 3-11 show typical acceleration time histories and power spectral densities for Span 2 northbound and south bound respectively. As apparent from these figures, the bridges experience significant acceleration under normal traffic loading (with 0.4 g the highest acceleration recorded). In addition, while both spans (which are nearly identical) have very well defined peaks (indicating low damping ratios), they display distinctly different natural frequencies (as shown in Table 3-3). In addition, the higher frequency modes of Span 2 northbound appear to be participating more than their counterparts for Span 2 southbound. While there are many potential reasons for this (such as the different locations of the sidewalks relative to the skew, or simply different traffic loading during the monitoring), at this point it is important to at least be aware that the vibration responses of the two bridges may have significant differences.

**Figure 3-10 - Acceleration Time History and Power Spectral Densities for Span 2 NB**

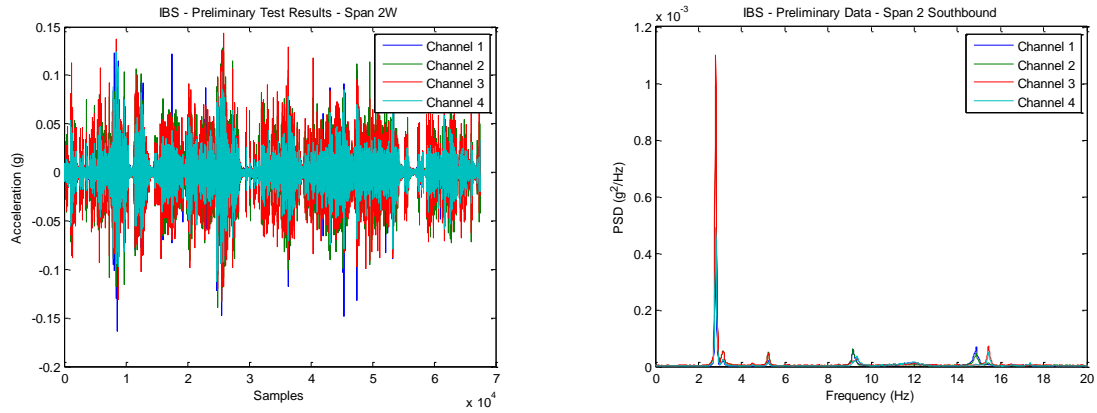
**Figure 3-11 - Acceleration Time History and Power Spectral Densities for Span 2 SB**
