MES - Machine Connectivity - Cartoner

72 Tests Complete

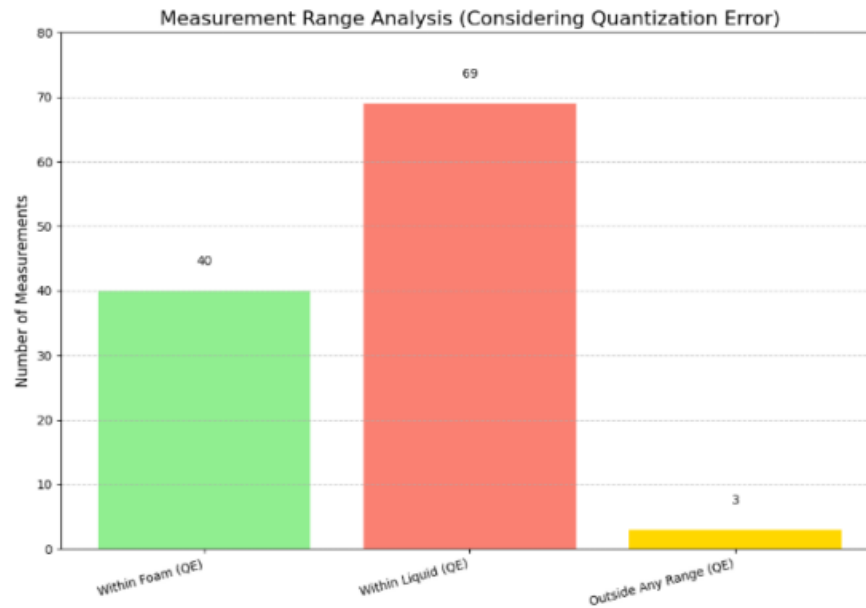
*Note about values outside range

The 3 tests that fell outside any range were the first iteration of tests for their respective part. Each part passed all other subsequent tests.

I believe the reason the system may have failed is that the tube connected to the pump being tested was not fully secure/pushed onto the pump output.

Its also possible the tube coming out of the sensor, and back into the water container, was blocked by the wall/bottom of the container.

The 3 tests that failed were all relatively early on in testing, and I resolved these operator-error issues in later tests, not encountering them again.

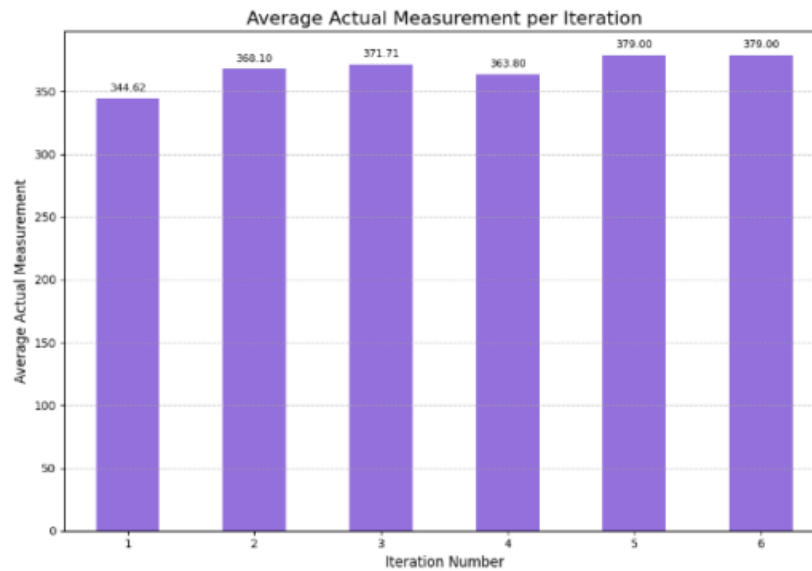
*1st iterations has lower readings

The first iteration of testing on many of the parts seemed to have a lower reading than subsequent readings frequently.

I believe this may be due to the tube not being fully connected to the pump. I frequently secured the tube further after the first iteration.
