## Sun StorEdge 3510 array: Multipathing sometimes fails to provide path redundancy following a controller failure in a dual-controller setup (Doc ID 1003900.1)

Sun Storage 3510 FC Array - Version Not Applicable and later  
All Platforms

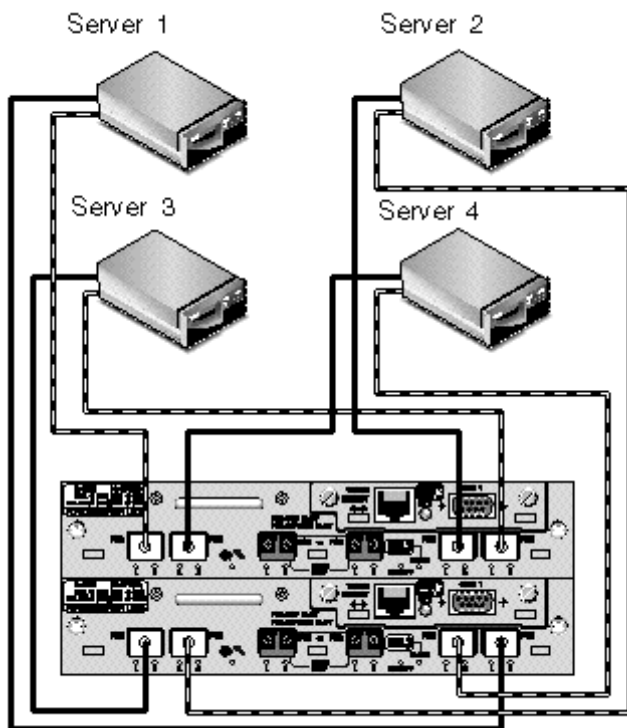
If dual host paths are connected to the dual channels on a single FC controller chip (ie. CH0 & CH1 and/or CH4 & CH5), the FC chip fails for any reason, and controller failover does not work as expected; the host connection to the LUNs within the SE3510 will be lost even though the multipathing software was setup correctly.

To avoid such failures on the SE3510, host cables should be connected to the different ports on different IOM and different FC controller chips. For example, if one host path was connected to the CH0 port on the top IOM, another host path should be connected to the CH4 or CH5 port on the bottom IOM. The following diagram is from [Sun StorEdge 3000 Family Best Practices Manual: Sun StorEdge 3510 FC and 3511 SATA Array](#), demonstrating an example of a best practice dual-controller multipath configuration. There is no single unique best configuration, but the diagram takes into account the issue described in this article.
