MICROCHIP dsPIC33EPXXXGM3XX/6XX/7XX FAMILY

dsPIC33EPXXXGM3XX/6XX/7XX Family Silicon Errata and Data Sheet Clarification

The dsPIC33EPXXXGM3XX/6XX/7XX family devices that you have received conform functionally to the current Device Data Sheet (DS70000689D), except for the anomalies described in this document.

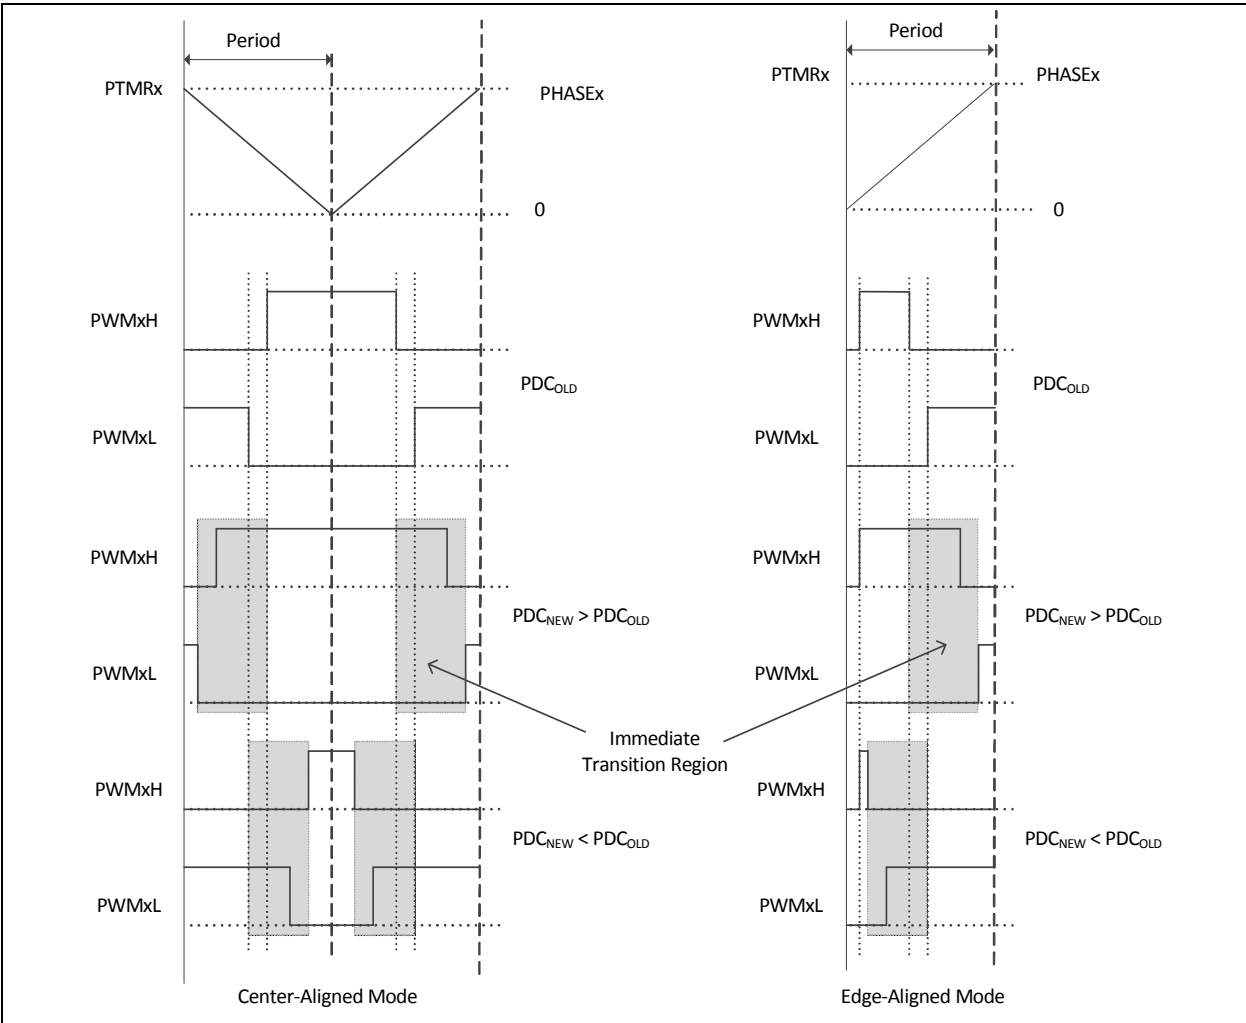
FIGURE 1: TIMING DIAGRAMS FOR CENTER-ALIGNED AND EDGE-ALIGNED MODES

The PWM generator may not assert dead time on the edges of transitions. This has been observed when all of the following conditions are present:

- The PWM generator is configured to operate in Complementary mode with Independent Time Base (ITB) or master time base;
- Immediate update is enabled; and
- The value in the PDC register is updated in such a manner that the PWMxH and PWMxL outputs make an immediate transition.

The current duty cycle, PDC_{OLD}, newly calculated duty cycle, PDC_{NEW}, and the point at which a write to the Duty Cycle register occurs within the PWM

time base, will determine if the PWMxH and PWMxL outputs make an immediate transition. PWMxH and PWMxL outputs make an immediate transition if the Duty Cycle register is written with a new value, PDC_{NEW}, at a point of time when the PWM time base is counting a value that is in between PDC_{NEW} and PDC_{OLD}. Additionally, writing to the Duty Cycle register, close to the instant of time where dead time is being applied, may result in a reduced dead time which is effective on the PWMxH and PWMxL transition edges.

In Figure 1, if the duty cycle write occurred in the shaded box, then PWMxH and PWMxL will make an immediate transition without dead time.

In most applications, the duty cycle update timing can be controlled using the TRIGx trigger, or Special Event Trigger, such that the above mentioned conditions are avoided altogether.

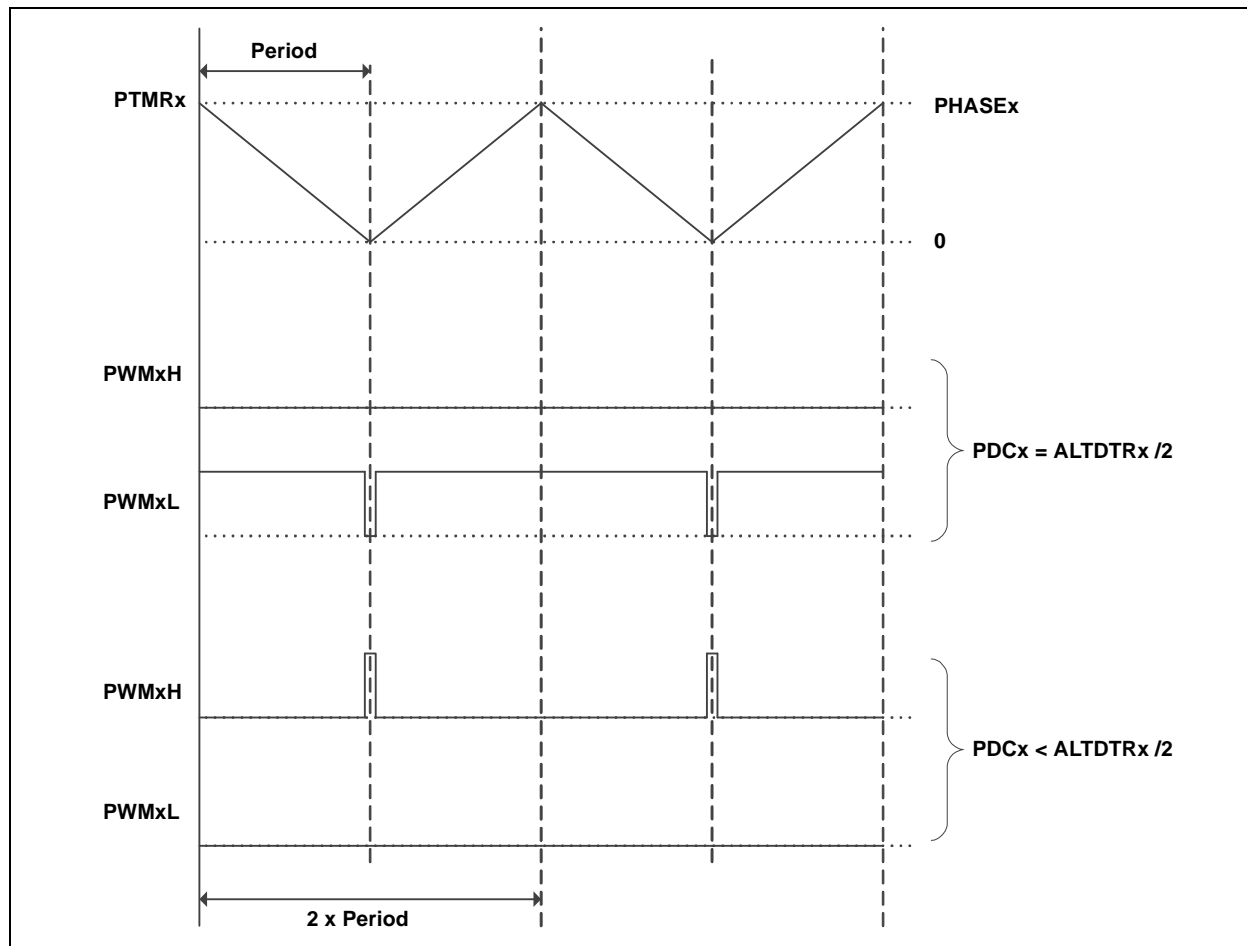
FIGURE 2: PWM GENERATOR TIMING DIAGRAM

In Center-Aligned Complementary mode with Independent Time Base, if the value in the PDCx register is less than one-half the value in the ALTDTRx register, the PWM generator will force the PWMxL to low, and on the PWMxH, generates pulses of a width less than twice the dead time, as shown in Figure 2.

Include a software routine to ensure that the duty cycle value written to the PDCx register is at least one-half of the value in ALTDTRx. Example 1 shows one method, with PDCtemp representing the variable which has the value to be written to the PDCx register. Alternatively, for duty cycle values less than half the desired dead-time value, zero out the ALTDTRx register or dynamically reduce the value in the ALTDTRx register, such that ALTDTRx is always equal to $2 * PDCx$, as shown in Example 2.

```
Altdtr_by2 = ALTDTRx / 2;
if (PDCtemp < Altdtr_by2)
{
    PDCx = Altdtr_by2;
}
else
{
    PDCx = PDCtemp;
}
```

```
#define DESIRED_DEADTIME 100
if (PDCtemp < (DESIRED_DEADTIME/2))
{
    ALTDTRx = PDCtemp * 2;
    PDCx = PDCtemp;
}
else
{
    ALTDTRx = DESIRED_DEADTIME;
    PDCx = PDCtemp;
}
```

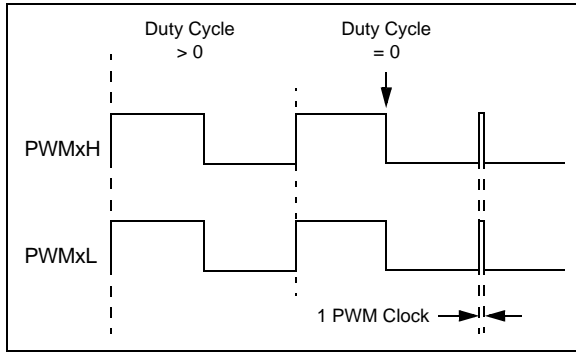
FIGURE 3:

In certain output modes, the PWMx module produces a pulse glitch of one PWM clock in width (Figure 3). This has been observed only when all of the following are true:

- Either Redundant or Push-Pull Output mode is selected ($\text{IOCONx}<11:10> = 10$ or 01);
- Immediate Update is disabled ($\text{PWMCONx}<0> = 0$); and
- The value of the current Duty Cycle register (either the PDCx or MDC register, as determined by $\text{PWMCONx}<8>$) is updated to zero from any non-zero value.

The pulse glitch has been observed to occur at the beginning of the following PWM boundary period.

If the application requires a duty cycle of zero, two possible work arounds are available.

1. Use the PWM overrides to force the output to a low state, instead of writing a '0' to the Duty Cycle register. When using this method, the PWM override must be disabled when the duty cycle is a non-zero value. If output override synchronization is configured to occur on CPU clock boundaries ($\text{IOCONx}<0> = 0$), enabling and disabling the override must be timed to occur as closely as possible to the PWM period boundary.
2. Configure the module for Immediate Update ($\text{PWMCONx}<0> = 1$) *before* enabling the module. In this mode, writes to the Duty Cycle register have an immediate effect on the output. As with the previous work around, writes to the Duty Cycle register must be timed to occur as close to the PWM period boundary as possible in order to avoid distortion of the output.

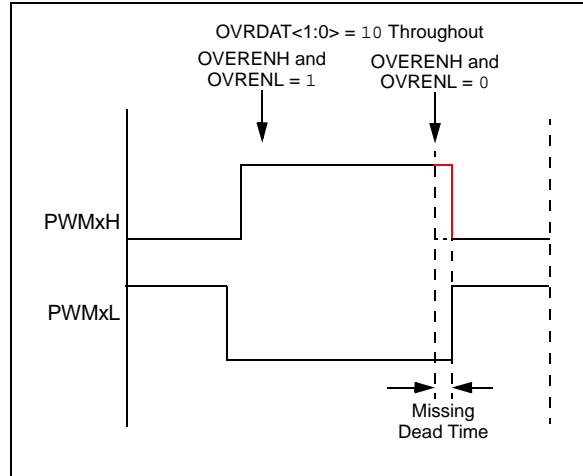
FIGURE 4:

In Complementary Output mode, the expected dead time between transitions of the PWMxH and PWMxL outputs may not be asserted when the following occurs:

- Output override synchronization is configured to occur on the CPU clock boundary ($\text{IOCONx}<0> = 0$);
- Both PWMxH and PWMxL overrides are enabled prior to the event (OVRENH and OVRENL are both '1'), and
- Both overrides are disabled (OVRENH and OVRENL are both '0') at the instant the dead time should be asserted (Figure 4).

This has been observed in both Center-Aligned and Edge-Aligned modes.

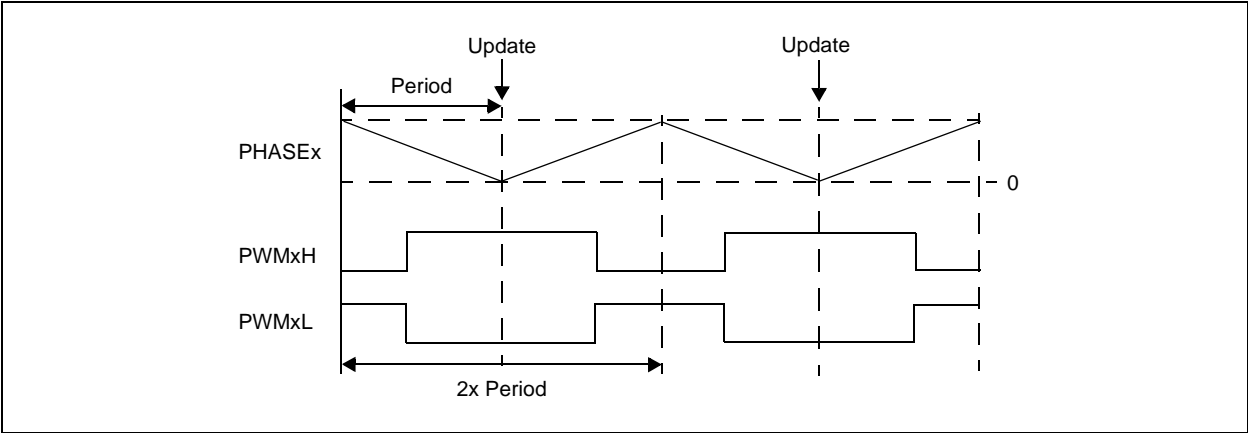
FIGURE 5:

In Center-Aligned Complementary mode with Independent Time Base, updates to the PHASEx register take effect in the middle of a Center-Aligned PWM cycle, as shown in Figure 5. This occurs only when the Immediate Update feature is disabled (IUE = 0). If Immediate Update is enabled (IUE = 1), the PHASEx register updates will take effect immediately.

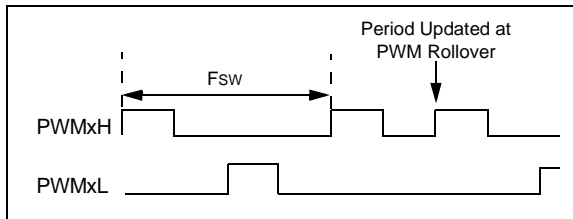
FIGURE 6:

When the PWM module is configured for Push-Pull mode (IOCONx<11:10> = 10) with the Enable Immediate Period Update bit enabled (PTCON<10> = 1), a write to the Period register that coincides with the period rollover event may cause the push-pull output logic to produce back-to-back pulses on the PWMx pins (Figure 6).

Ensure that the update to the PWM Period register occurs away from the PWM rollover event by setting the EIPU bit (PTCON<10> = 1). Use either the PWM Special Event Trigger (SEVTCMP) or the PWM Primary Trigger (TRIGx) to generate a PWM Interrupt Service Routine (ISR) near the start of the PWM cycle. This ISR will ensure that period writes do not occur near the PWM period rollover event.
