September 14, 2025

Incontrovertible Proof AAIB Obfuscated Evidence in its AI 171 “Preliminary Report”

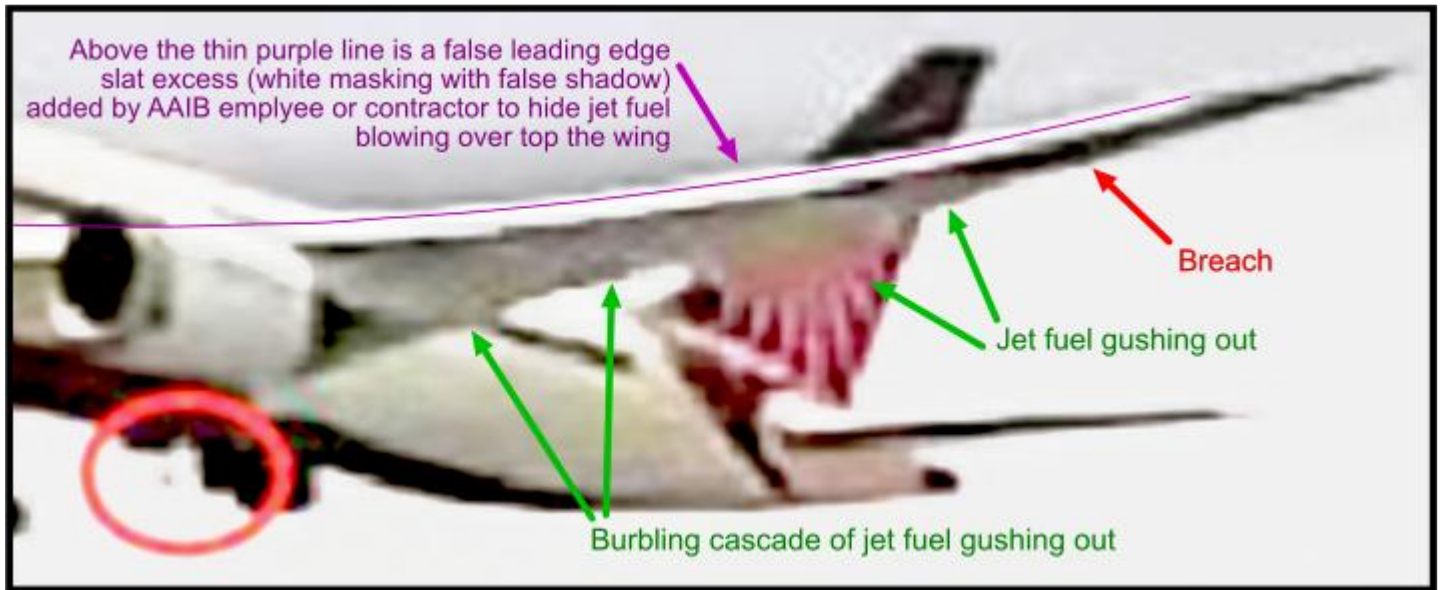
The enhanced and annotated image shown above speaks for itself. It is very clear that the Boeing 787-8 of Air India 171 suffered a catastrophic failure of its left wing during rotation.

That breach being pointed to in the image above begins near the wingtip with the leading edge of the bottom CFRP wing panel at Rib 39 and continues all the way back to at least Rib 13 near the left engine mount (see **Exhibit K-4**). That big straw-colored gush of jet fuel under the left wing appears to be located between the two outer control fairings, which can't be seen because they are submerged in said gush of jet fuel.

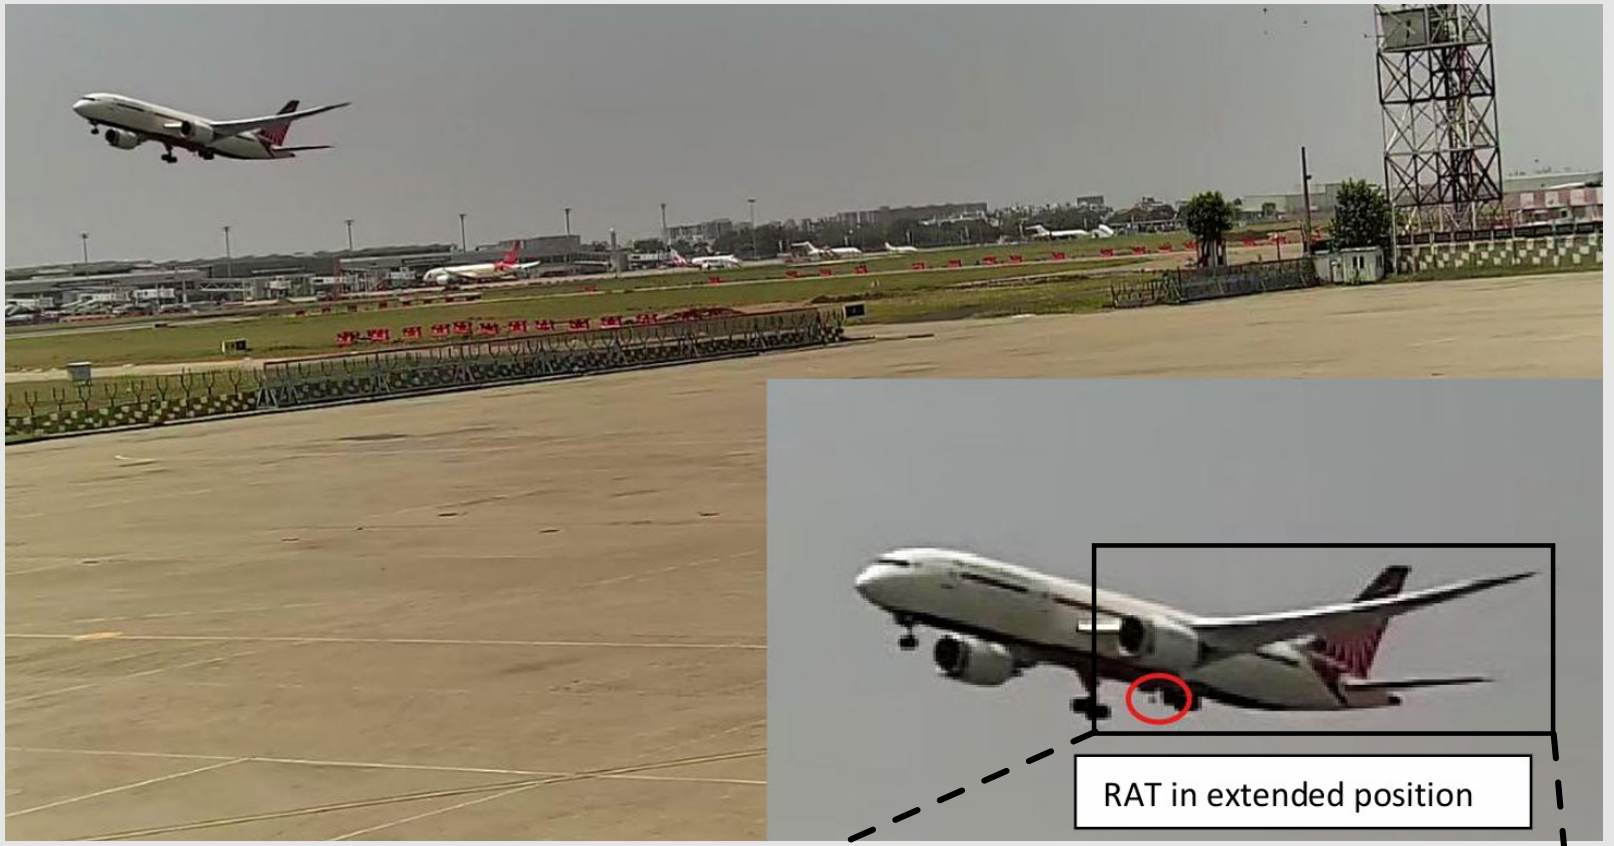
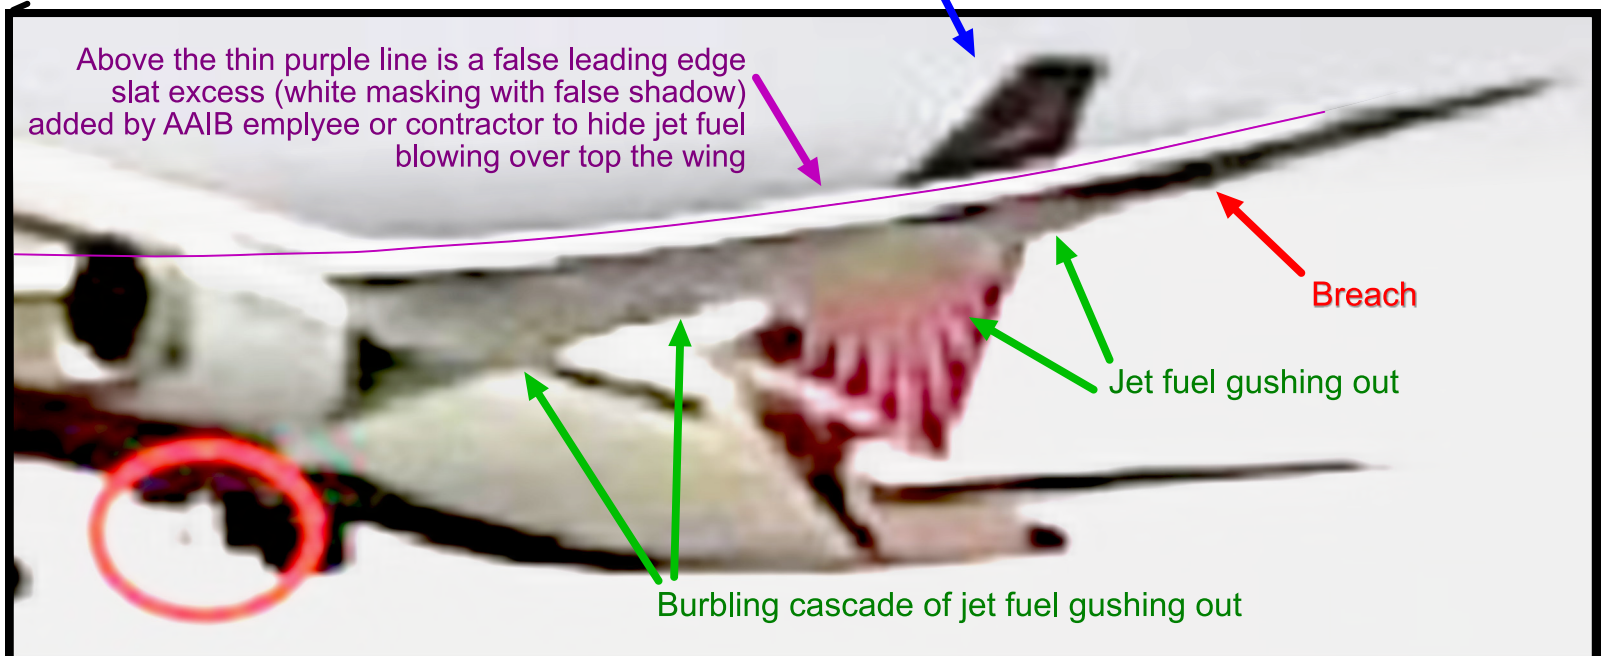
Exhibit K-1

For comparison, attached **Exhibit K-1** shows a cropping of the original obfuscated image as it appears on page 14 of the AAIB “Preliminary Report” and the enhanced and annotated one shown above. Note that the upper half of the vertical stabilizer is completely desaturated of any color, which is why it appears black and devoid of any color. It was cut and pasted over the original to conceal from public view the fact that jet fuel is bubbling out and over the top of the wing during the time that frame was captured by CCTV #2.

This image is cropped from the main image appearing on Page 14 of India's AAIB "Preliminary Report" released to the public on July 11, 2025. The exploded and enhanced views below it show incontrovertibly that Air India 171 suffered a catastrophic failure of its left wing during rotation, when the forward-facing top and/or bottom Carbon Fiber Re-enforced Polymer (CFRP) wing panels separated from their corresponding forward spar caps, resulting in a 10-20 meter long breach.

Completely desaturated vertical stabilizer upper half, wherein AAIB personnel cropped and pasted over jet fuel spray appearing in original CCTV#2 frame

Above the thin purple line is a false leading edge slat excess (white masking with false shadow) added by AAIB employee or contractor to hide jet fuel blowing over top the wing

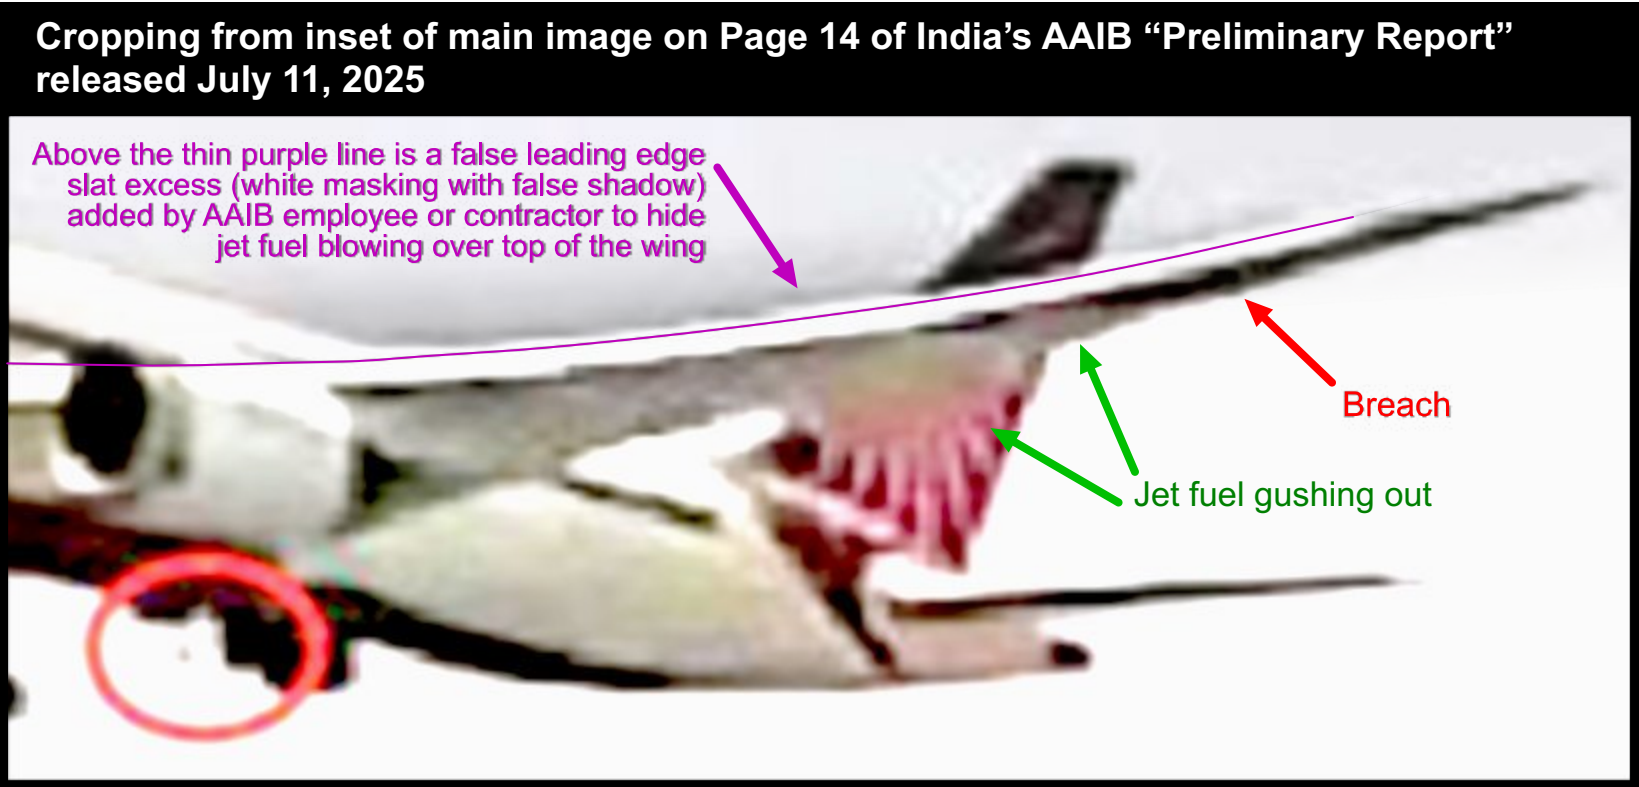
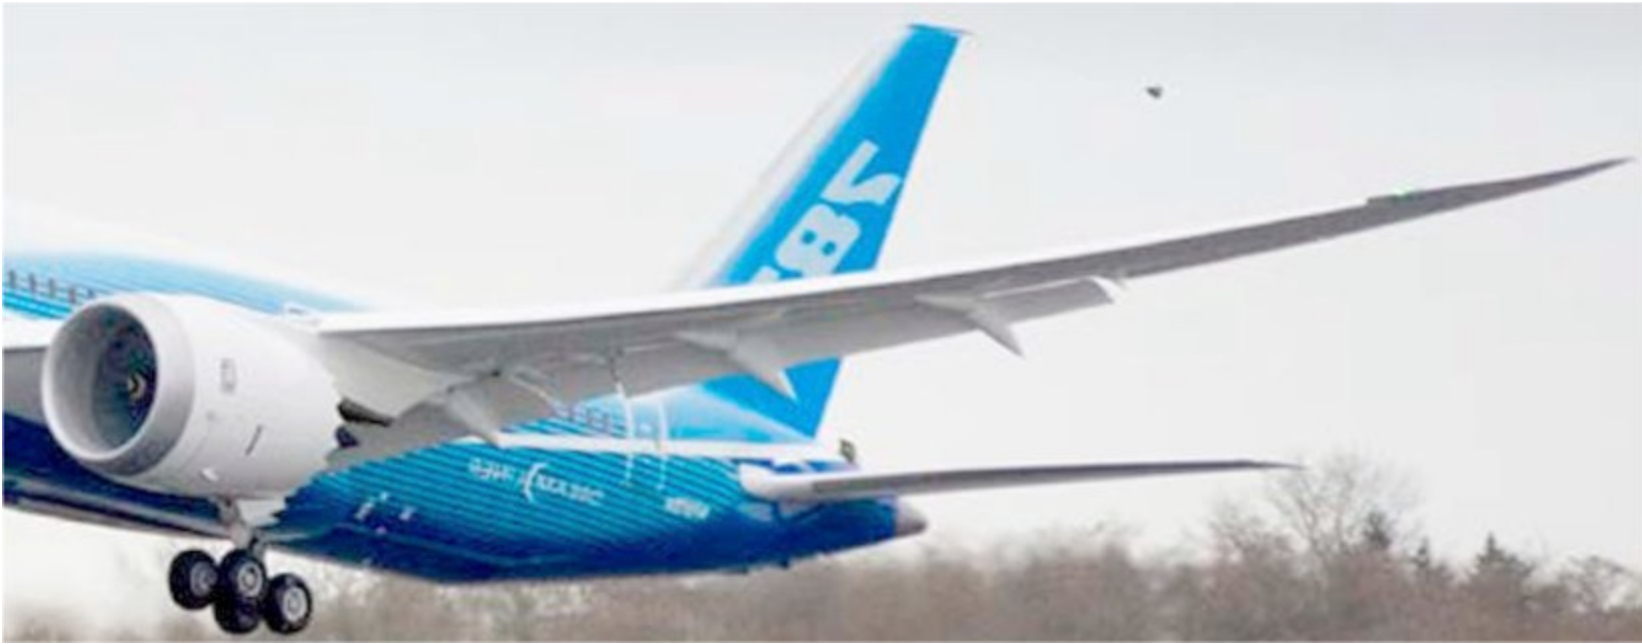
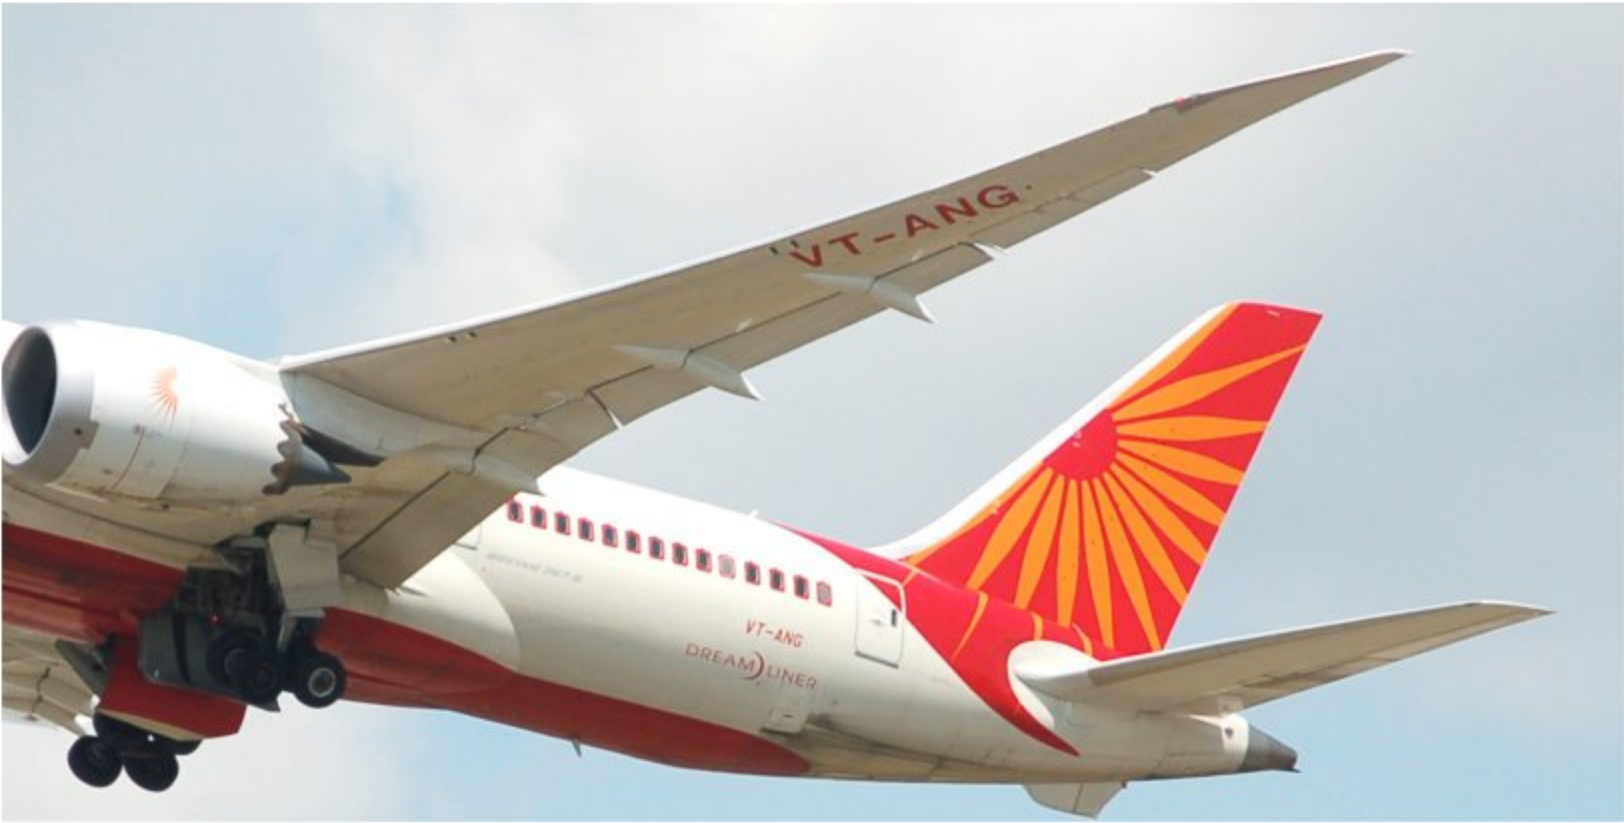
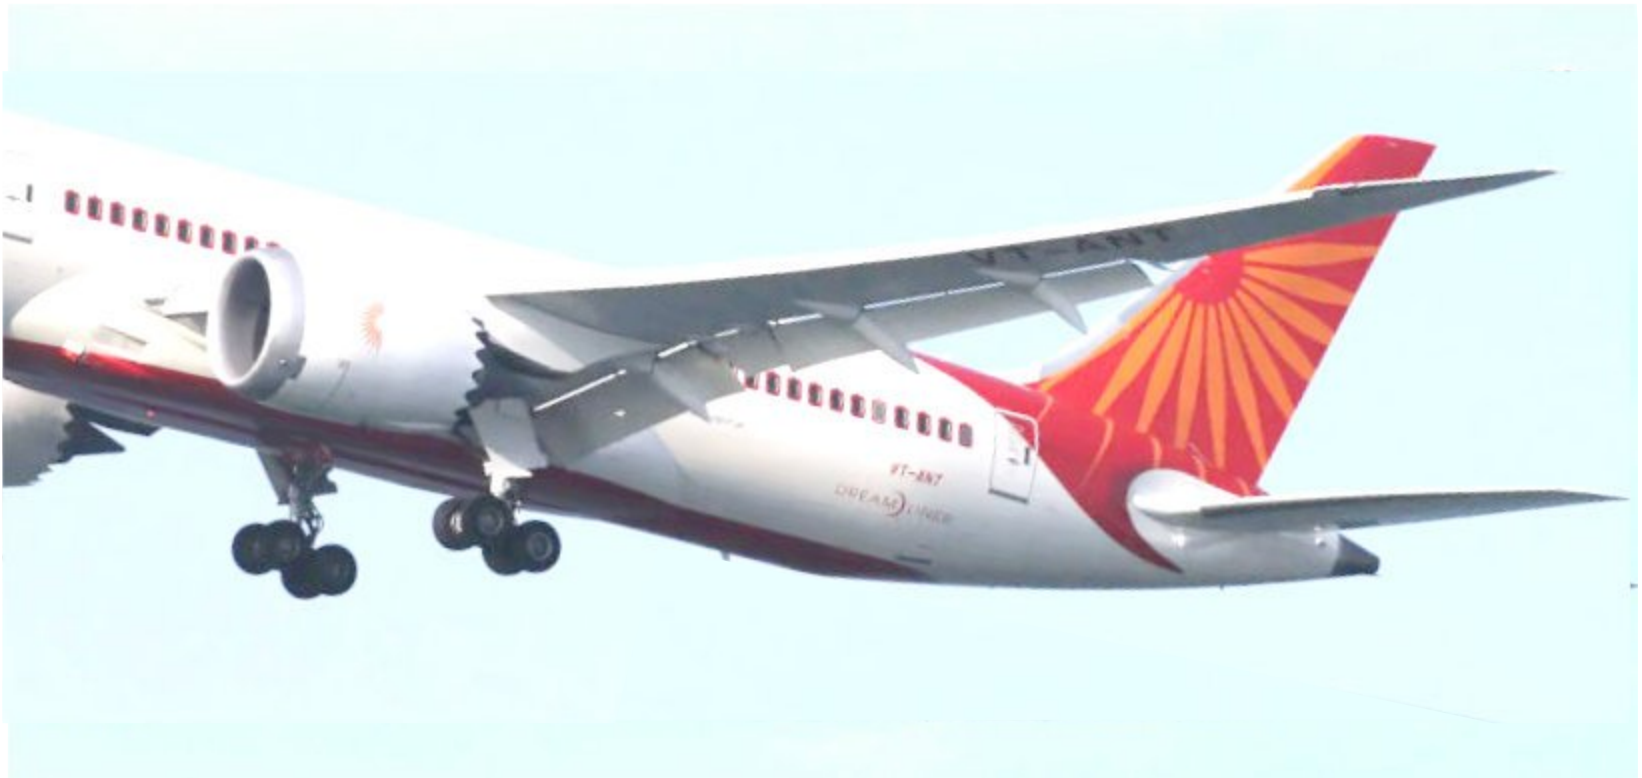
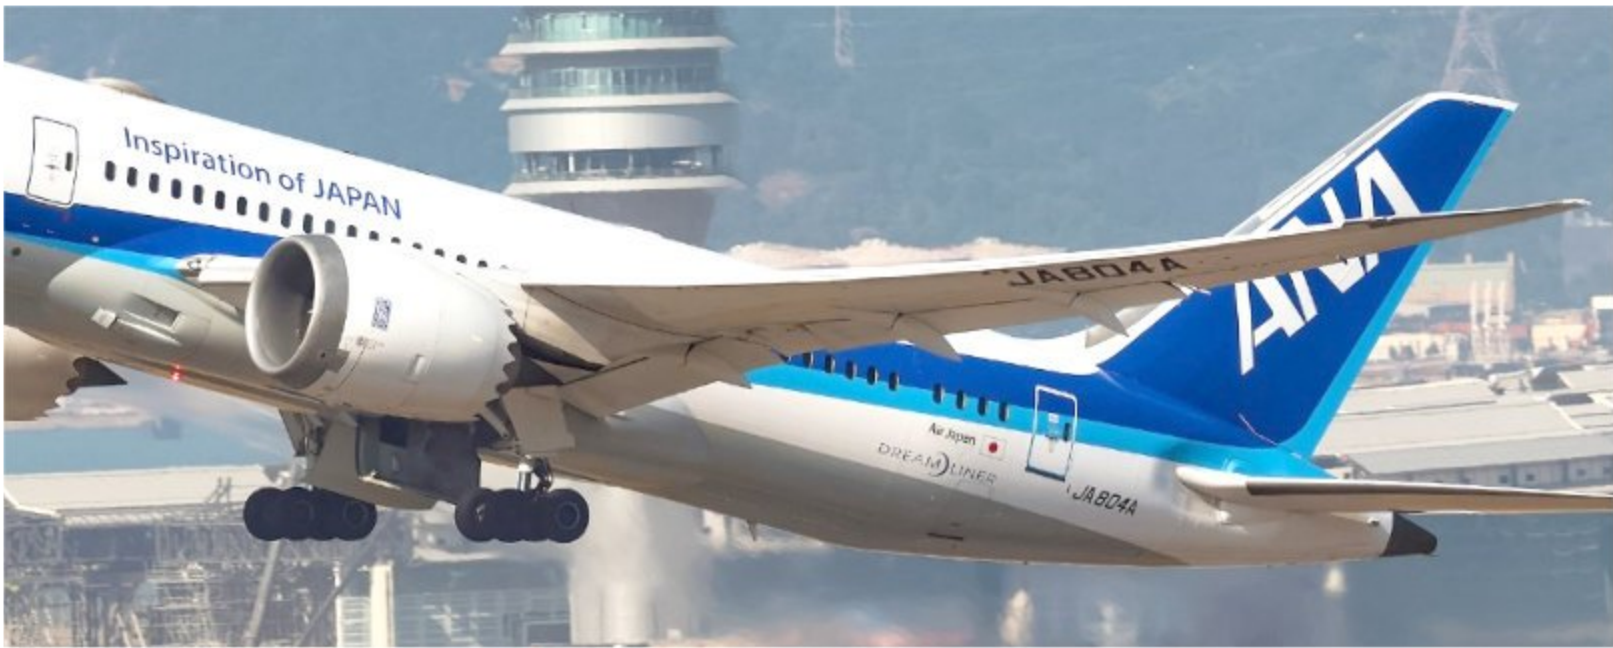
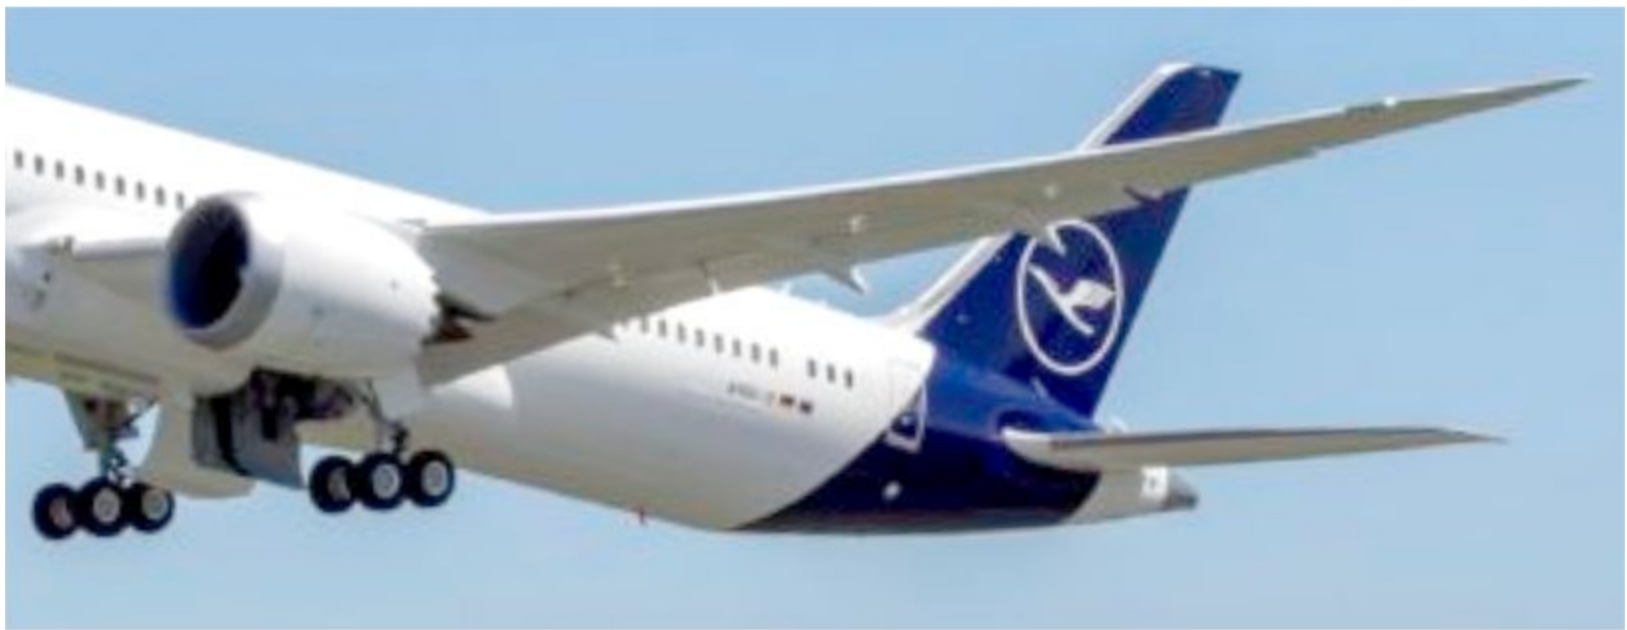
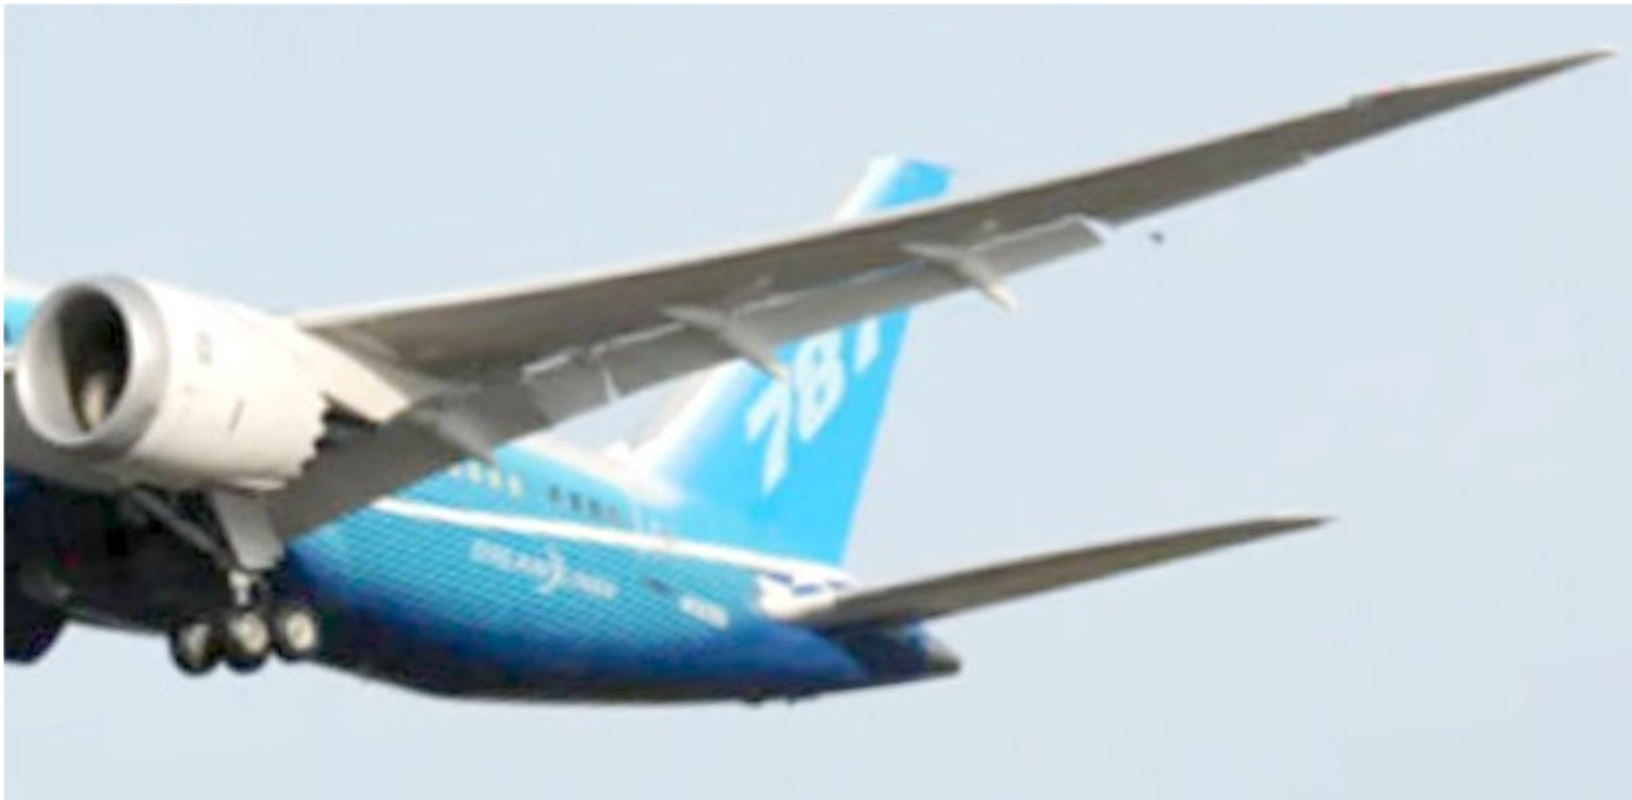
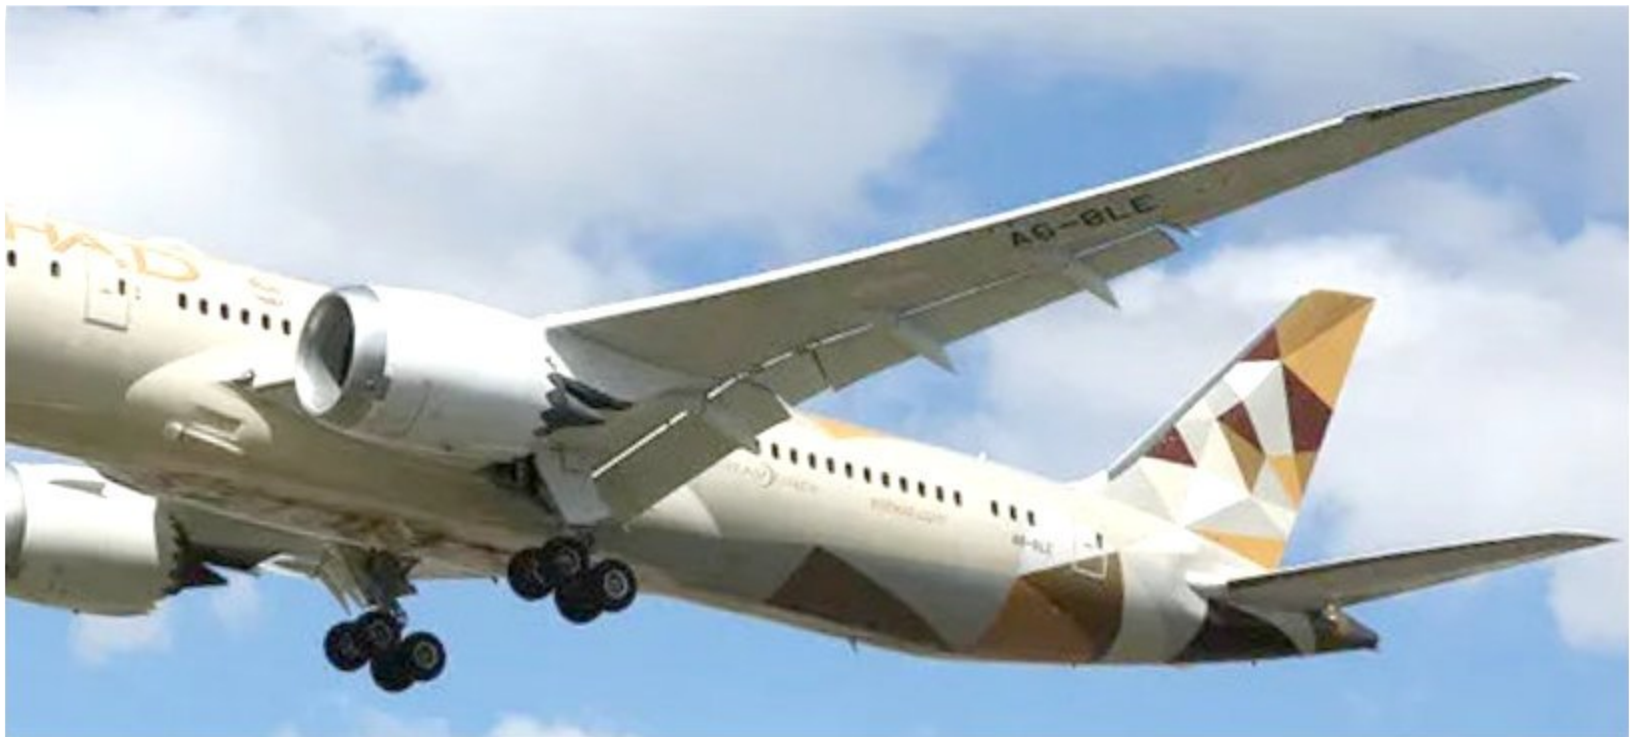
Attached **Exhibit K-3** compares the above enhanced image with seven other Boeing 787s as a sort of study to get an idea of what a Boeing 787 from that angle should look like. Exhibit K-3 makes it very clear that the left wing of Air India 171’s Boeing 787 suffered severe damage during rotation.

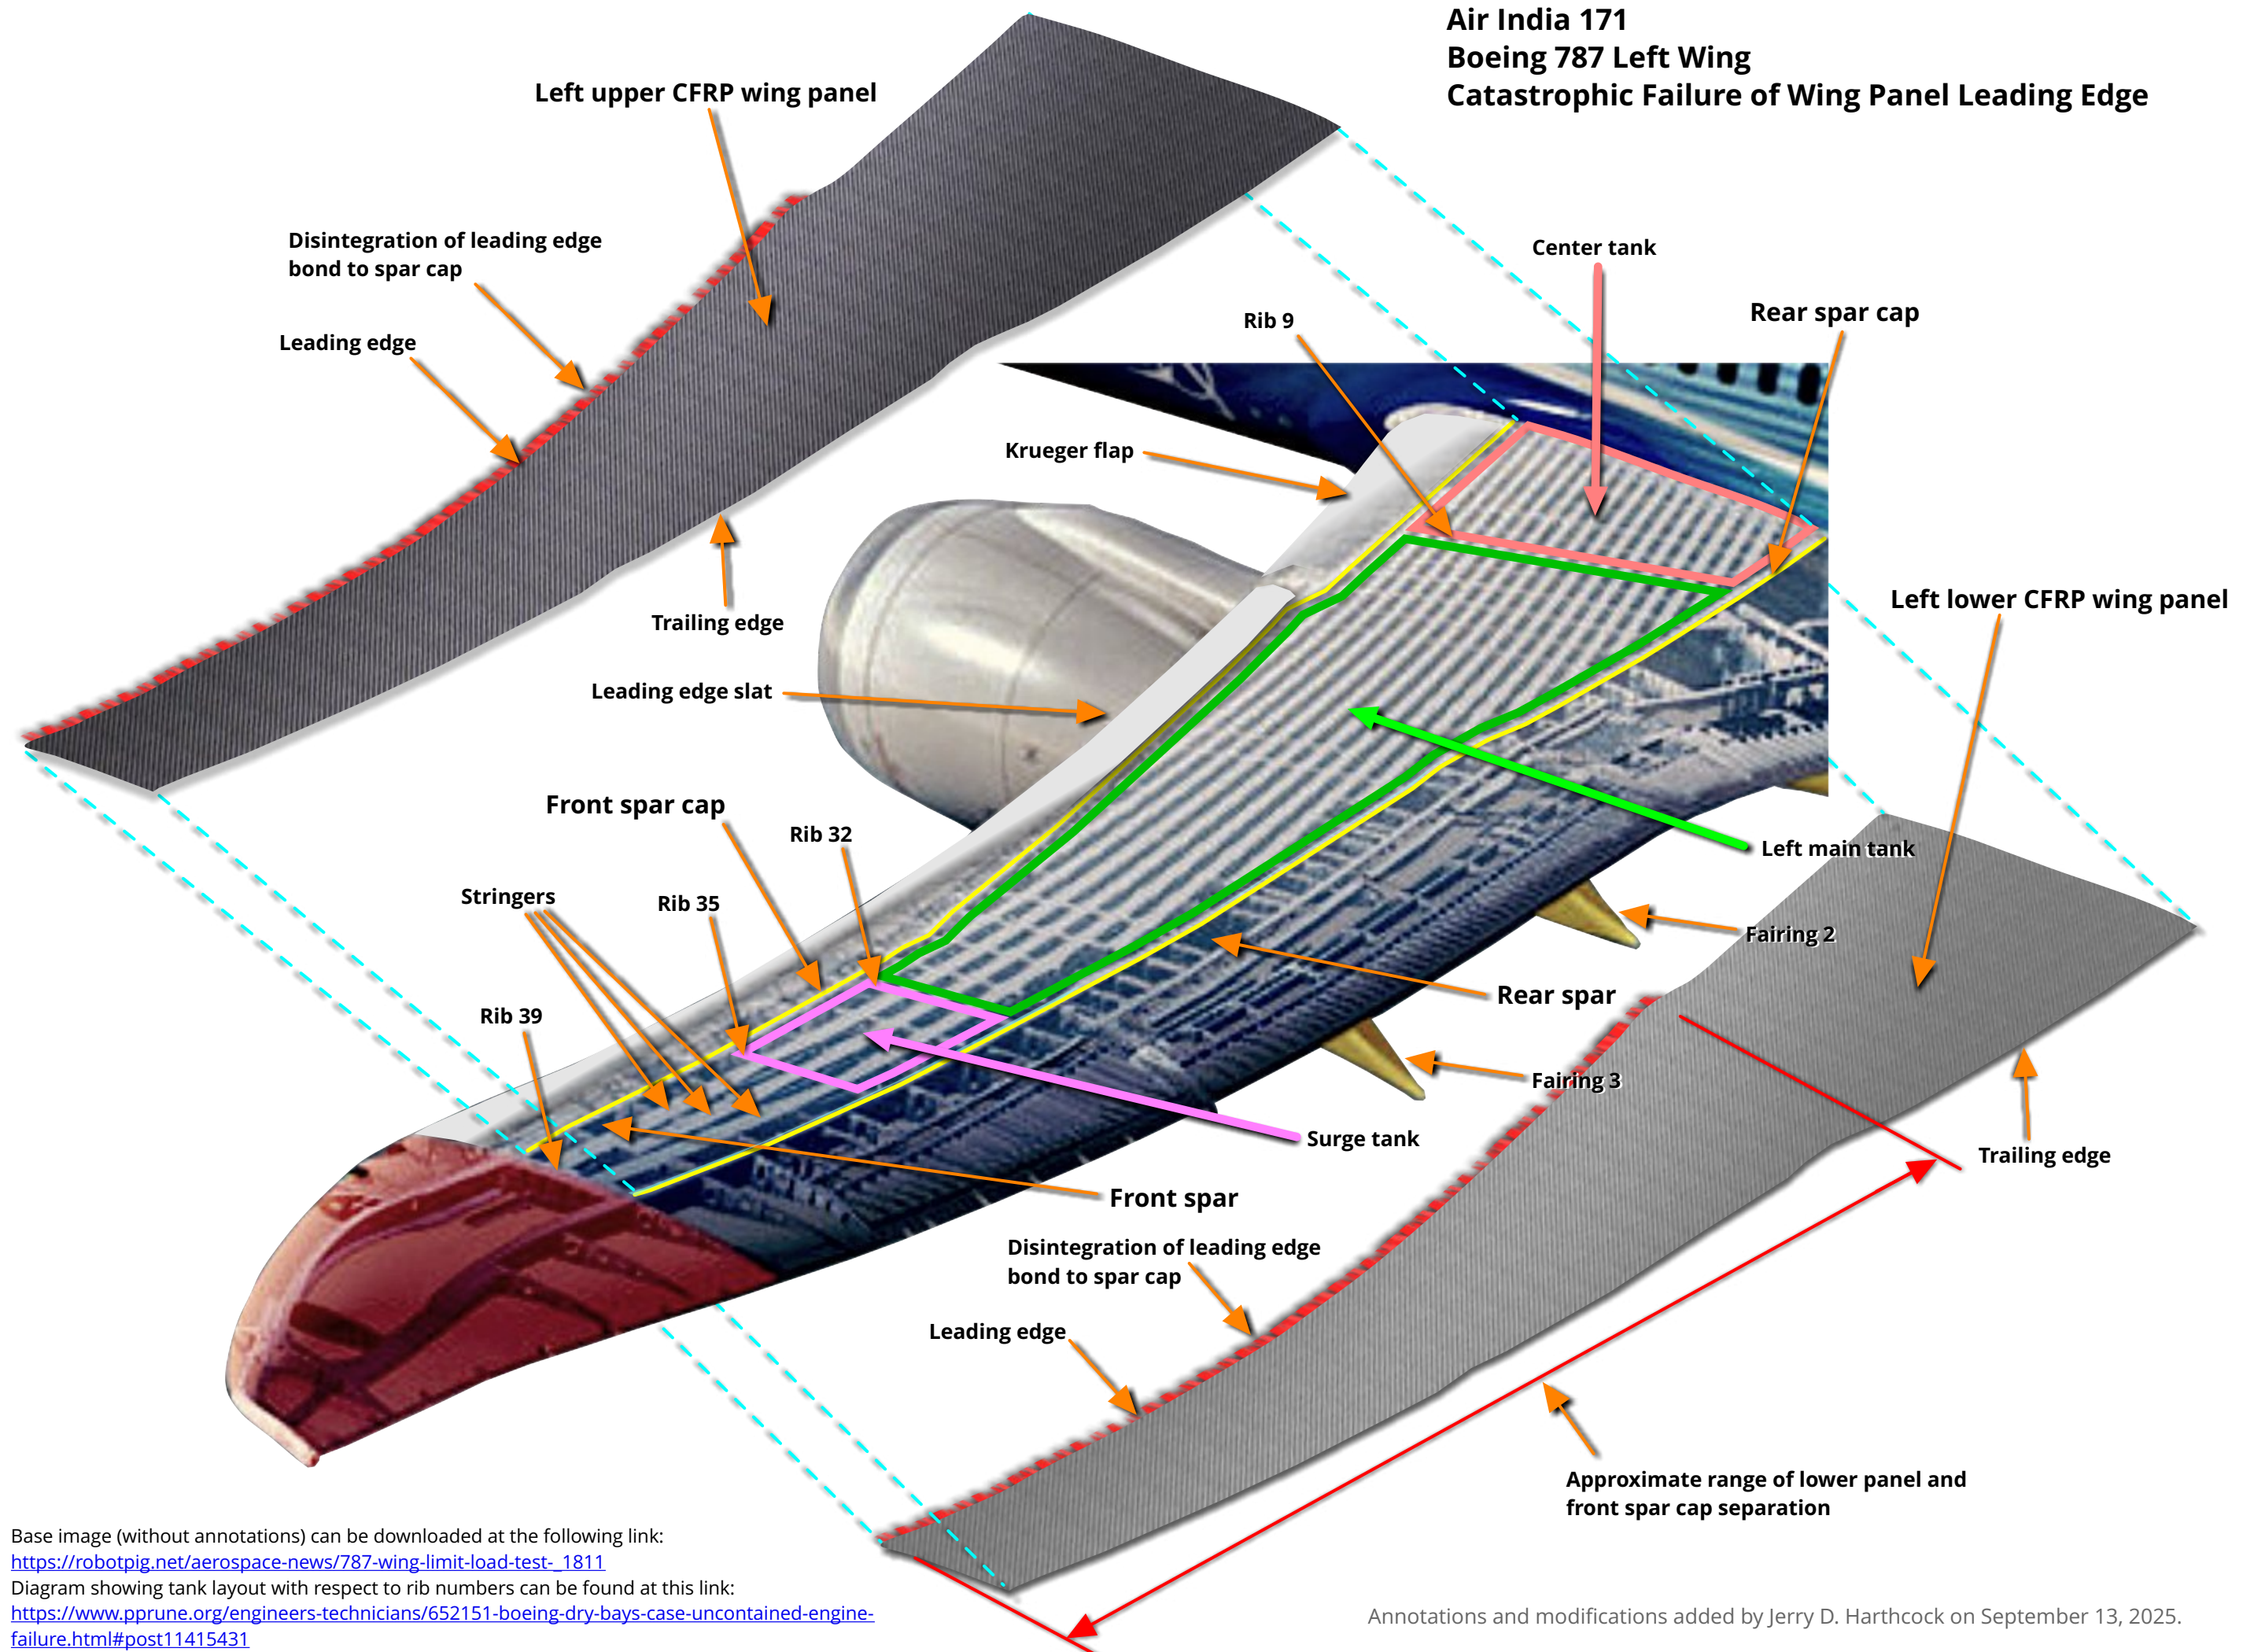
Exhibit K-4

Air India 171 Boeing 787 Left Wing Catastrophic Failure of Wing Panel Leading Edge

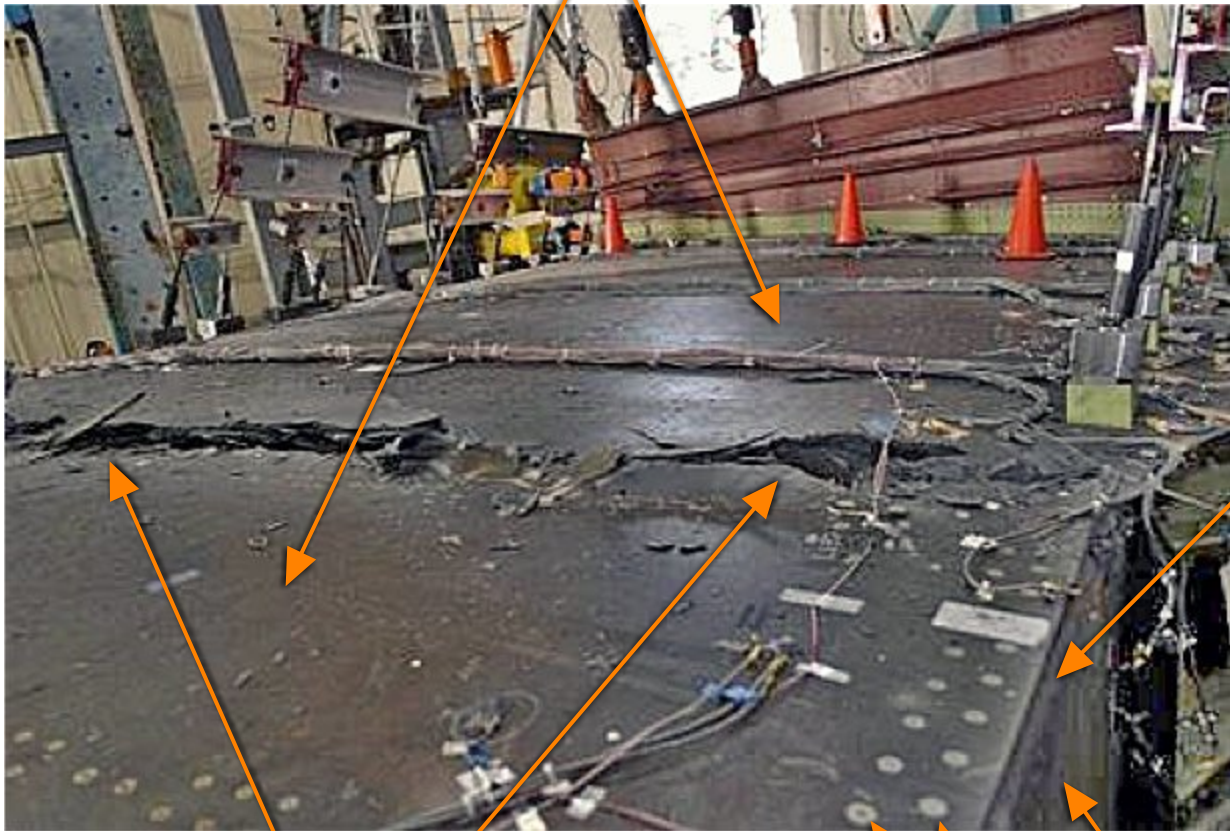
Exhibit K-5 shows an example of early stages of wing testing at Boeing. Here you can see what a catastrophic failure of a CFRP wing panel looks like in terms of delamination and disintegration as a result of extreme fatigue.

Catastrophic failure of Carbon Fiber Re-enforced Polymer (CFRP) wing panel showing severe delamination and fracture due to fatigue
