Exhibit K-5

Carbon Fiber Re-enforced Polymer (CFRP) wing panel

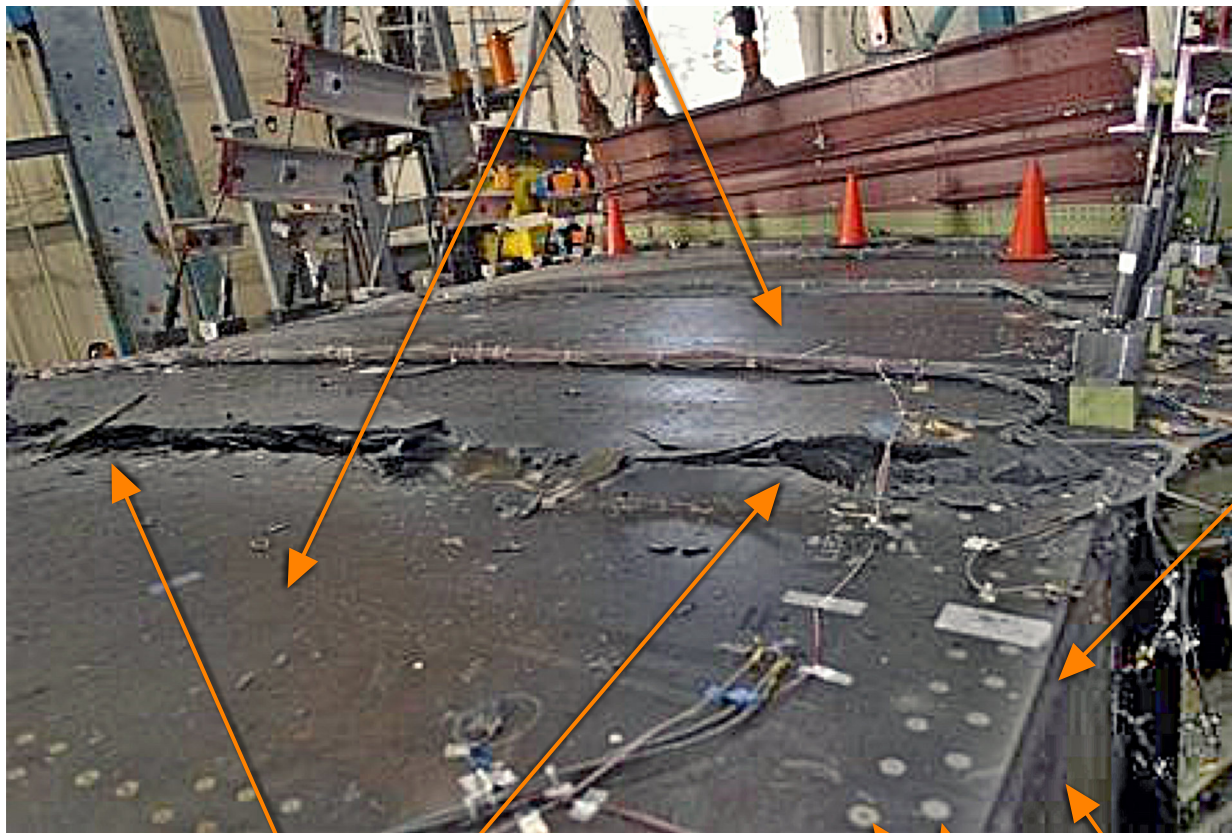
Spar cap

Catastrophic failure of Carbon Fiber Re-enforced Polymer (CFRP) wing panel showing severe delamination and fracture due to fatigue

Spar
Mechanical fastening to spar cap
