Re: Water Drainage
Onto 100 St. Paul Street Condominium
Brookline, Massachusetts

Structural Investigation Report

100 St. Paul Street, Brookline MA, 02446

Prepared by
**SurfZone Engineering
Consultants LLC**
February 10, 2024

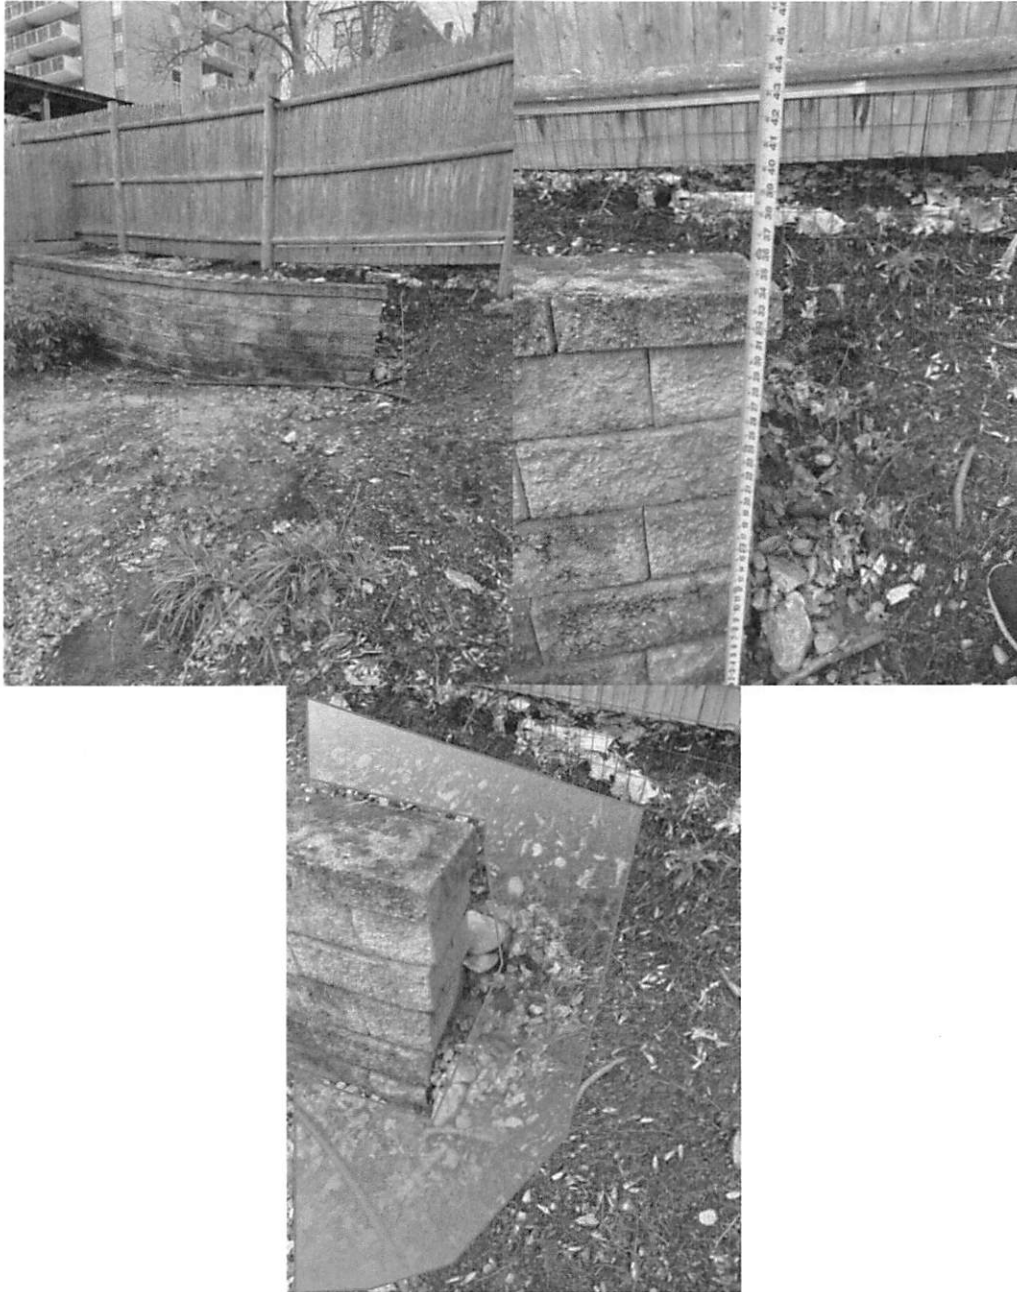
The right neighbor at 108, 114, and 118 St. Paul St. condominium residential buildings has over 8,500 sqft of paved parking lot without a drainage system. The pavement sloped toward the 100 St. Paul St. backyard. A significant amount of runoff water flowing under the fence at the corner of the property lot has eroded the backyard landscaping and deteriorated the existing 3-foot-tall retaining wall and wooden posts.

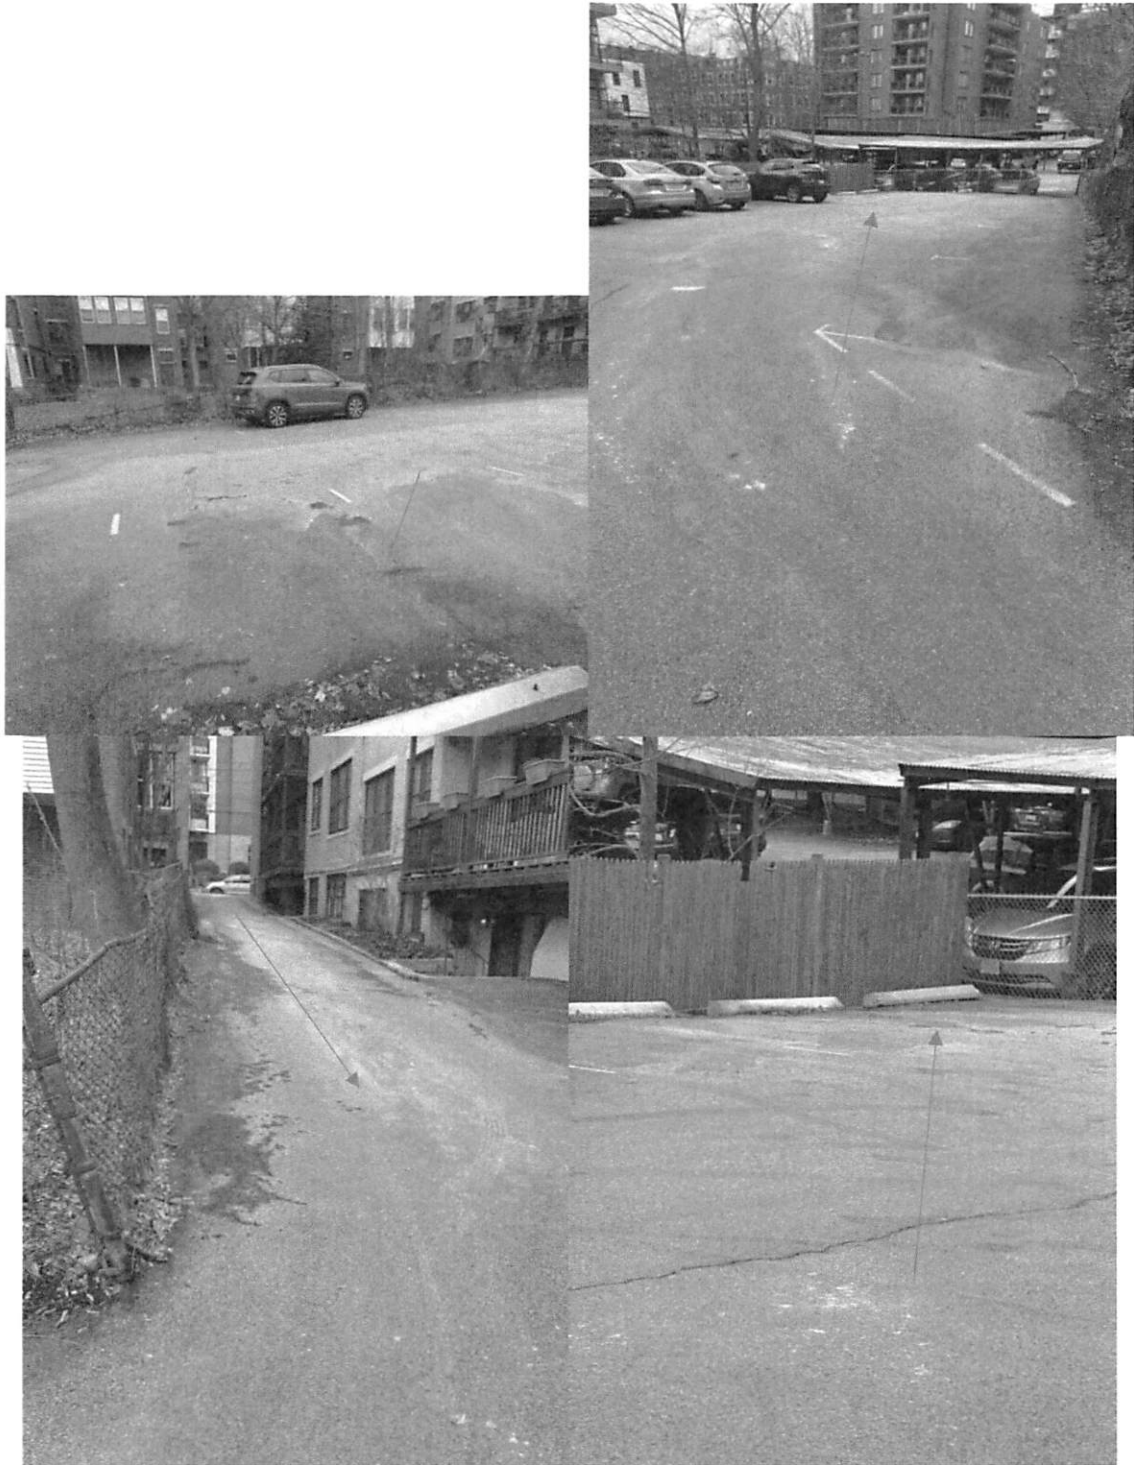
Considering the impervious area of the right neighbor, complete stormwater calculations design and runoff analysis of the impervious surface are required to comply with the Town of Brookline Stormwater management requirements.

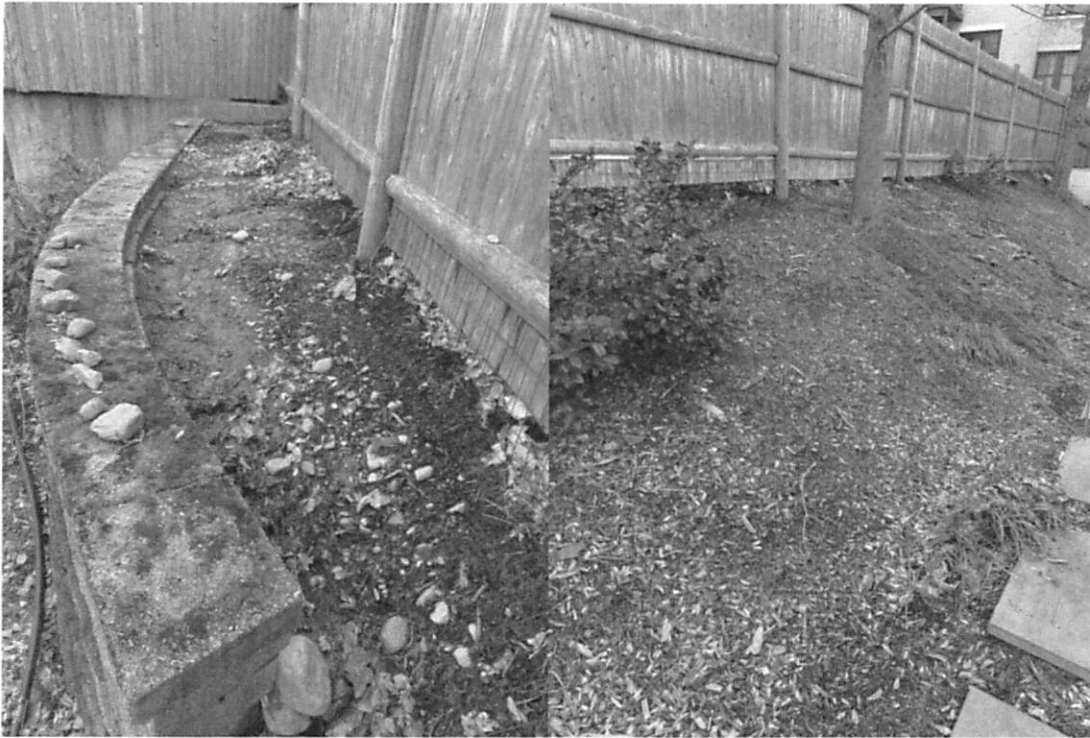
In 2020, a landscaping project was completed at 100 Saint—Paul St. address. The project consisted of an underground drywall installation in the backyard to collect the rainwater from the downspouts. Due to the size of the backyard and lack of access to heavy excavation equipment, there is no further capacity to accept overflow runoff water from the adjacent parking lot.

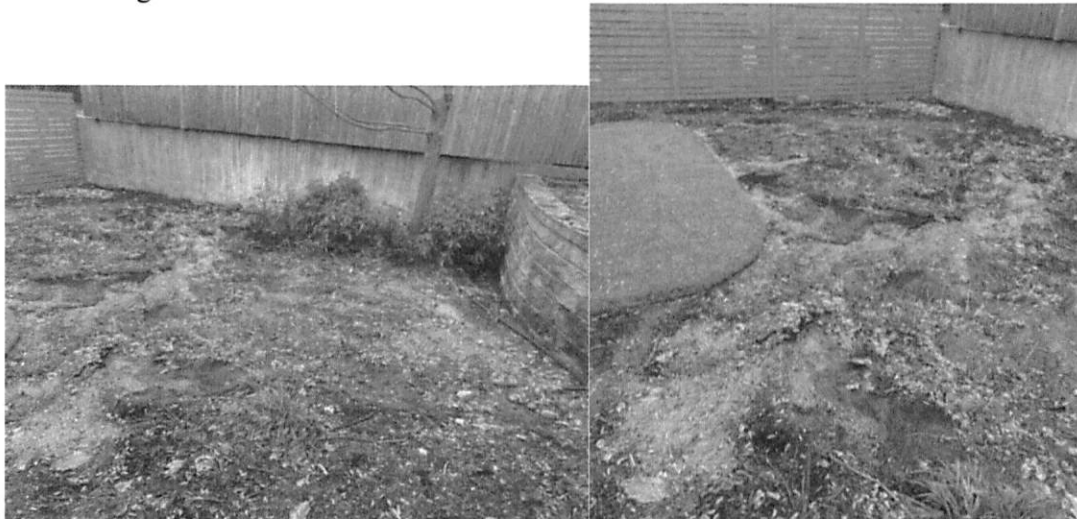
The damaged and polluted backyard area by runoff water and the suspended solids discharged from the neighbor's property was observed during the site visit. Proper media filters need to be installed on neighbor's side to collect and remove the TSS.
