## Tx Rx Filter v1.0 PCB Errata

17th Aug, 2017

ji1udd

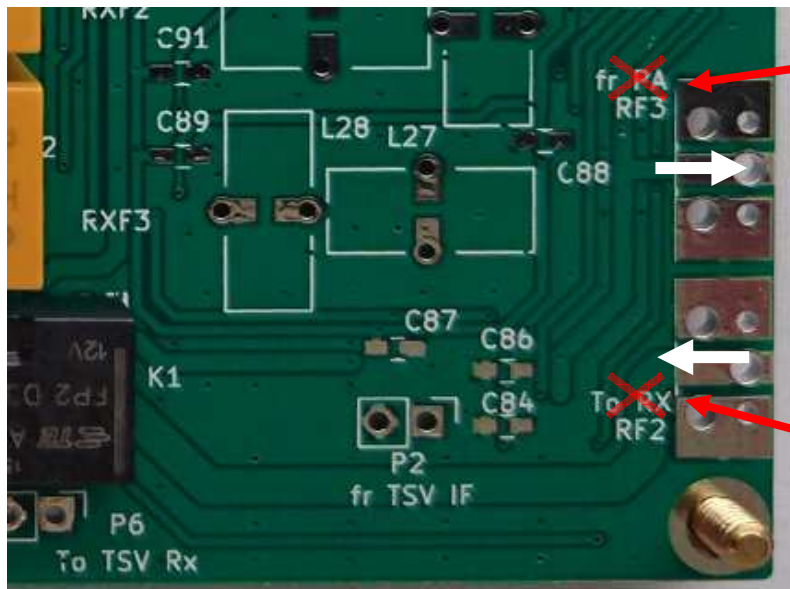
### 1) Wrong Silk

The silks near RF2 and RF3 are swapped

RF3  
from HPF  
to RX (HLv2)

RF2  
from PA (HLv2)  
to T/R relay

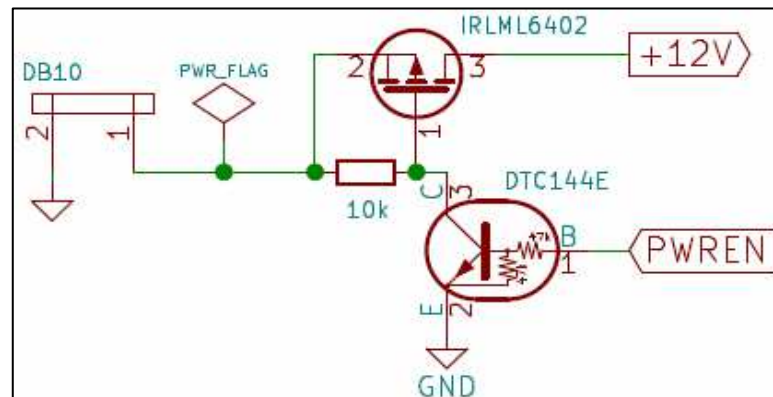
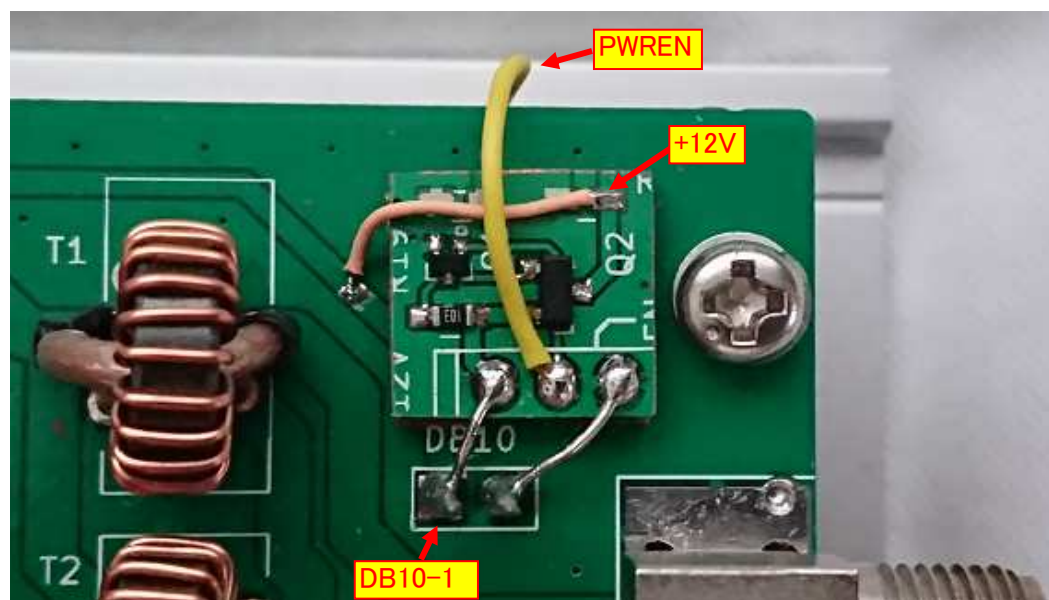
### 2) Leakage current

Leakage occurred from DB10-1(+12V source) to +3.3V through Relay driver (TPL 7407) while HL2 turned off. Add high side switch.
