# AURIX™ TC38x errata sheet

**Marking/Step: (E)ES-AE, AE**

10464AERRA

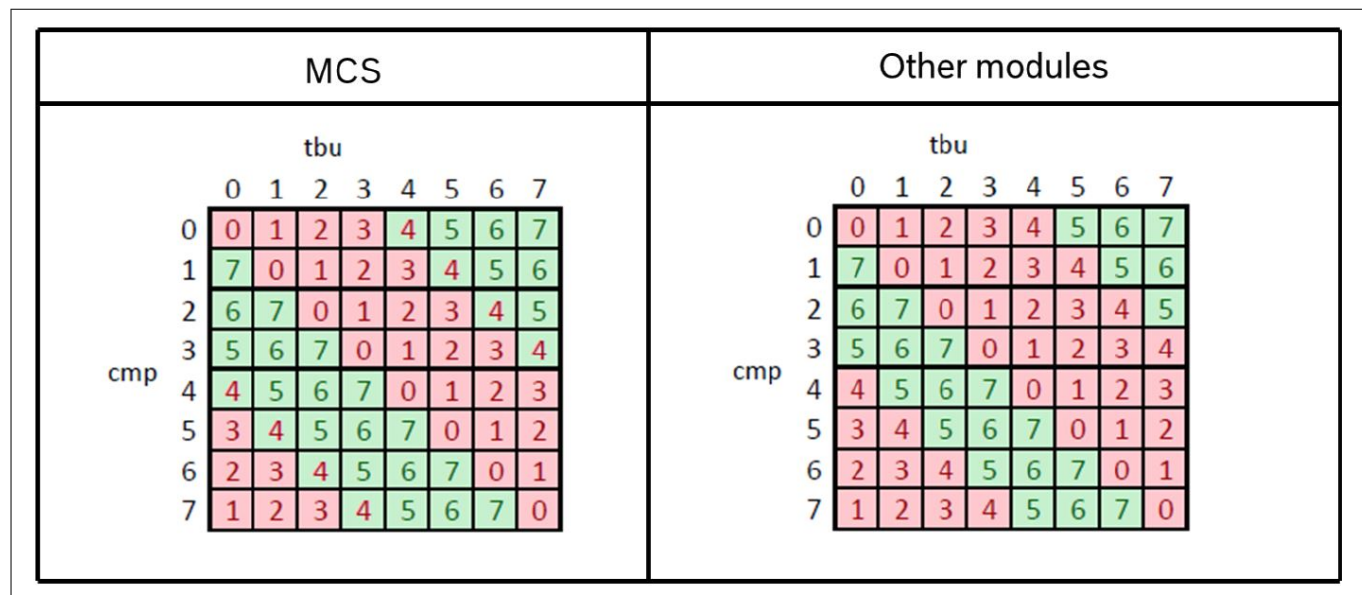
**Figure 9** TBU value evaluation MCS against other modules. Red (past) and green (future).

With the revised specification of GTM 4.1 it was revealed that the implementation for the WUCE instruction is not correct for the boundaries. The implementation of the WUCE instruction has an inverted behavior for both boundaries between future and past.
