AURIX™ TC35x errata sheet

Marking/Step: (E)ES-AB, AB

10470AERRA

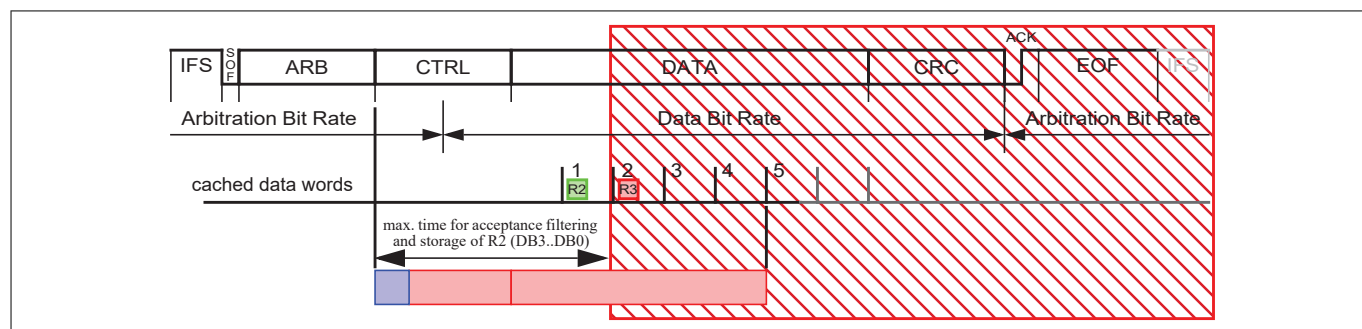
Figure 5 CAN Frame with DLC > 4

Under the following conditions a received message will have corrupted data while the received message is signaled as valid to the host.

The figure that follows shows how the available time for acceptance filtering and storage is reduced.

Due to condition 3) the issue only occurs sporadically. Use an end-to-end (E2E) protection (for example, checksum or CRC covering the data field) and add it to all messages in the CAN system, to detect data corruption in received frames.
