AURIX™ TC37x errata sheet

Marking/Step: (E)ES-AA, AA

10467AERRA

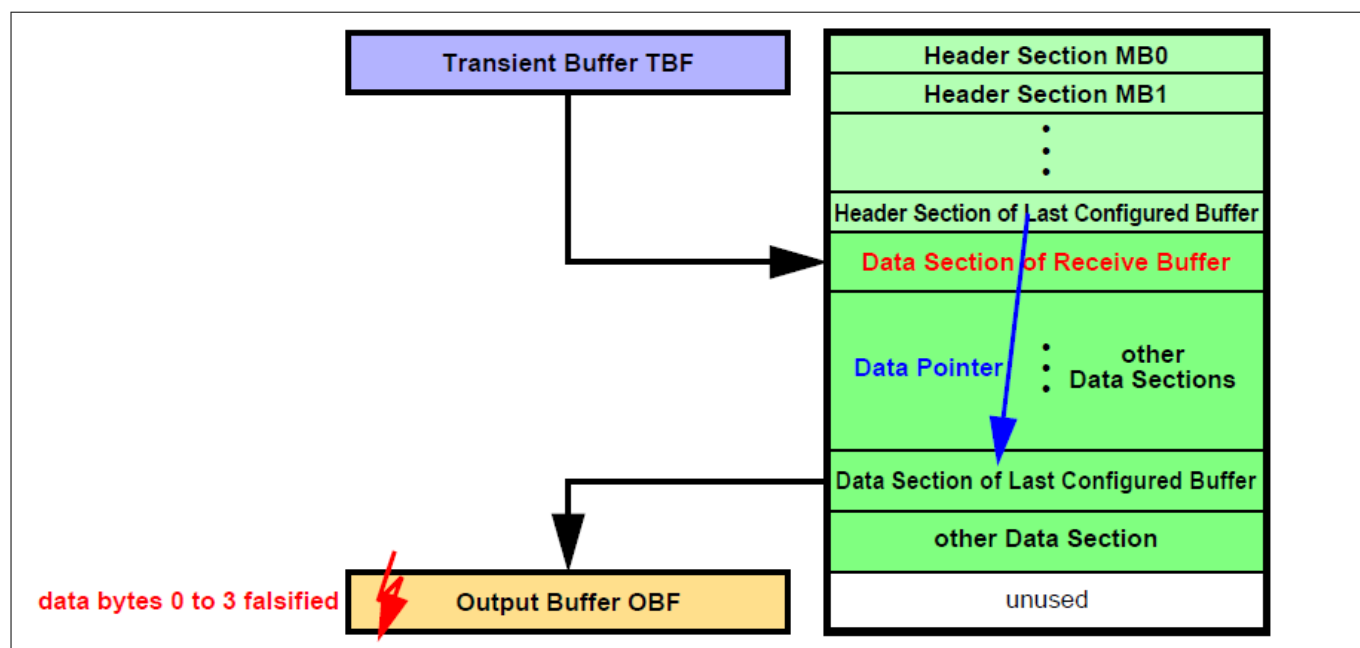
Figure 1 Message buffer transfer from Message RAM to OBF

When the message buffer has its payload configured to maximum length (`PLC = 127`), the OBF word on address `00h` (payload data bytes 0 to 3) is overwritten with unexpected data at the end of the transfer.

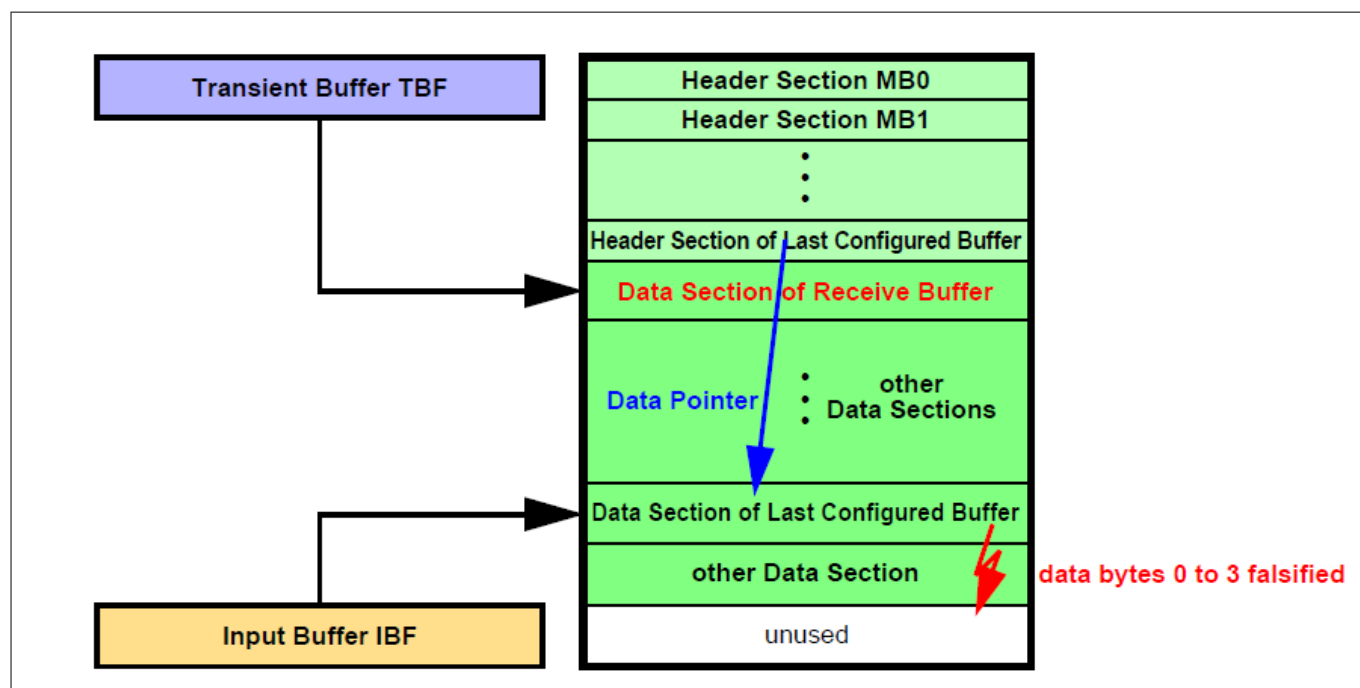
Figure 2 Message buffer transfer from IBF to Message RAM

b) Message buffer transfer from IBF to Message RAM

After the Data Section of the selected message buffer in the Message RAM has been written, one additional write access overwrites the following word in the Message RAM which might be the first word of the next Data Section.

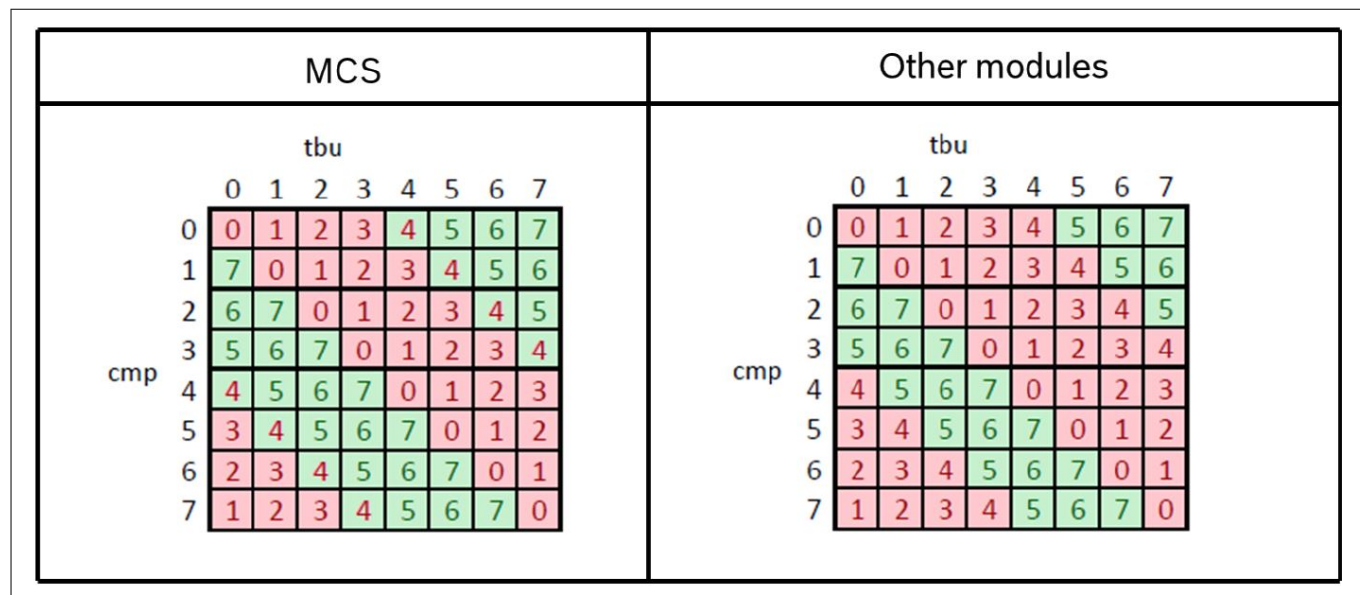
To ensure that a correct execution of MCS channel code is not influenced by certain traffic scenarios on the MCS AEI/ADC bus master interface, only proven usage scenarios are allowed for MCS to AEI/ADC communication. The most common usage scenarios tested to be safe include:

With the revised specification of GTM 4.1 it was revealed that the implementation for the WUCE instruction is not correct for the boundaries. The implementation of the WUCE instruction has an inverted behavior for both boundaries between future and past.

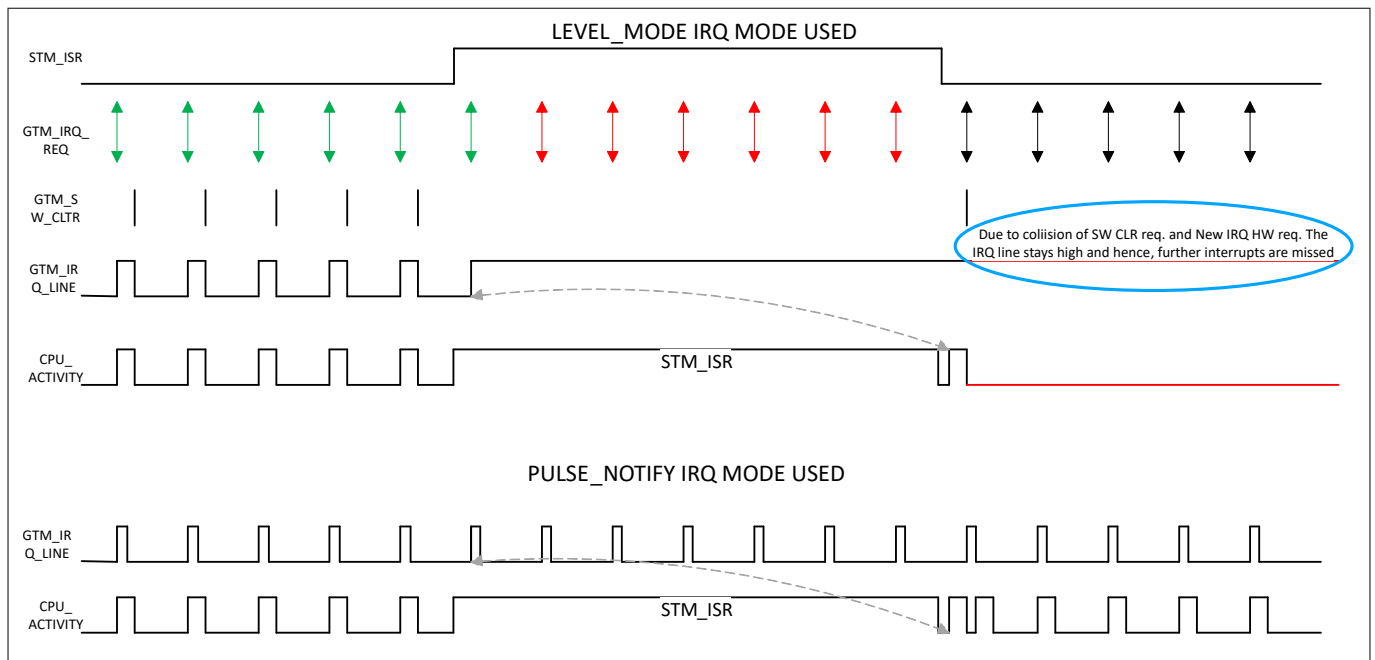
Figure 12 Interrupt Level vs. Pulse-Notify mode - Corner Case Example

no transition on GTM_IRQ_XX. Thus, any forthcoming interrupt events in this scenario are lost as there is no chance to release the CPU IRQ when a collision happens as shown in Figure below.
