# AURIX™ TC33xEXT errata sheet

**Marking/Step: (E)ES-AA, AA**

10472AERRA

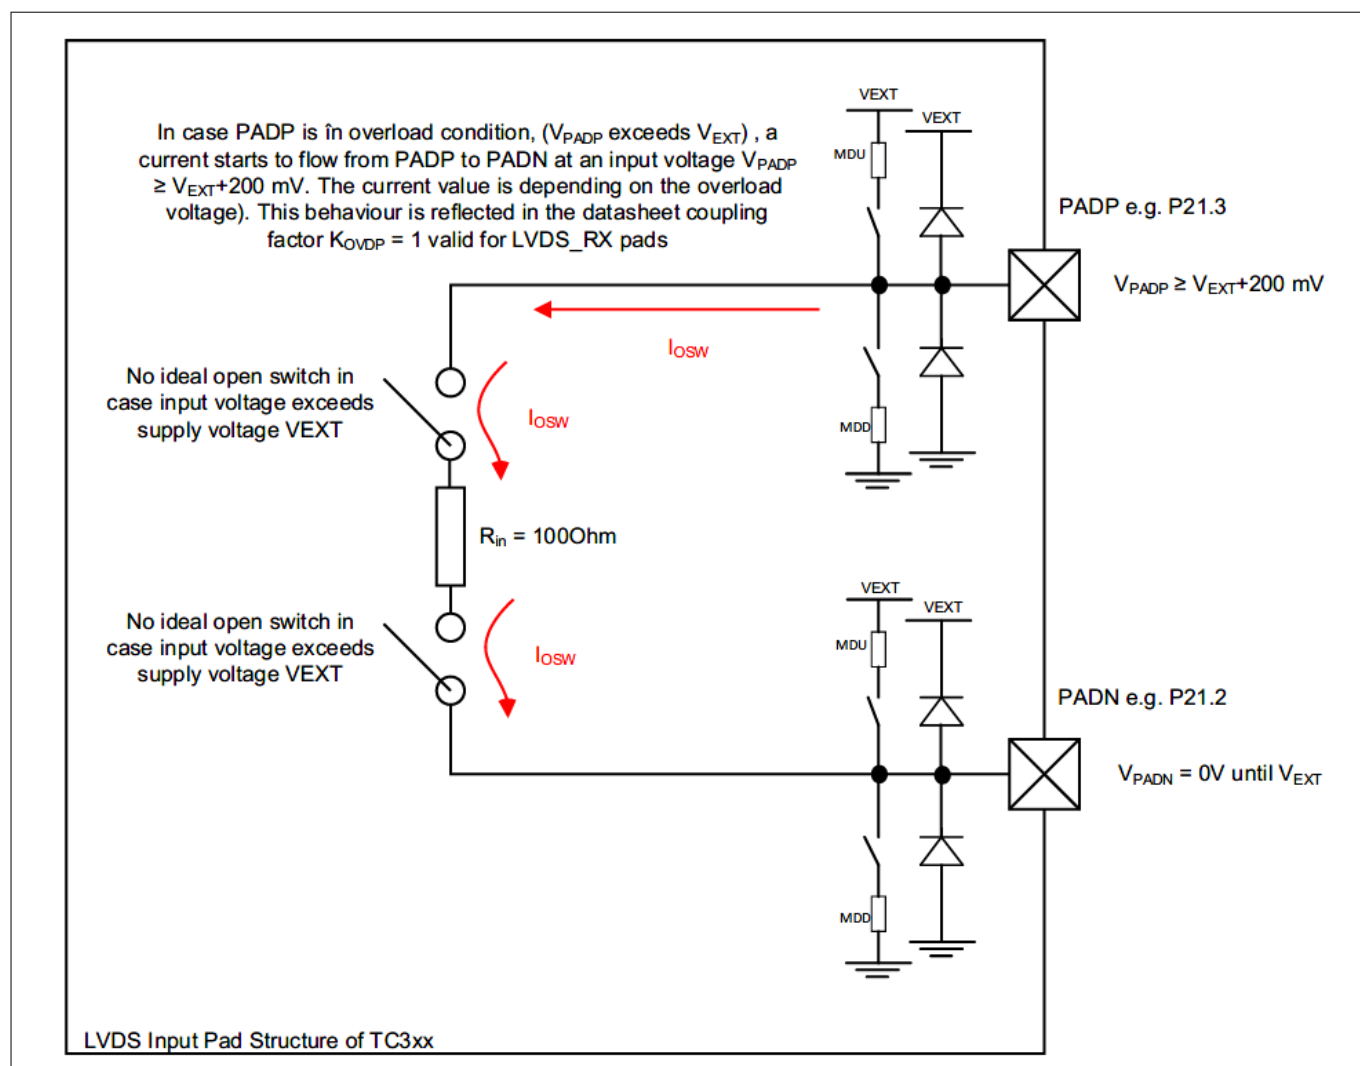
**Figure 3** Positive overload on P-pad of a LVDS RX pin pair (both used as inputs)

The overload current  $I_{OSW}$  through the non-ideal open switch significantly increases when  $V_{PADP} \geq V_{EXT} + 200 \text{ mV}$ .

**Note:** In general, the effect will also occur if the N-pad is used as output, or for a negative overload condition on either the P-pad or the N-pad.
