# AURIX™ TC37xEXT errata sheet

**Marking/Step: (E)ES-AB, AB**

## About this document

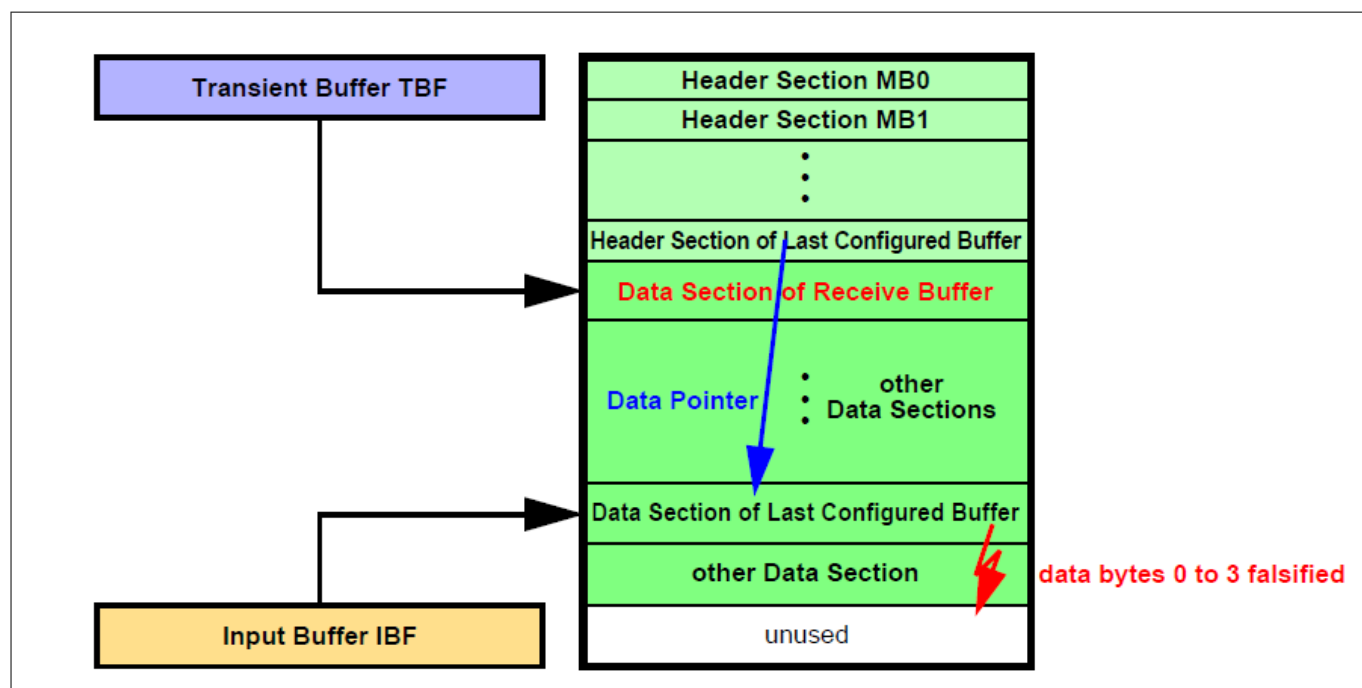
**Figure 2** Message buffer transfer from IBF to Message RAM

After the Data Section of the selected message buffer in the Message RAM has been written, one additional write access overwrites the following word in the Message RAM which might be the first word of the next Data Section.

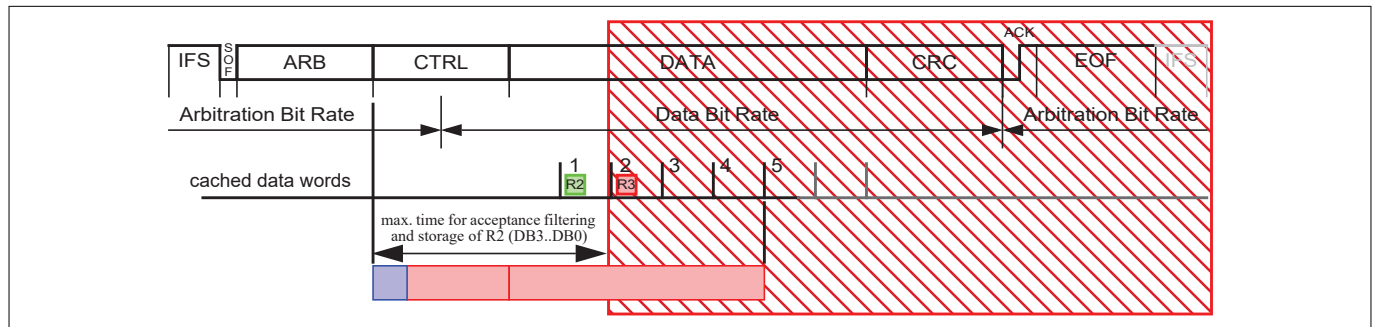
**Figure 10** CAN Frame with DLC > 4

The figure that follows shows how the available time for acceptance filtering and storage is reduced.

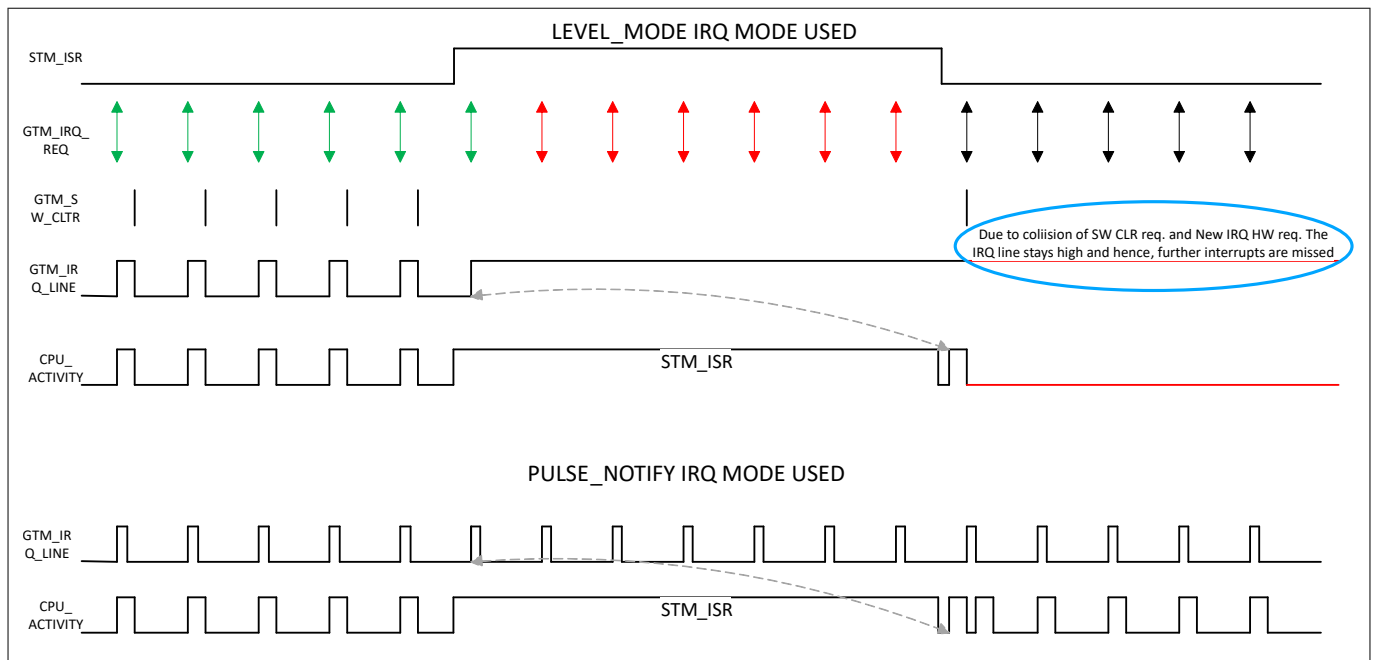
**Figure 12** Interrupt Level vs. Pulse-Notify mode - Corner Case Example

no transition on GTM\_IRQ\_XX. Thus, any forthcoming interrupt events in this scenario are lost as there is no chance to release the CPU IRQ when a collision happens as shown in Figure below.

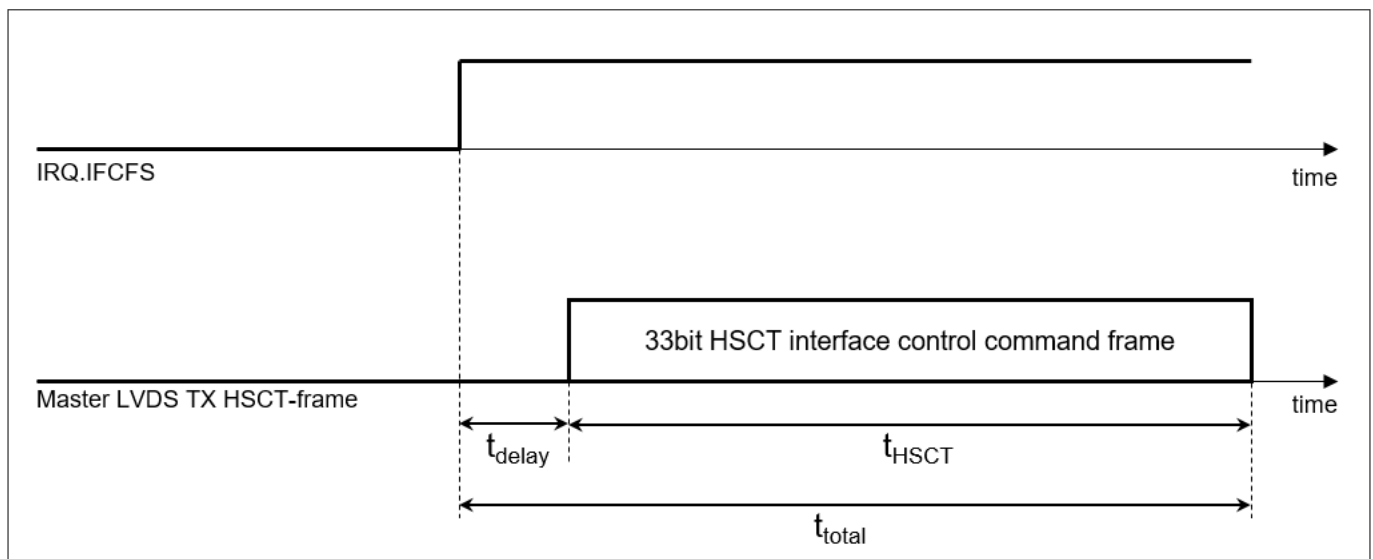
**Figure 13 Timing of LVDS TX interface command sending in relation to IRQ.IFCFS**

the user might falsely assume that also the actual sending on the LVDS TX port has already occurred once the IRQ.IFCFS flag is set, which is not true.

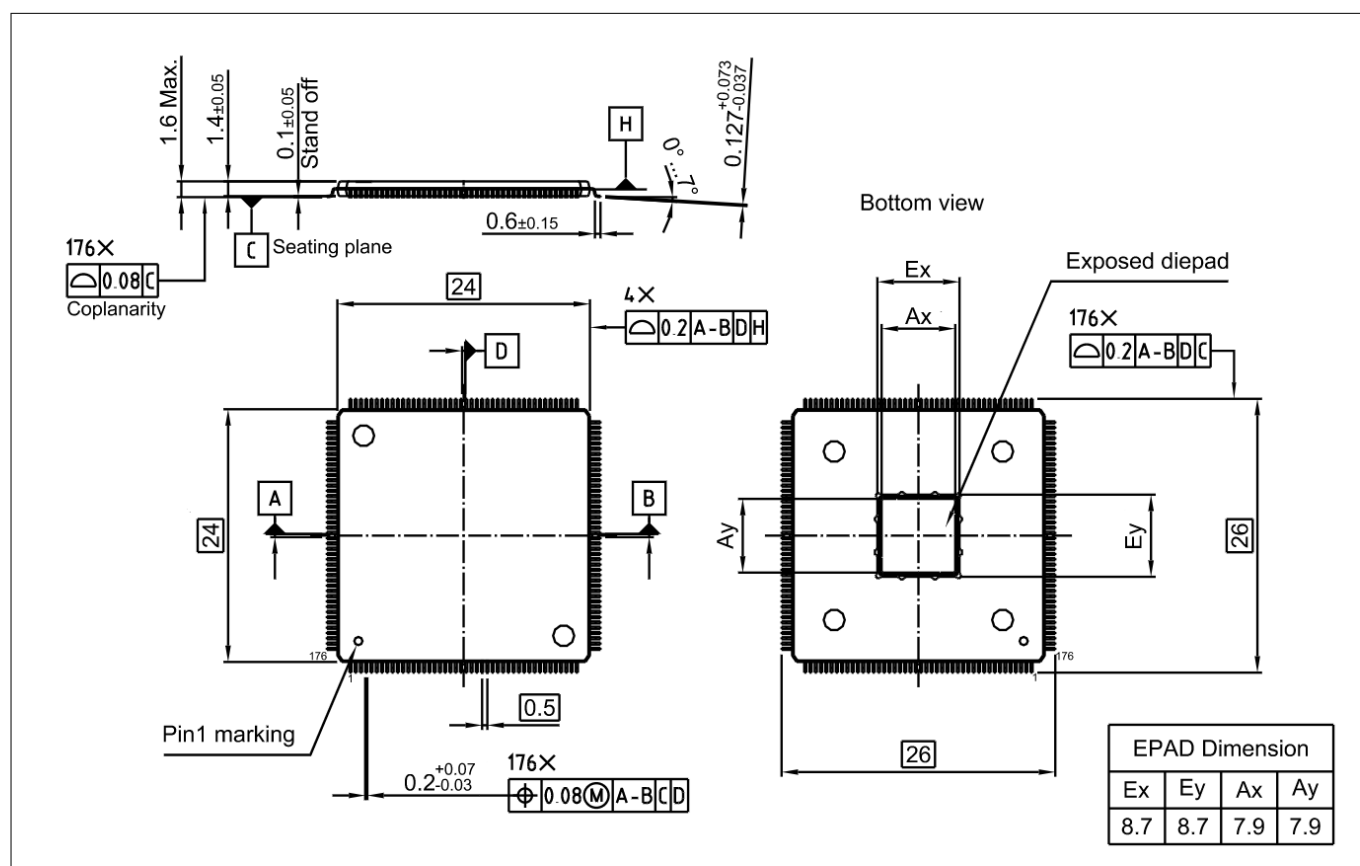
**Figure 14** Package Outlines LQFP-176 for TC37xEXT

**Note:** For the exposed diepad of the LQFP-176 package of the TC37xEXT, structural corner protrusions have to be considered for purposes of system design and integration with a maximum boundary of 9.4 mm.

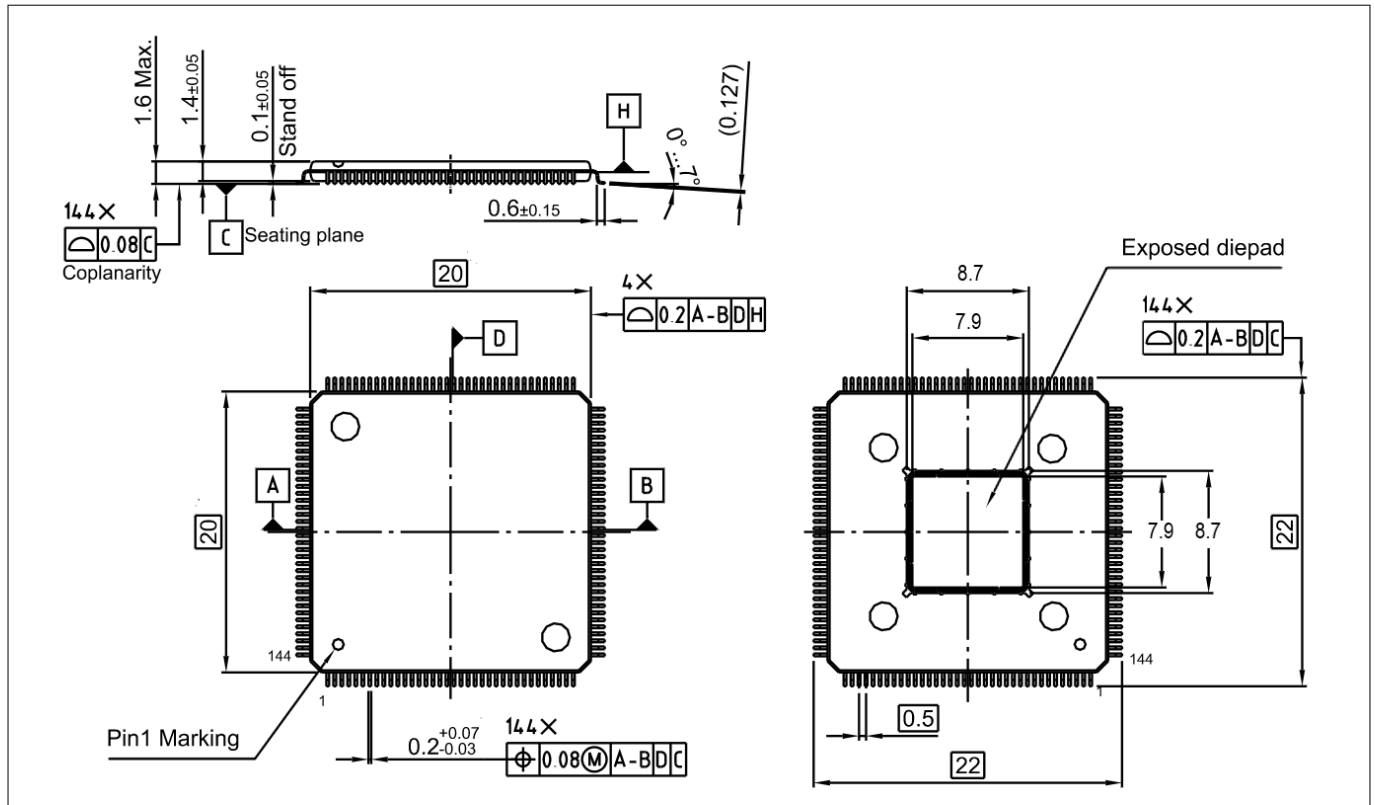
**Figure 15** Package Outlines LQFP-144 for TC37xEXT

**Note:** For the exposed diepad of the LQFP-144 package of the TC37xEXT, structural corner protrusions have to be considered for purposes of system design and integration with a maximum boundary of 9.4 mm.
