AURIX™ TC33x/TC32x errata sheet

Marking/Step: (E)ES-AA, AA

10471AERRA

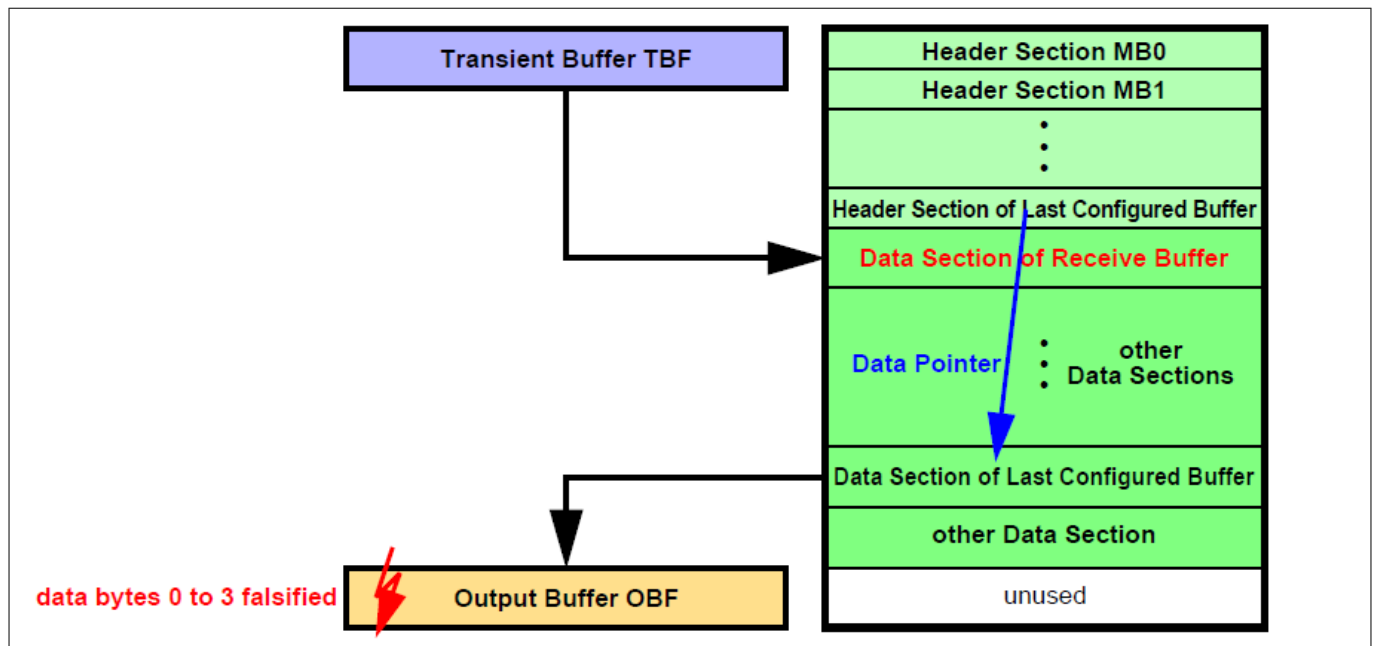
Figure 1 Message buffer transfer from Message RAM to OBF

When the message buffer has its payload configured to maximum length (PLC = 127), the OBF word on address 00h (payload data bytes 0 to 3) is overwritten with unexpected data at the end of the transfer.

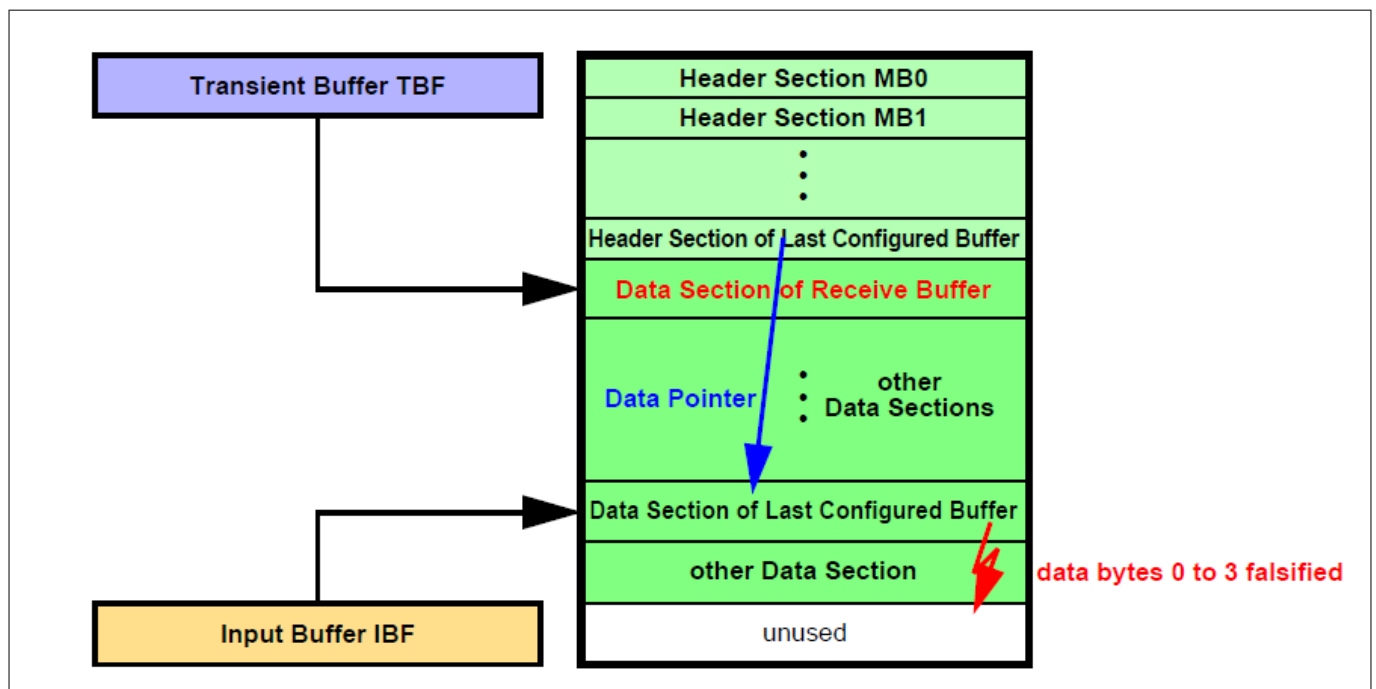
Figure 2 Message buffer transfer from IBF to Message RAM

After the Data Section of the selected message buffer in the Message RAM has been written, one additional write access overwrites the following word in the Message RAM which might be the first word of the next Data Section.

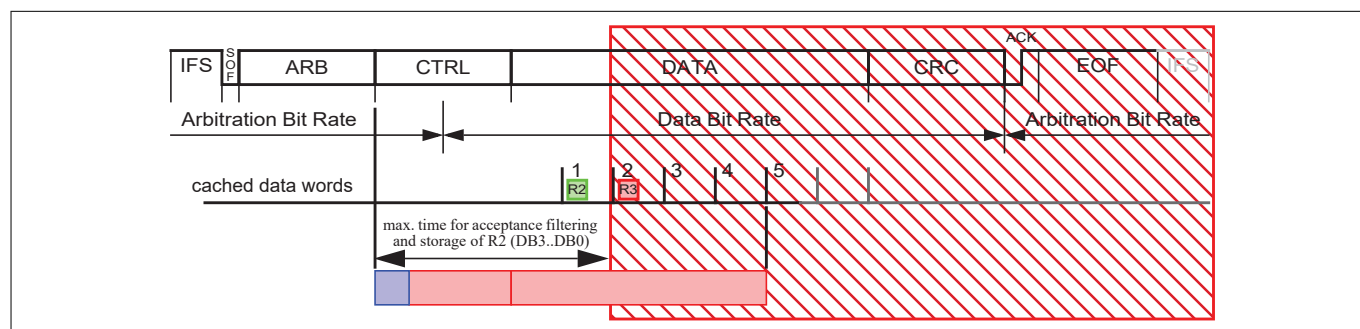
2 Functional deviations

Under the following conditions a received message will have corrupted data while the received message is signaled as valid to the host.

1. The data length code (DLC) of the received message is greater than 4 ($DLC > 4$)
2. The storage of R_i of a received message into the Message RAM (after acceptance filtering is done) has not completed before R_(i+1) is transferred from the CAN Core into the cache of the Rx Handler (where $2 \leq i \leq 5$)
3. While condition 1) and 2) apply, a concurrent read of data word R_i from the cache and write of data word R_(i+1) into the cache of the Rx handler happens

The figure that follows shows how the available time for acceptance filtering and storage is reduced.

Due to condition 3) the issue only occurs sporadically. Use an end-to-end (E2E) protection (for example, checksum or CRC covering the data field) and add it to all messages in the CAN system, to detect data corruption in received frames.

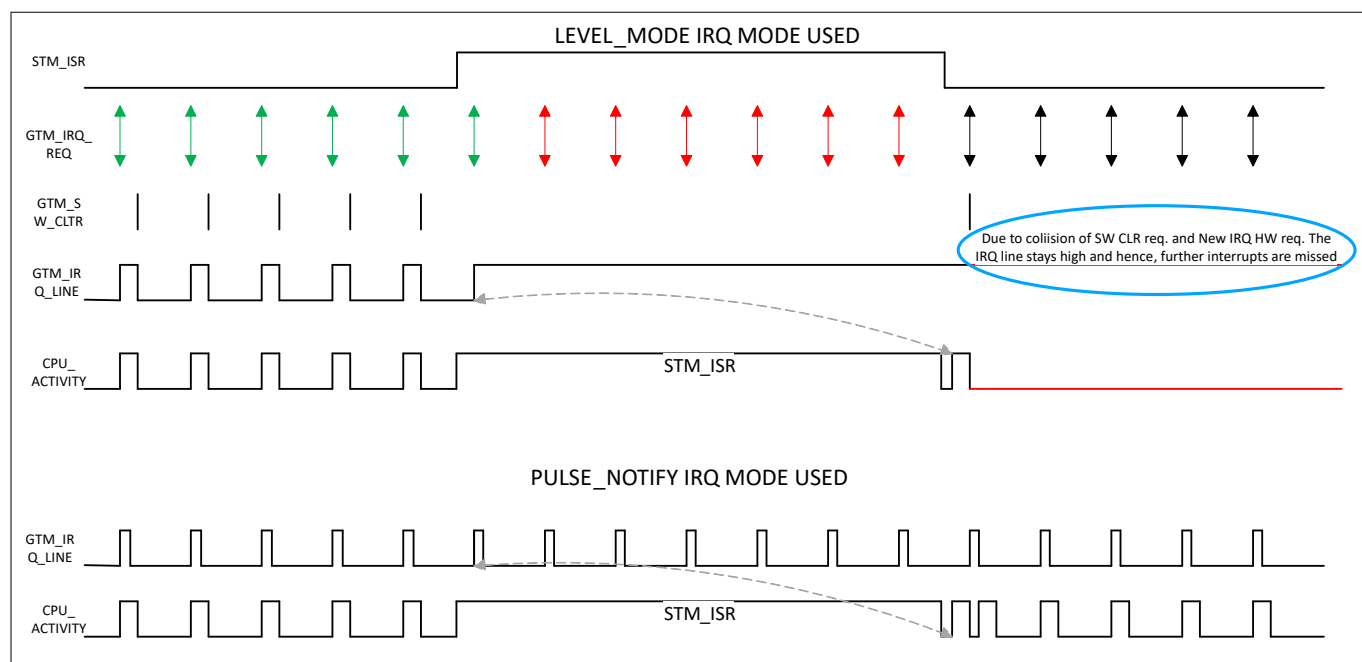
Figure 7 Interrupt Level vs. Pulse-Notify mode - Corner Case Example

no transition on GTM_IRQ_XX. Thus, any forthcoming interrupt events in this scenario are lost as there is no chance to release the CPU IRQ when a collision happens as shown in Figure below.

If Pulse-Notify mode is selected, every internal trigger will be forwarded to the IR, irrespective of the time of occurrence and the clear event, as the pulse-notify leads to set and reset of GTM_IRQ_XXX as compared to only setting of the GTM_IRQ_XXX line in Level mode.

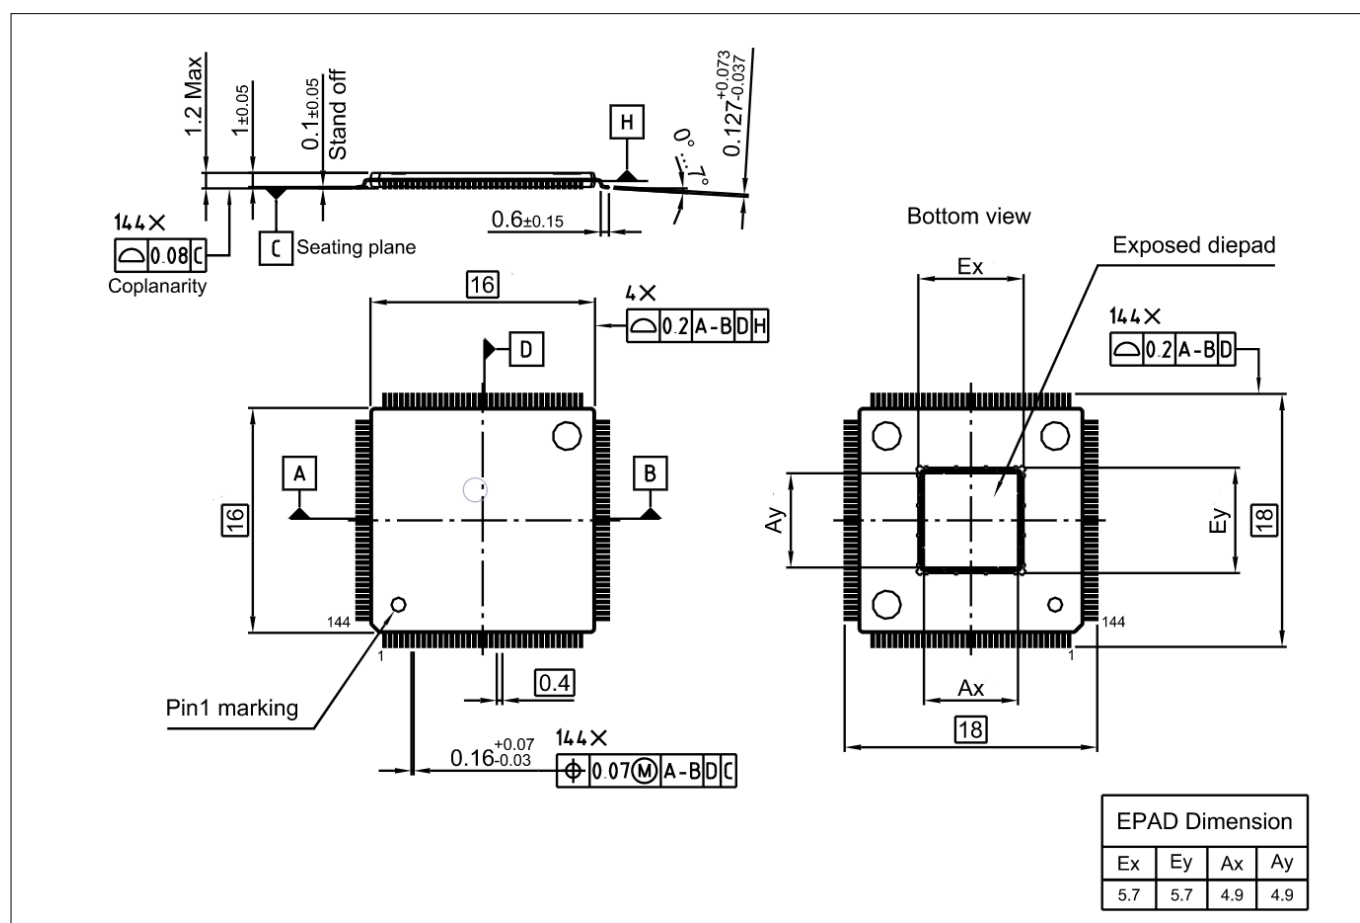
Figure 8 Package Outlines TQFP-144 for TC33x/TC32x

Note: For the exposed diepad of the TQFP-144 package of the TC33x/TC32x, structural corner protrusions have to be considered for purposes of system design and integration with a maximum boundary of 6.2 mm.
