MX8ULP-EVK9SOM (52006)

MX8ULP-EVK9SOM Board Errata

Rev. 0.1 -- 18/Aug/2023

E-001: SPI FLASH U14 doesn't work.

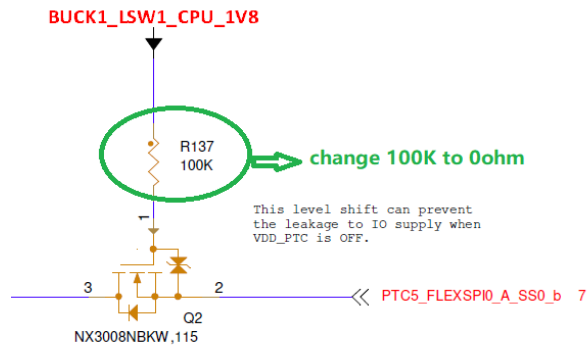
SPI FLASH access failed

It is caused by the high value(100K) of R137

SPI FLASH U14 doesn't work in rev B boards

Replace R137 with 0ohm/0402 resistor
