PHYSICAL NEEDS ASSESSMENT

PHYSICAL NEEDS ASSESSMENT of EAST STROUDSBURG READINESS CENTER 42B30 271 Washington Street East Stroudsburg, Pennsylvania 18301-2839

EMG Project #: 88798.09R-009.017
Date of Report: June 30, 2009
On site Date: May 26, 2009

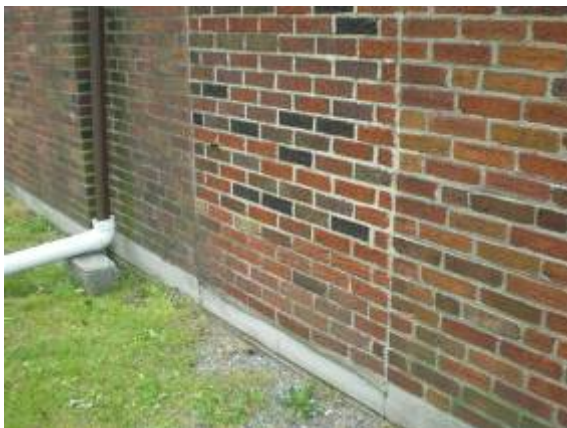
Photo #16: Stone trim. Note: Pointing deterioration

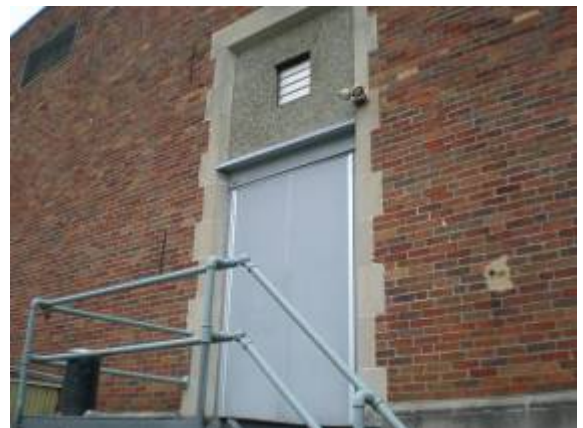
Photo #17: Brick veneer. Note: staining.

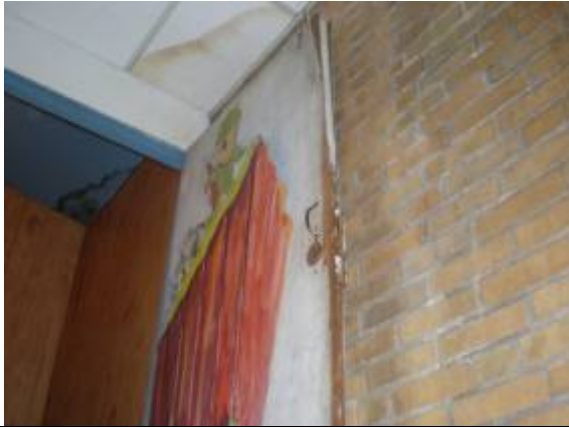
Photo #55:	Damage to finishes at second floor ceiling and walls
------------	--

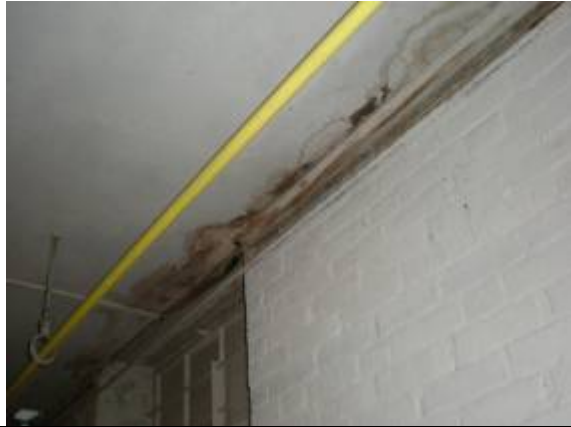
Photo #56:	Damage to finishes from water intrusion at Physical Training room
------------	---

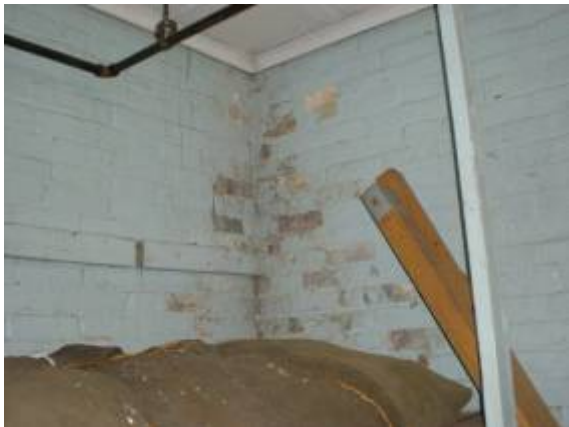
Photo #57:	Damage to finish from water intrusion at east corners of Basement
------------	---

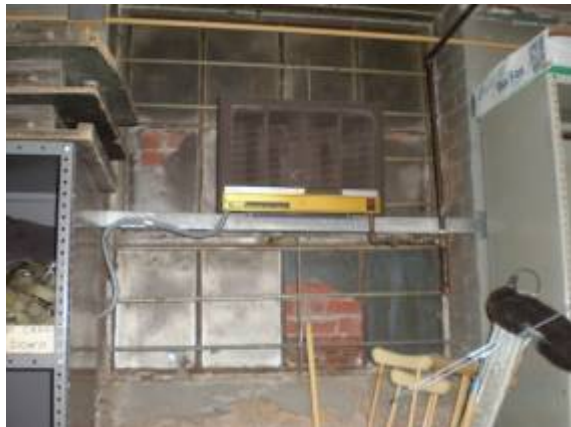
Photo #58:	Filled in window condition in Basement
------------	--

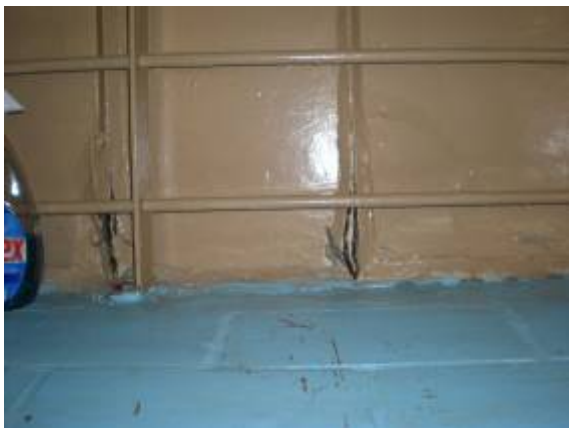
Photo #59:	Water intrusion damage at filled window in Basement
------------	---

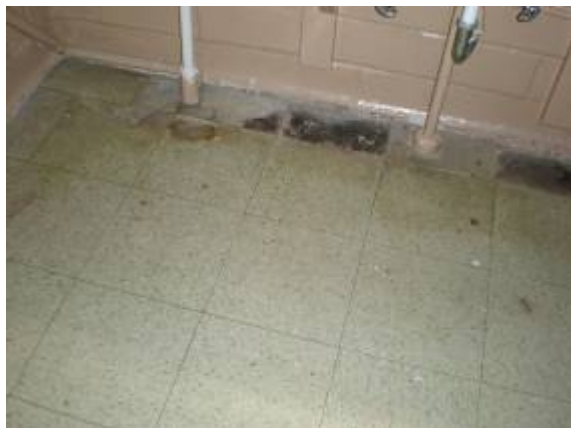
Photo #60:	Deterioration of vinyl floor tiles at Basement restroom
------------	---

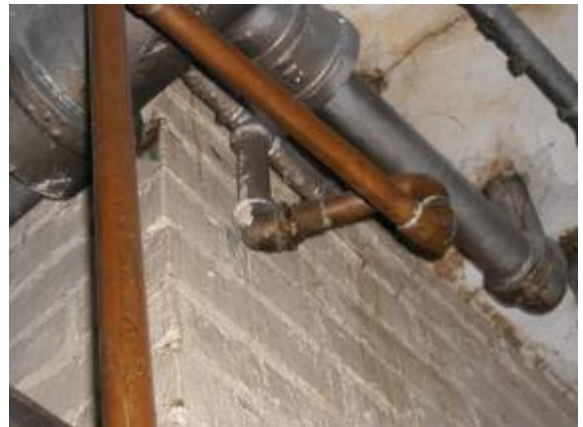
- The condition and extent of galvanized steel domestic water supply lines is not readily apparent. Galvanized steel is not a recommended potable distribution piping material. Replacement of the water distribution piping is recommended to correct the low flow problem as well as upgrading the steel piping. The services of a Professional Engineer are required to determine the design and estimate costs. A cost allowance for the engineering services and pipe replacement are included in the Replacement Reserves Report. Refer to Section 7.2 for additional discussion.

Photo #88: Copper piping from water heater to galvanized steel piping in building; note absence of dielectric union

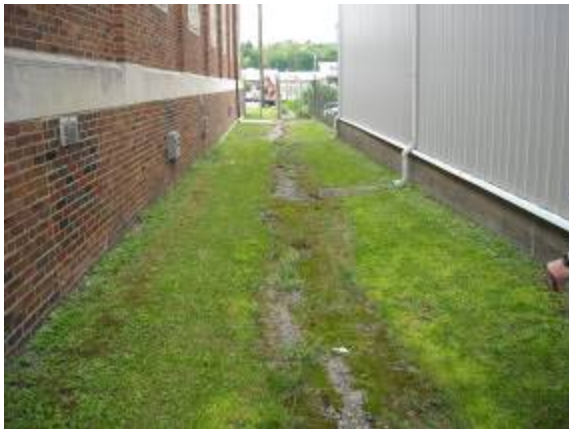
Photo #116: Erosion from roof storm water runoff on south side of building

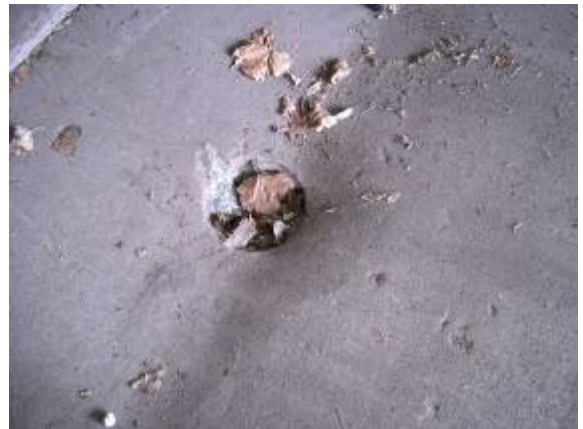
Photo #117: Storm water runoff path on south side of building

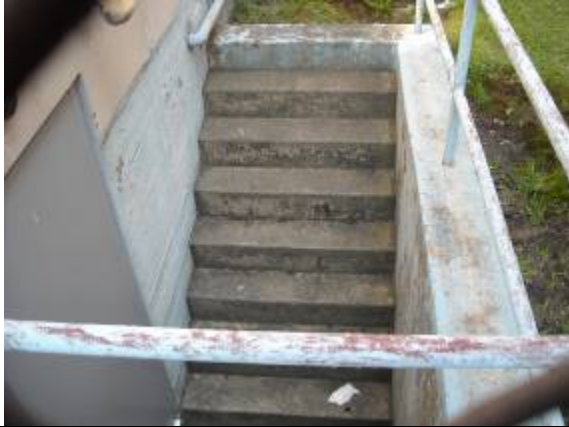
Photo #121:	Railings on top of retaining wall deteriorated and need painting
-------------	--

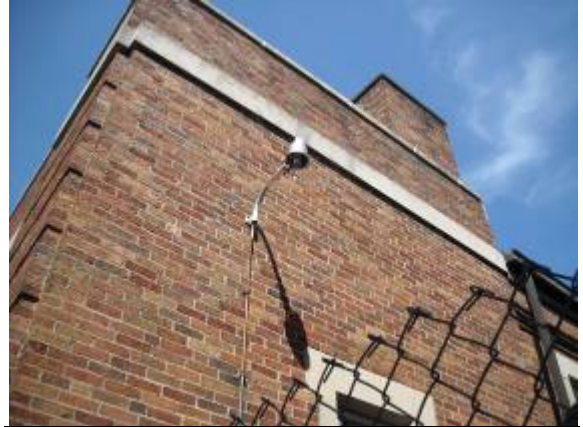
Photo #122:	Site lighting fixture broken
-------------	------------------------------
