INFOGRAPH POWERLINE INSPECTION SYSTEM REPORT

Report Created: August 21th, 2024; 10:10:30

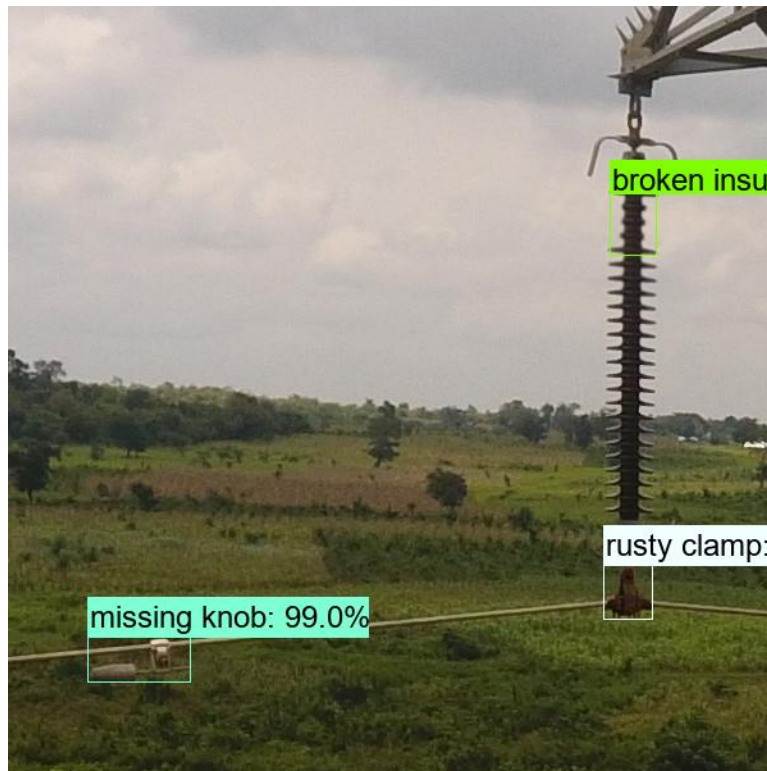
Fault Image Name: _DJI_650_3 - Copy - Copy.png

Fault Type	Severity
missing knob	82.69 %
rusty clamp	99.28 %
broken insulator	94.88 %

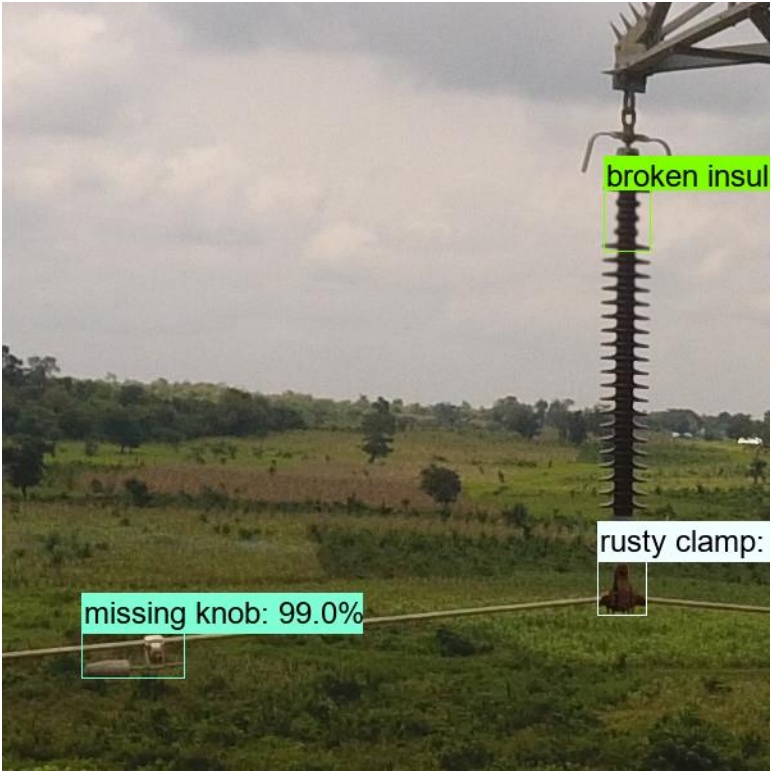
Fault Image Name: _DJI_650_3 - Copy.png

Fault Type	Severity
missing knob	98 %
rusty clamp	86.57 %
broken insulator	93.79 %

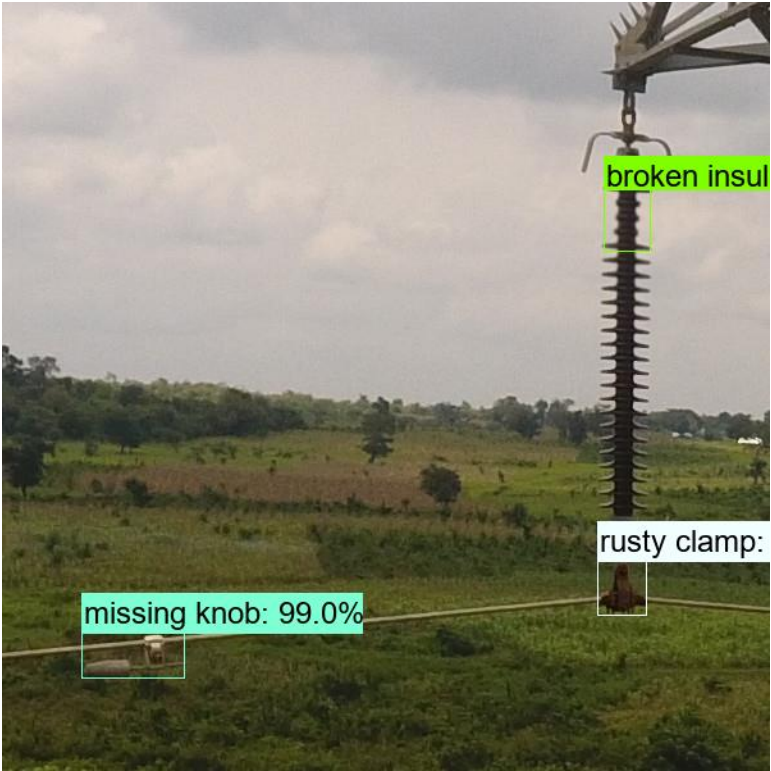
Fault Image Name: _DJI_650_3.png

Fault Type	Severity
missing knob	99.78 %
rusty clamp	89.45 %
broken insulator	82.97 %

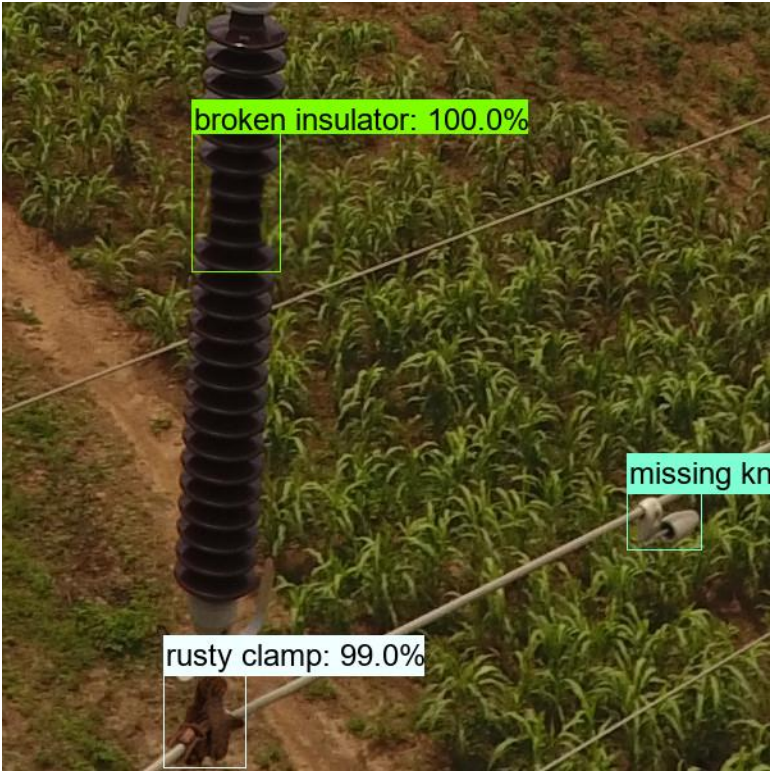
Fault Image Name: _DJI_651_2 - Copy - Copy.png

Fault Type	Severity
missing knob	99.45 %
broken insulator	99.66 %
rusty clamp	95.78 %

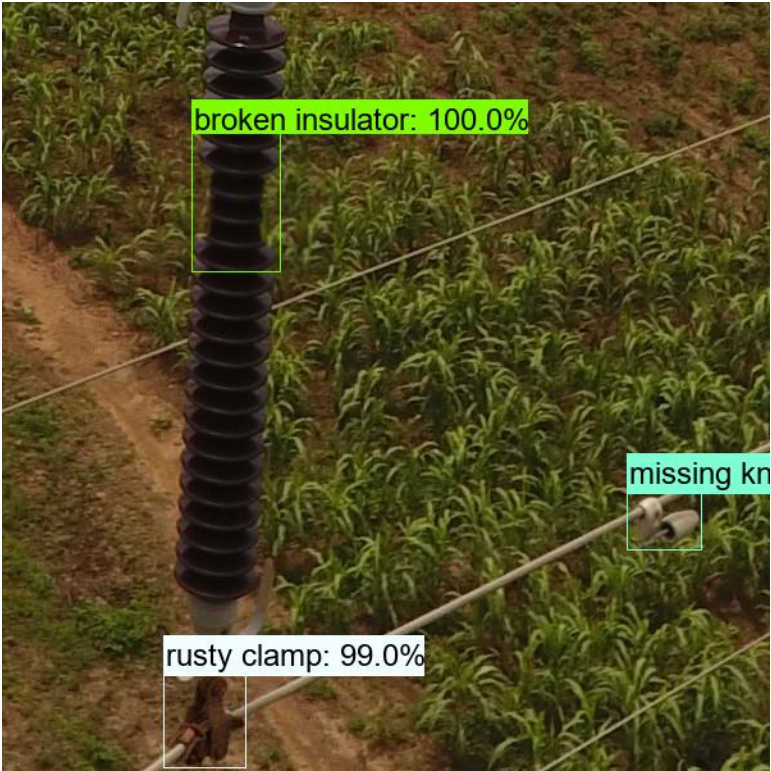
Fault Image Name: _DJI_651_2 - Copy.png

Fault Type	Severity
missing knob	95.78 %
broken insulator	92.17 %
rusty clamp	98.33 %

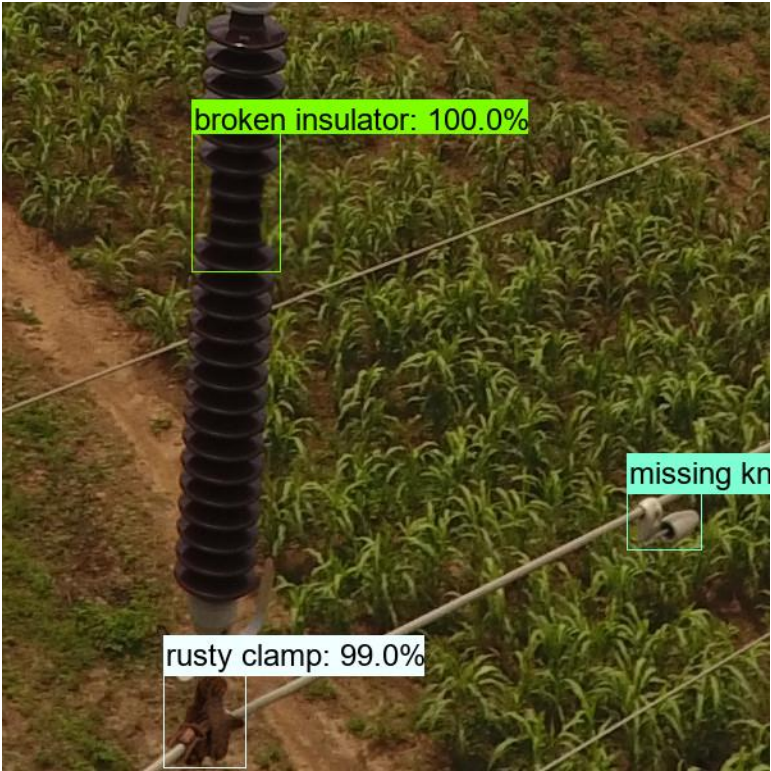
Fault Image Name: _DJI_651_2.png

Fault Type	Severity
missing knob	99.87 %
broken insulator	86.57 %
rusty clamp	93.28 %

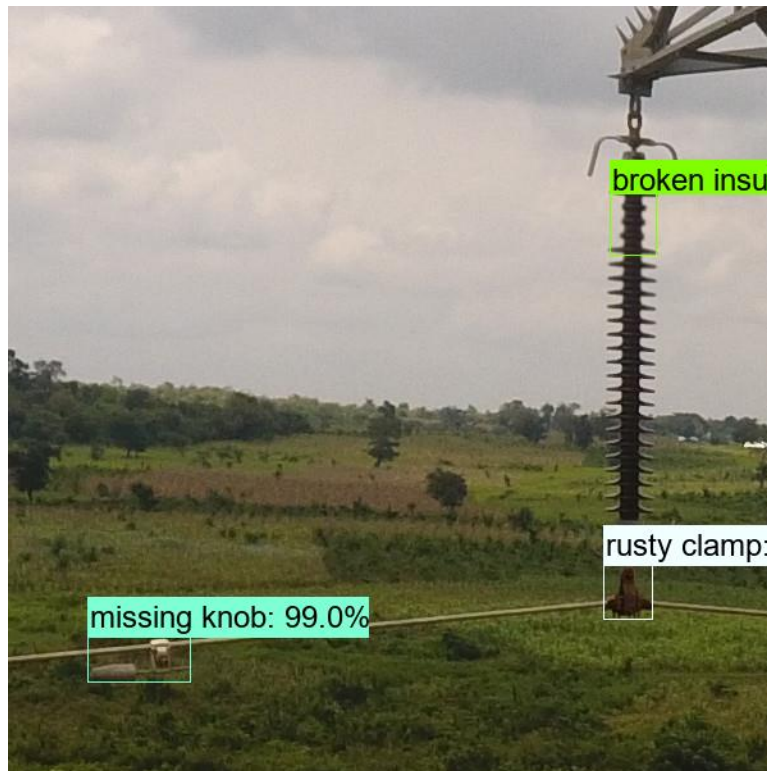
Fault Image Name: _DJI_652_3 - Copy - Copy.png

Fault Type	Severity
missing knob	77.45 %
rusty clamp	69.32 %
broken insulator	89.15 %

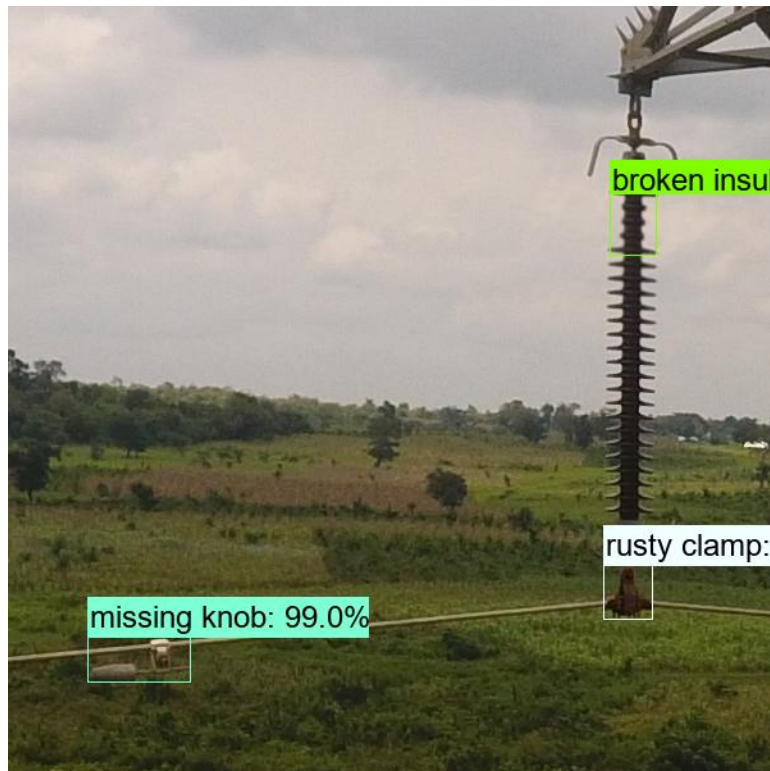
Fault Image Name: _DJI_652_3 - Copy.png

Fault Type	Severity
missing knob	56.48 %
rusty clamp	82.51 %
broken insulator	73.86 %

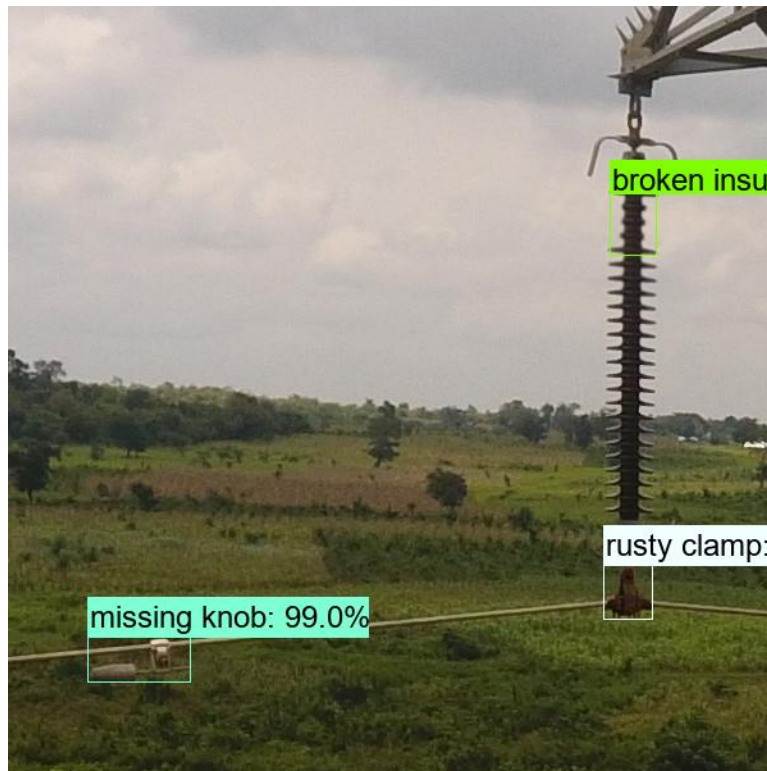
Fault Image Name: _DJI_652_3.png

Fault Type	Severity
missing knob	99.41 %
rusty clamp	98.39 %
broken insulator	95.77 %

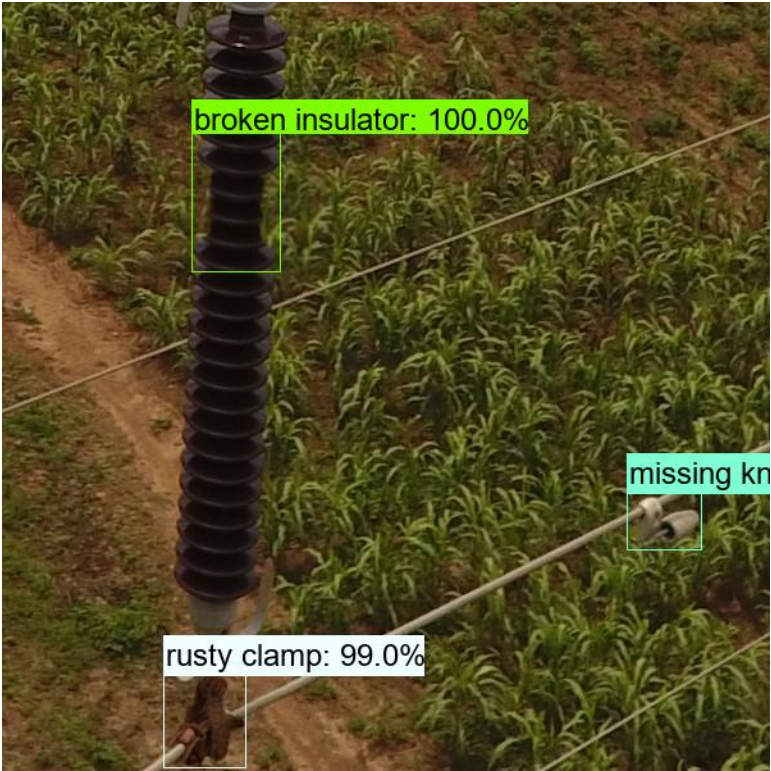
Fault Image Name: _DJI_653_2 - Copy - Copy.png

Fault Type	Severity
missing knob	86.24 %
broken insulator	32.78 %
rusty clamp	78.93 %

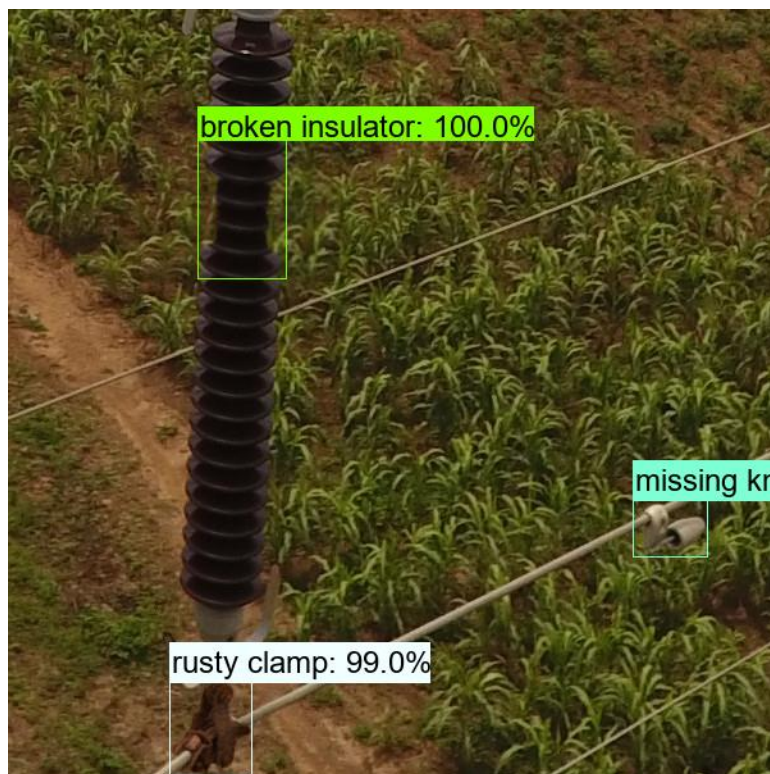
Fault Image Name: _DJI_653_2 - Copy.png

Fault Type	Severity
missing knob	91.55 %
broken insulator	86.78 %
rusty clamp	99.45 %

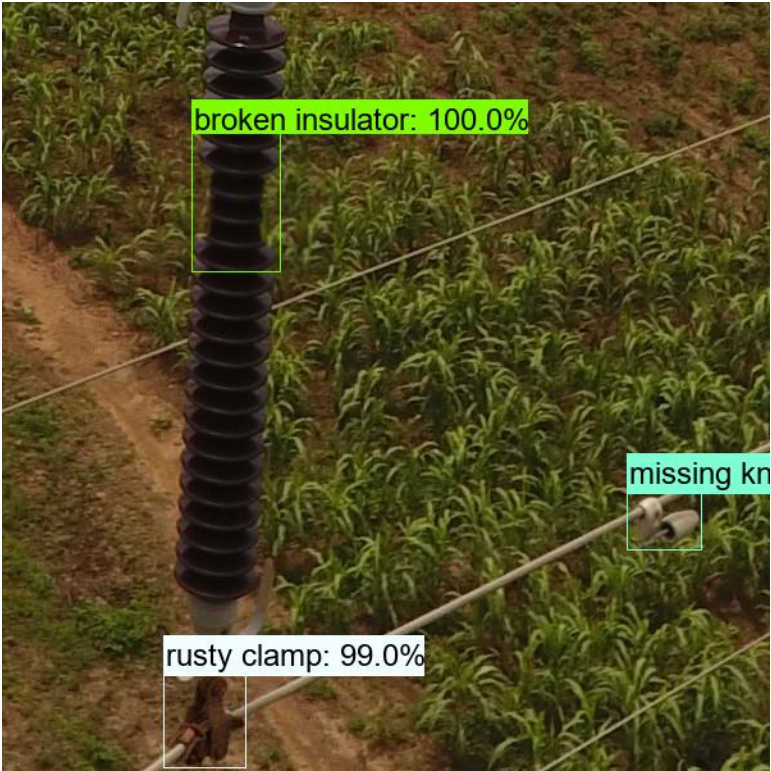
Fault Image Name: _DJI_653_2.png

Fault Type	Severity
missing knob	99.66 %
broken insulator	99.53 %
rusty clamp	99.26 %

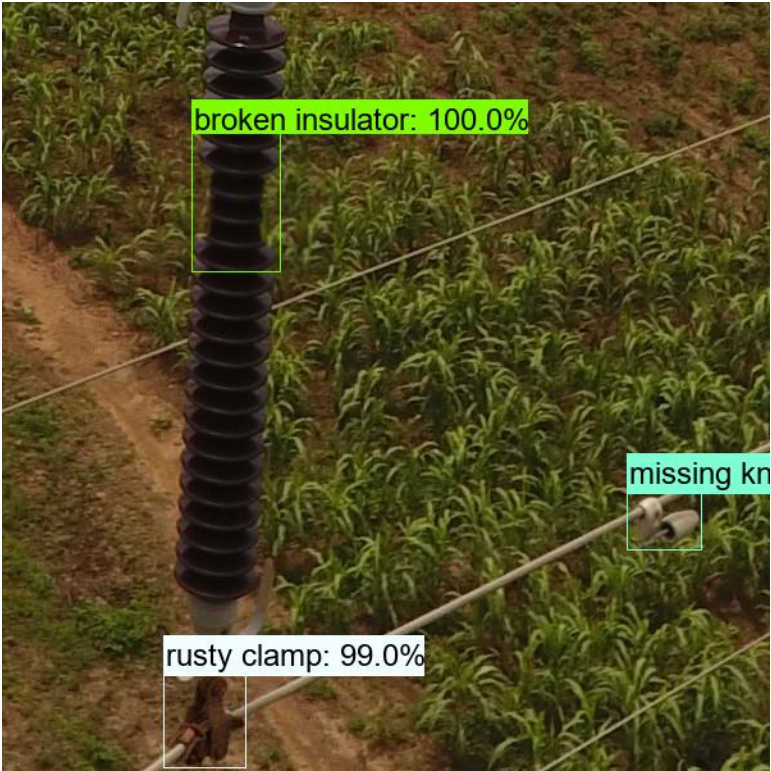
Fault Image Name: _DJI_654_2 - Copy - Copy.png

Fault Type	Severity
missing knob	90.75 %
broken insulator	56.45 %
rusty clamp	78.69 %

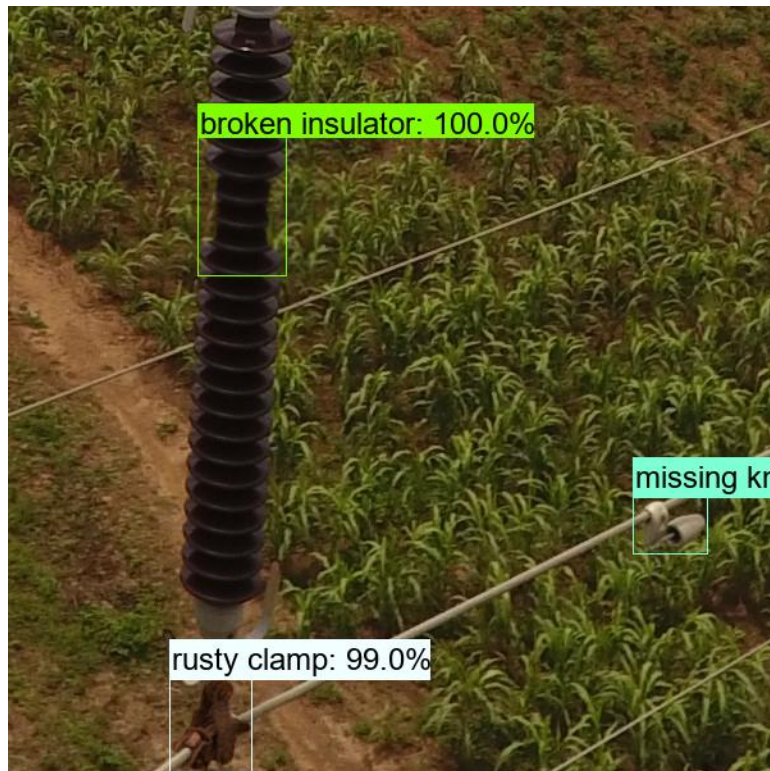
Fault Image Name: _DJI_654_2 - Copy.png

Fault Type	Severity
missing knob	93.78 %
broken insulator	77.01 %
rusty clamp	85.43 %

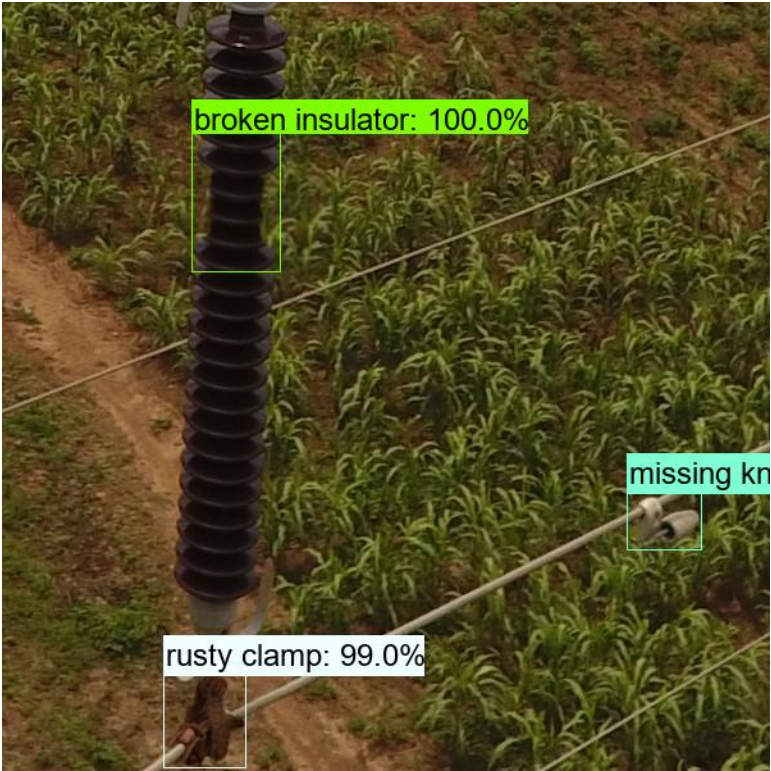
Fault Image Name: _DJI_654_2.png

Fault Type	Severity
missing knob	99.66 %
broken insulator	99.53 %
rusty clamp	99.26 %

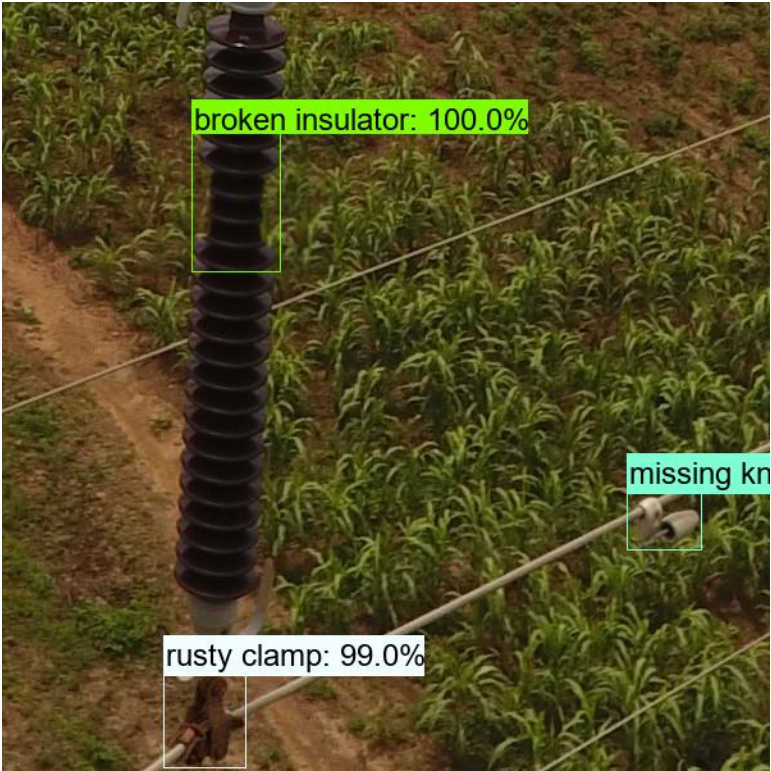
Fault Image Name: _DJI_655_2 - Copy - Copy.png

Fault Type	Severity
missing knob	100 %
broken insulator	95.45 %
rusty clamp	48.27 %

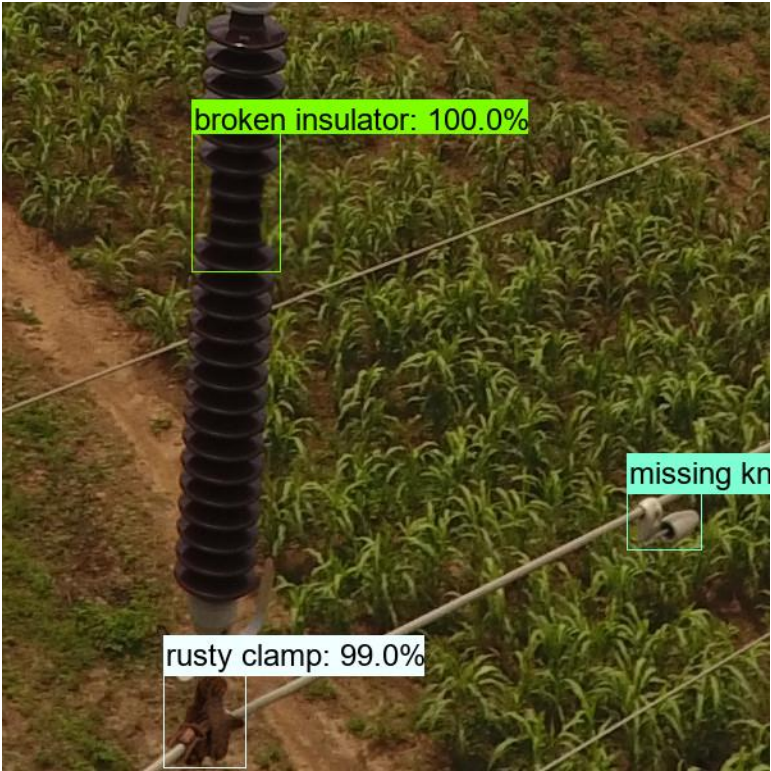
Fault Image Name: _DJI_655_2 - Copy.png

Fault Type	Severity
missing knob	92.45 %
broken insulator	97.54 %
rusty clamp	88.2 %

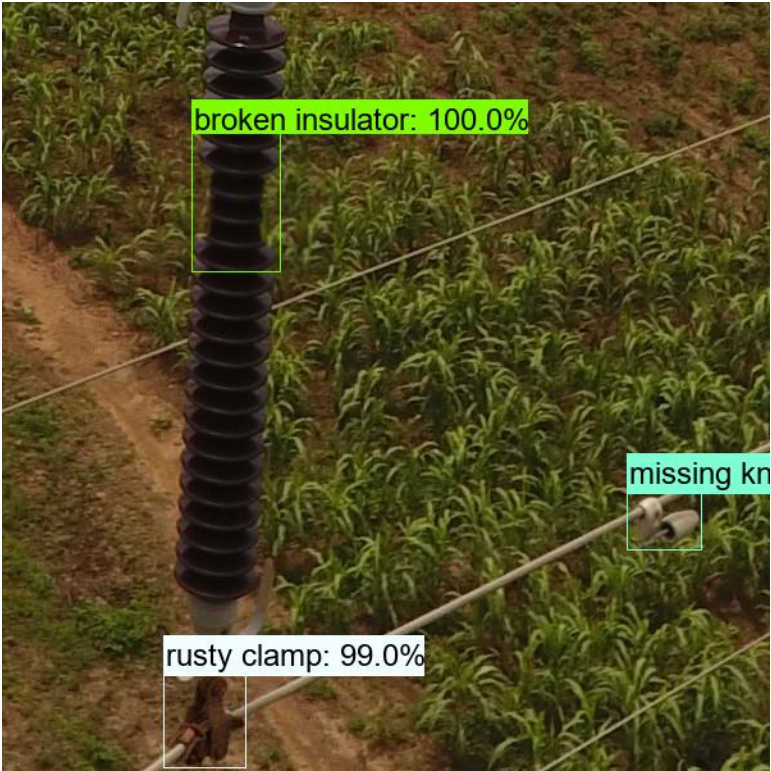
Fault Image Name: _DJI_655_2.png

Fault Type	Severity
missing knob	89.45 %
broken insulator	99.66 %
rusty clamp	80.64 %

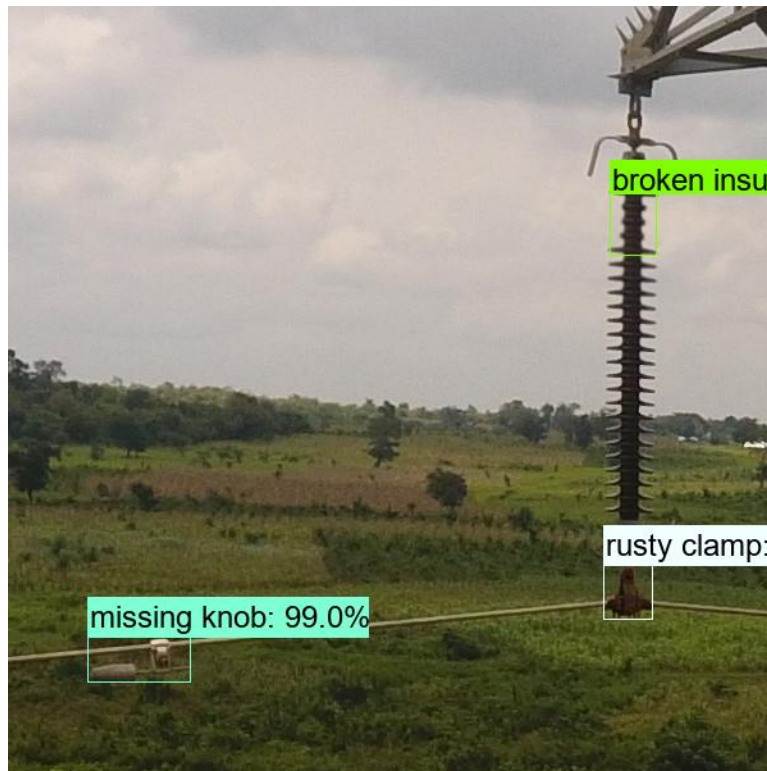
Fault Image Name: _DJI_656_3 - Copy - Copy.png

Fault Type	Severity
missing knob	90.56 %
rusty clamp	84.11 %
broken insulator	90.17 %

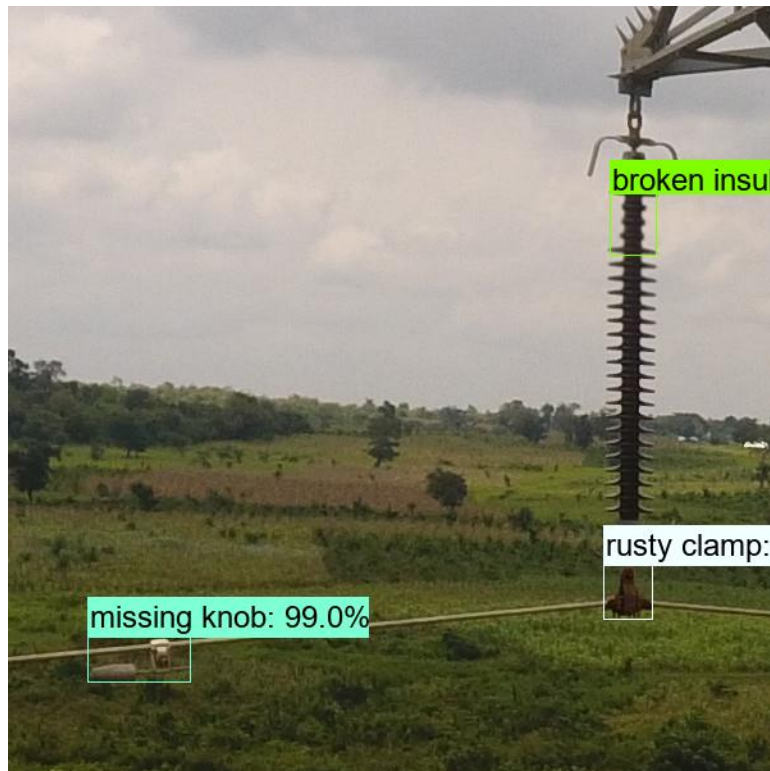
Fault Image Name: _DJI_656_3 - Copy.png

Fault Type	Severity
missing knob	99.68 %
rusty clamp	66.77 %
broken insulator	80.89 %

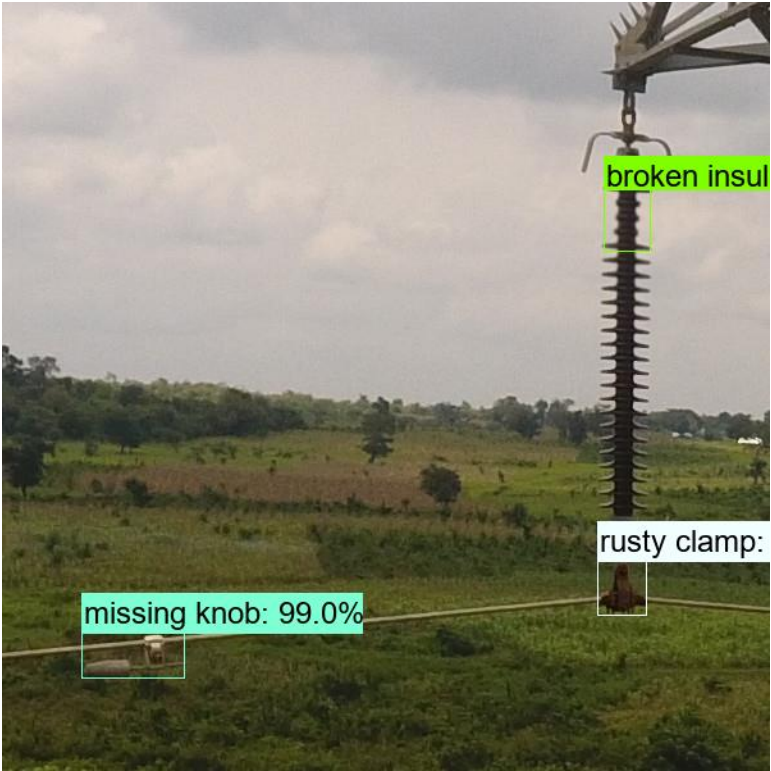
Fault Image Name: _DJI_656_3.png

Fault Type	Severity
missing knob	100 %
rusty clamp	98.31 %
broken insulator	78.31 %

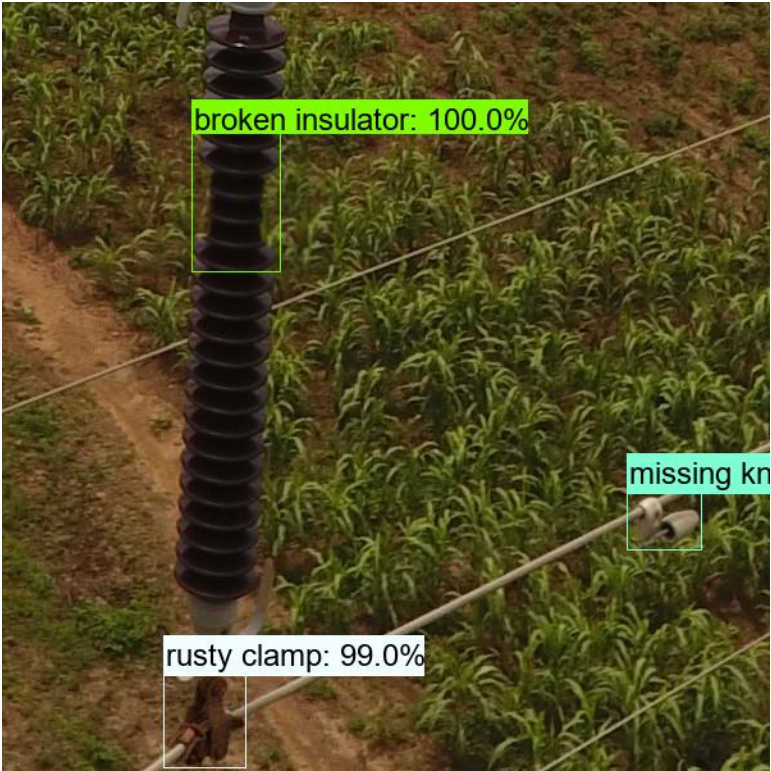
Fault Image Name: _DJI_657_2 - Copy - Copy.png

Fault Type	Severity
missing knob	86.54 %
broken insulator	88.64 %
rusty clamp	100 %

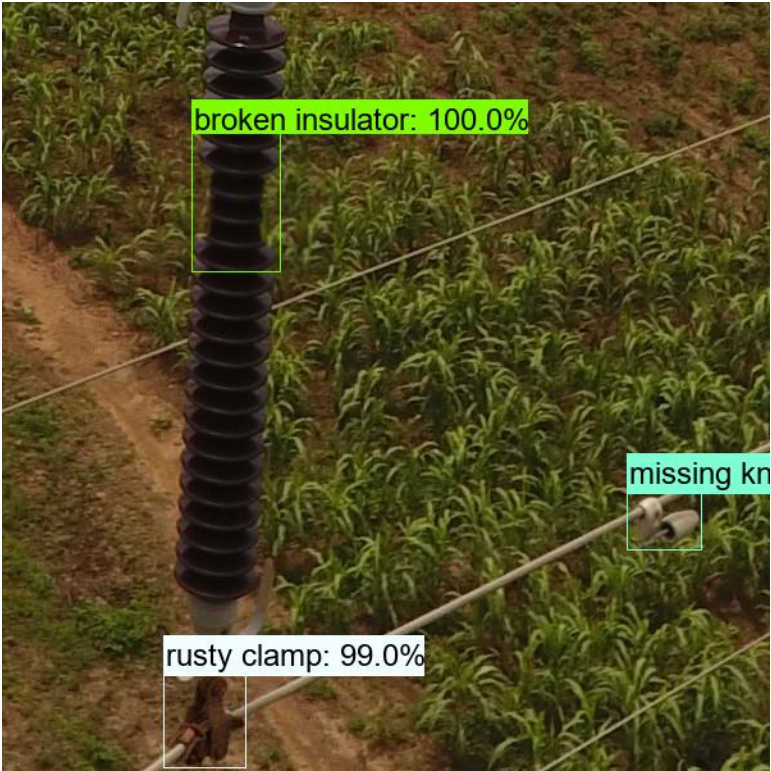
Fault Image Name: _DJI_657_2 - Copy.png

Fault Type	Severity
missing knob	92.54 %
broken insulator	89.45 %
rusty clamp	78.41 %

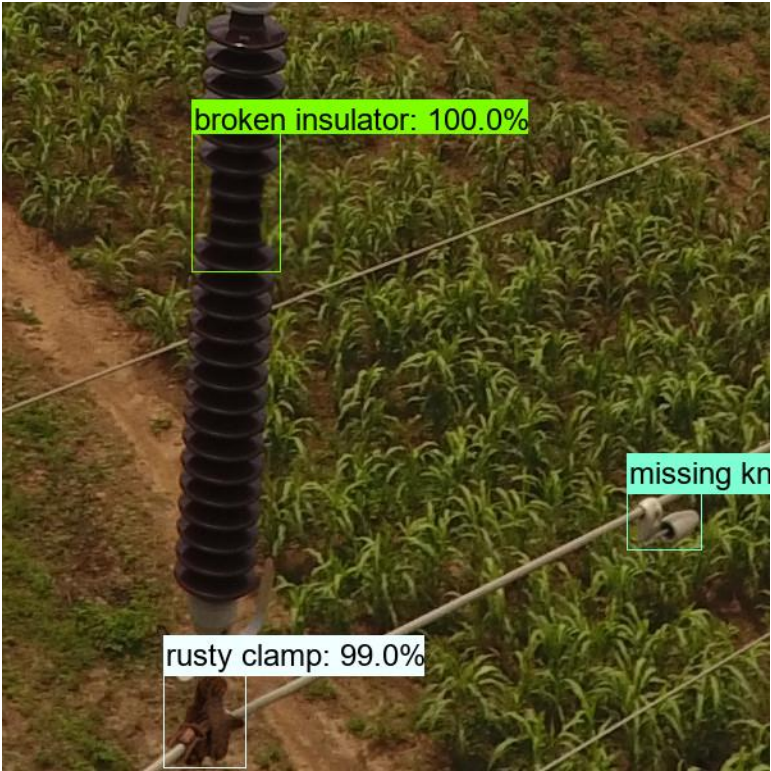
Fault Image Name: _DJI_657_2.png

Fault Type	Severity
missing knob	99.52 %
broken insulator	99.67 %
rusty clamp	99.87 %

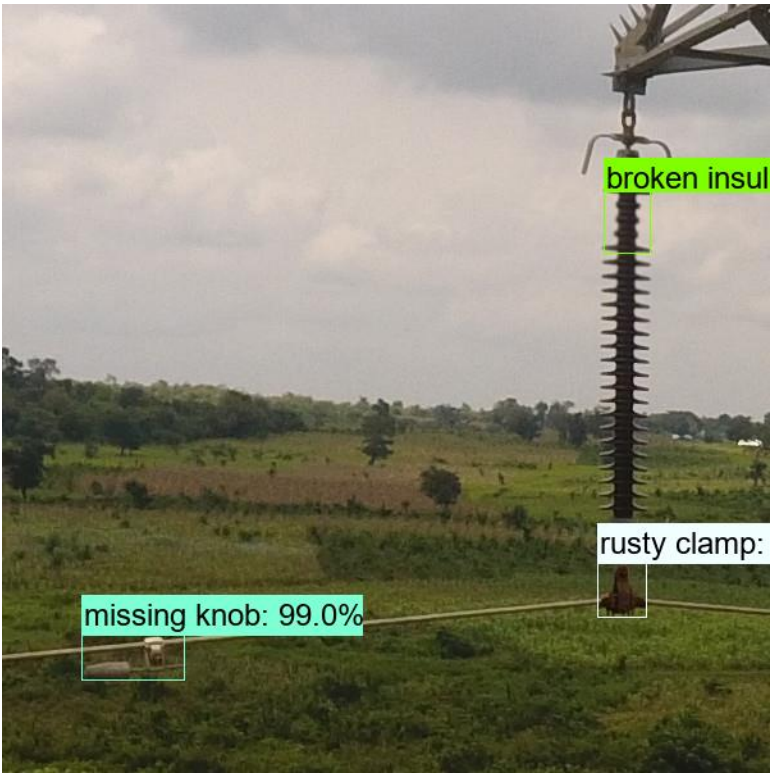
Fault Image Name: _DJI_658_3 - Copy - Copy.png

Fault Type	Severity
missing knob	89 %
rusty clamp	65 %
broken insulator	60.78 %

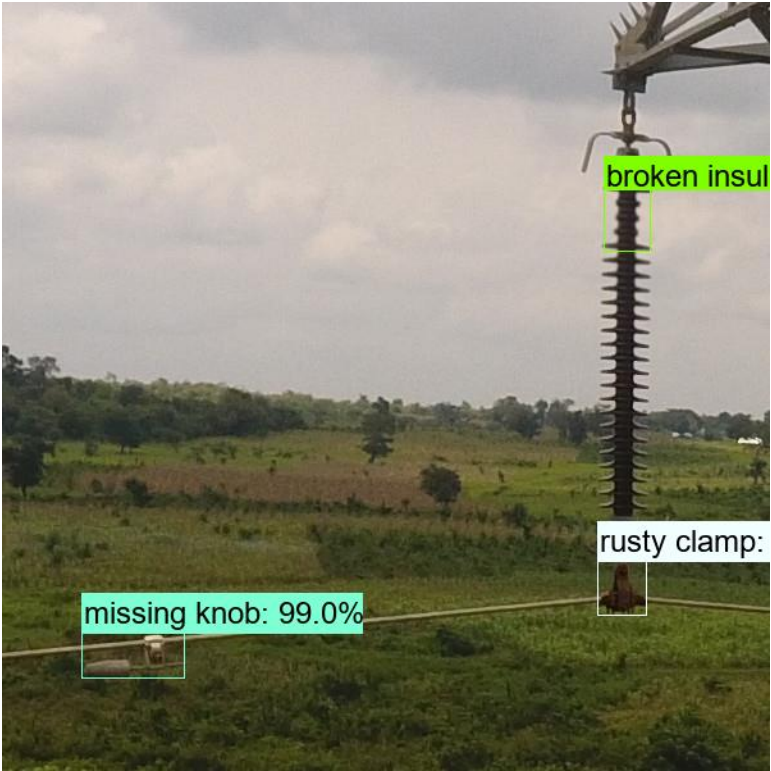
Fault Image Name: _DJI_658_3 - Copy.png

Fault Type	Severity
missing knob	89.78 %
rusty clamp	95.64 %
broken insulator	77.99 %

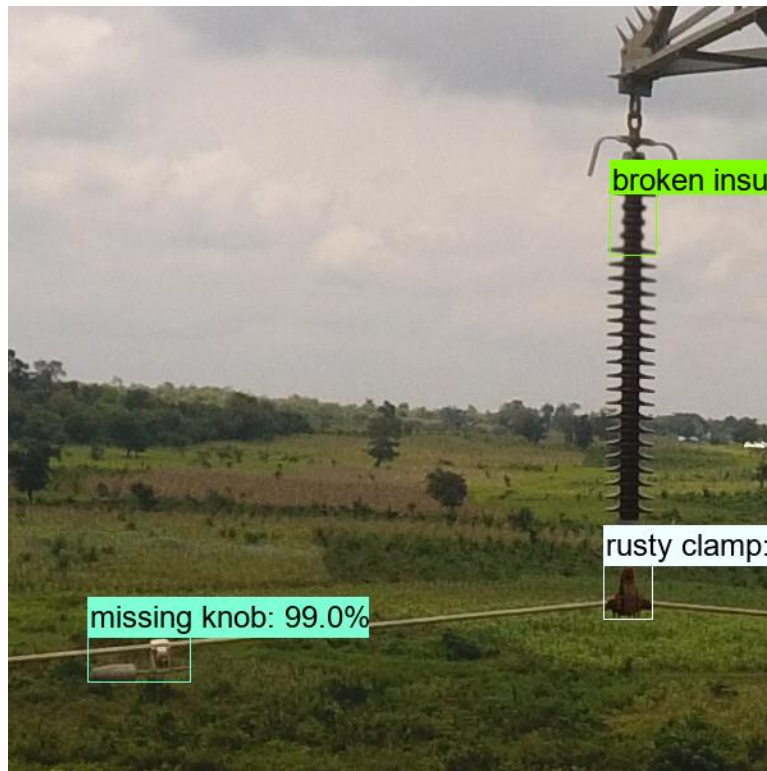
Fault Image Name: _DJI_658_3.png

Fault Type	Severity
missing knob	89.12 %
rusty clamp	89.13 %
broken insulator	63.47 %

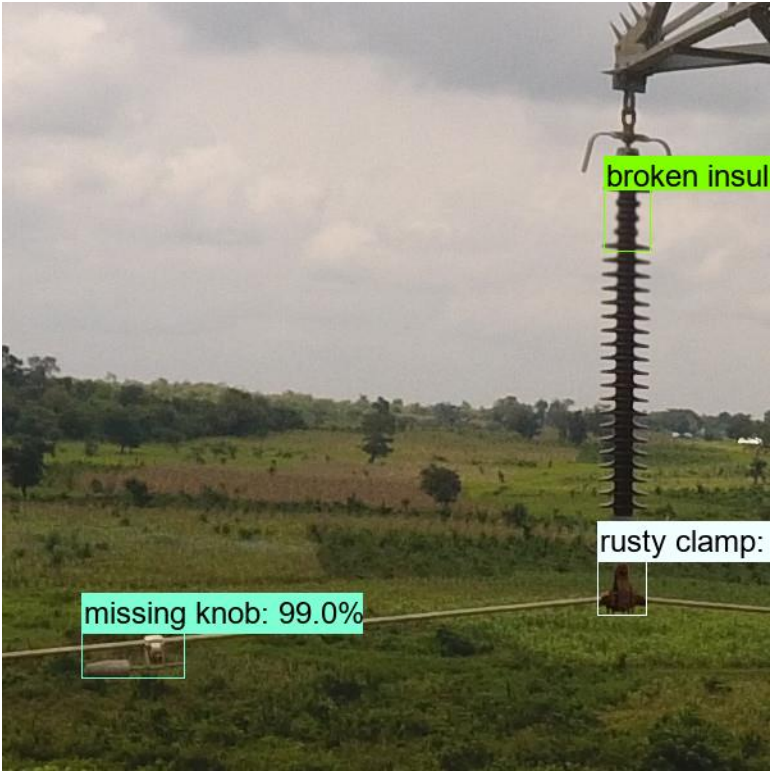
Fault Image Name: _DJI_659_3 - Copy - Copy.png

Fault Type	Severity
missing knob	89.65 %
rusty clamp	89 %
broken insulator	61.24 %

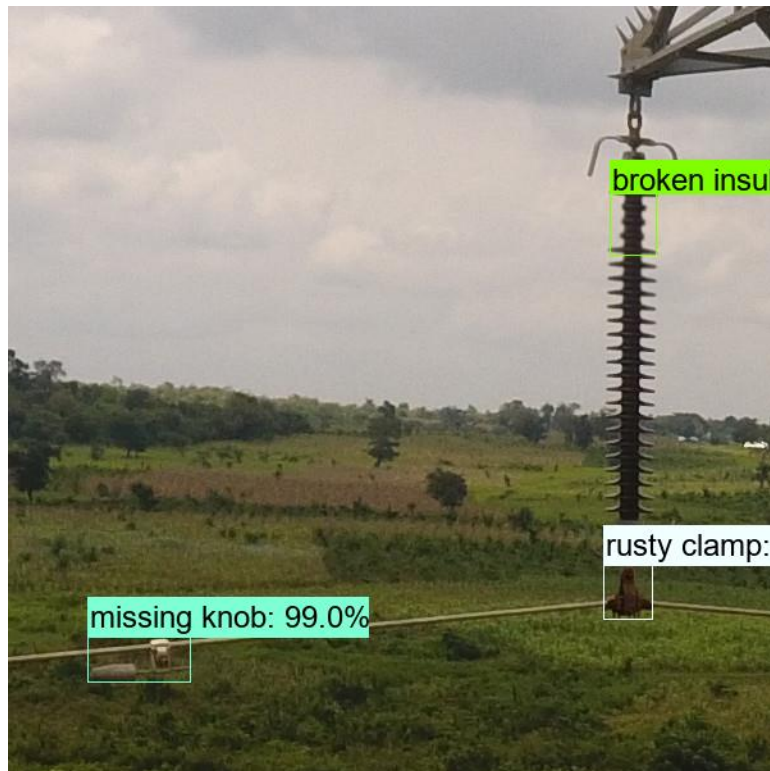
Fault Image Name: _DJI_659_3 - Copy.png

Fault Type	Severity
missing knob	96.22 %
rusty clamp	93.65 %
broken insulator	78.45 %

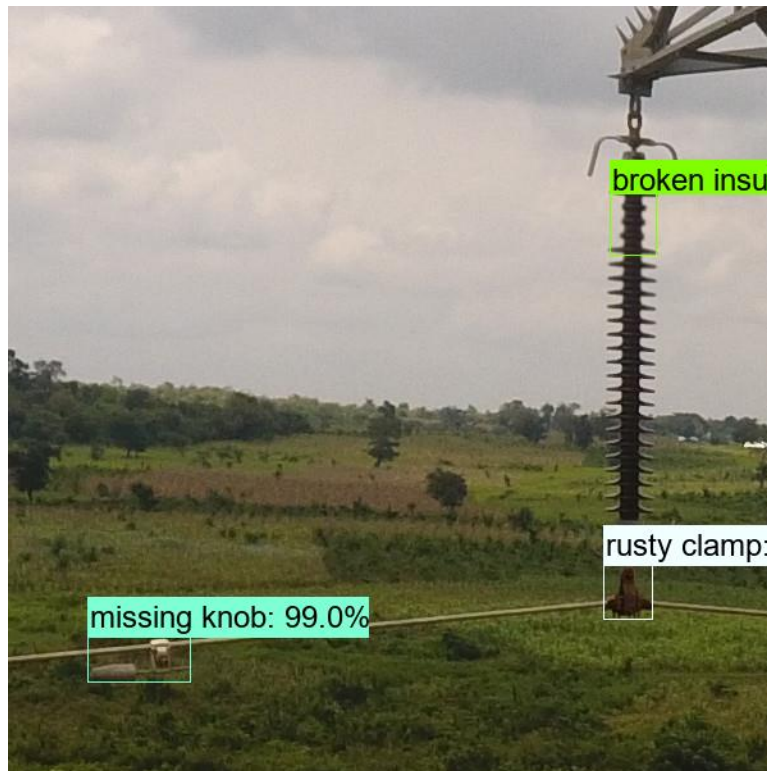
Fault Image Name: _DJI_659_3.png

Fault Type	Severity
missing knob	97.55 %
rusty clamp	91.25 %
broken insulator	94.63 %
