NORTHERN CORRIDOR
TRANSIT AND TRANSPORT
COORDINATION AUTHORITY

SURVEY REPORT ON PRIORITY BLACK SPOTS ALONG THE NORTHERN CORRIDOR ROUTE IN KENYA

February 2020

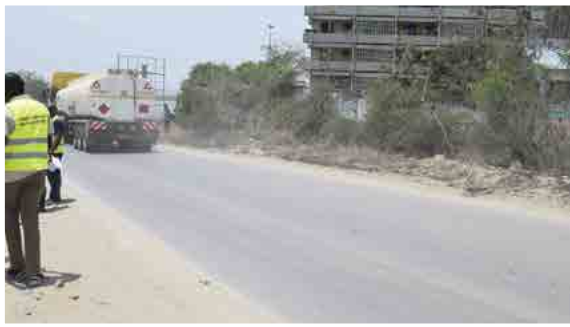
Figure 2: Missing road markings at Makupa Causeway

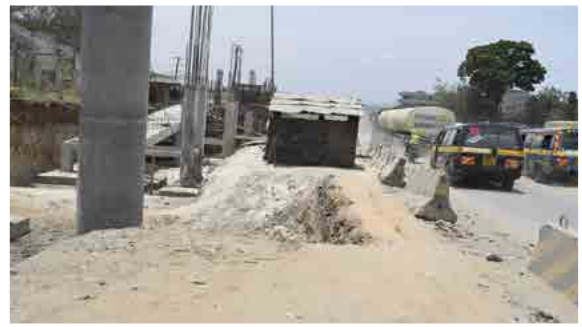
Figure 5: Site management concerns at the ongoing footbridge construction (Unsecured excavation)

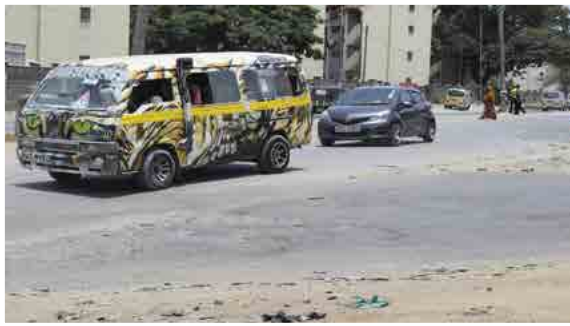
Figure 3: Deteriorated road surface at Makande Junction

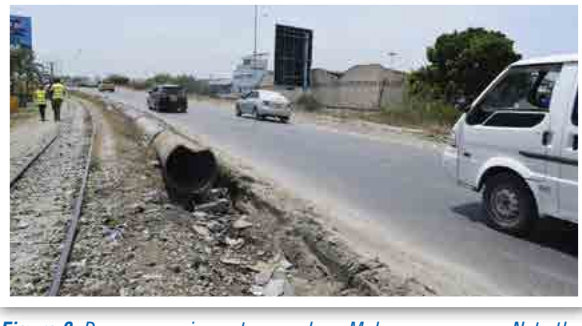
Figure 6: Dangerous pipe outcrops along Makupa causeway. Note the close proximity between the carriageway and railway line

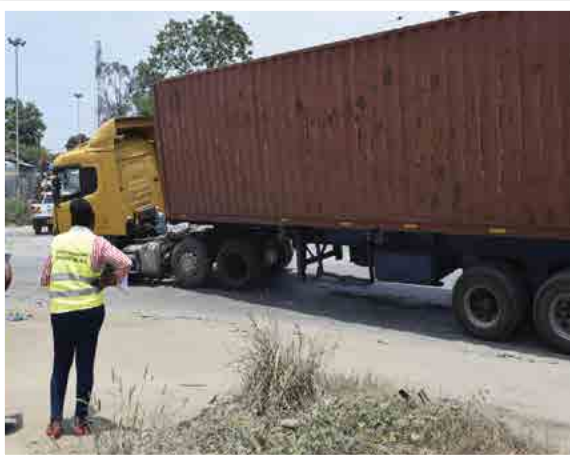
Figure 4: Insufficient turning radius for heavy trucks at Makande Junction

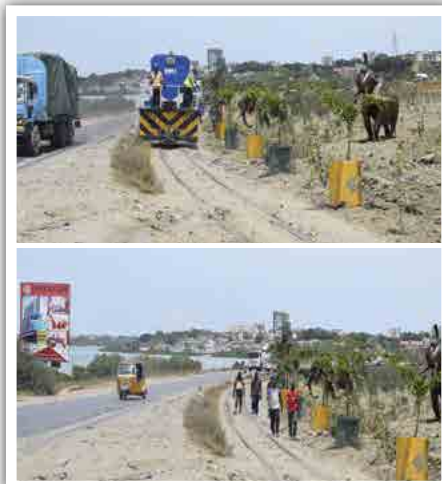
Figure 7: Absence of a barrier between the road and railway line posing a safety hazard to pedestrians.

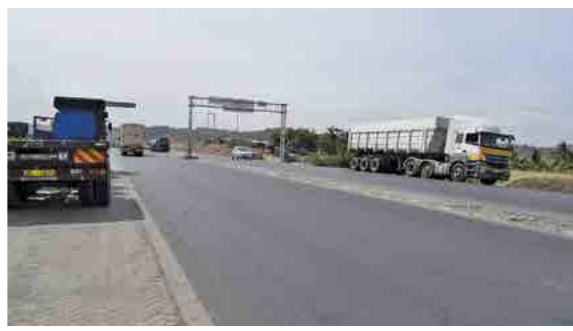
Figure 8: Faded road markings

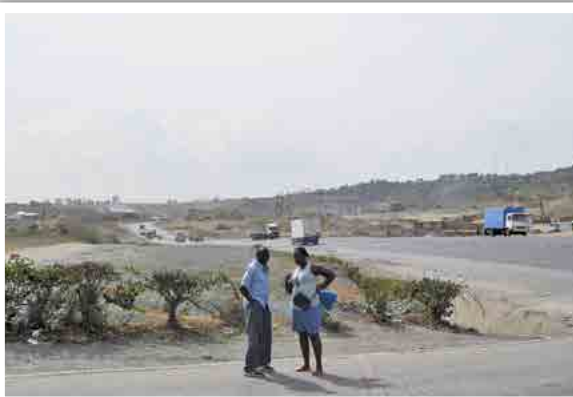
Figure 9: Successive combination of horizontal and vertical curves

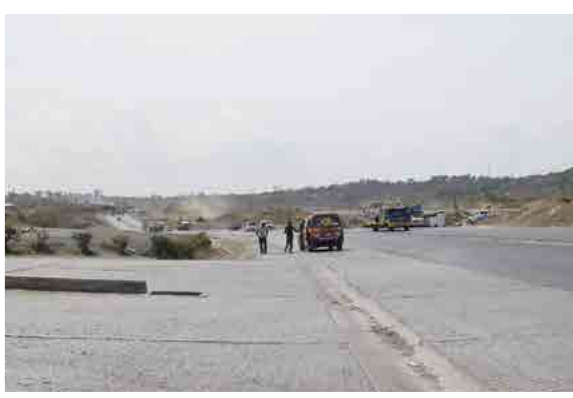
Figure 10: Picking up/dropping off of passengers at non-designated locations (no provision for a bus bay)

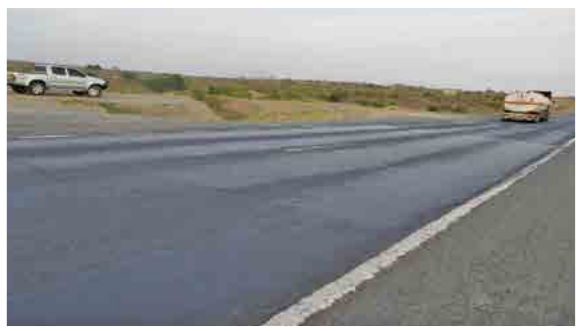
Figure 11: Bleeding road surface

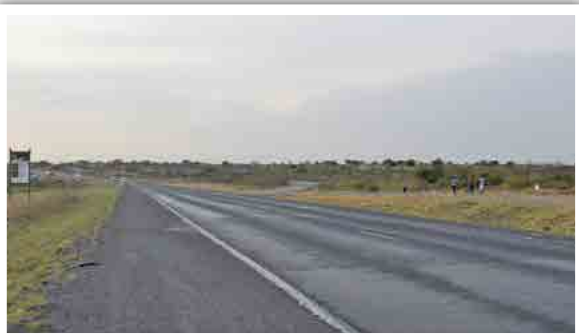
Figure 12: Deep open drains too close to the carriageway

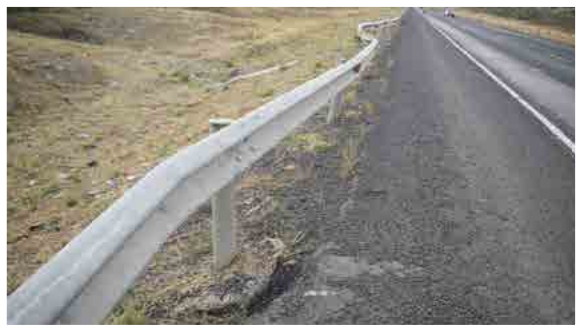
Figure 13: Damaged safety fences/guard rails

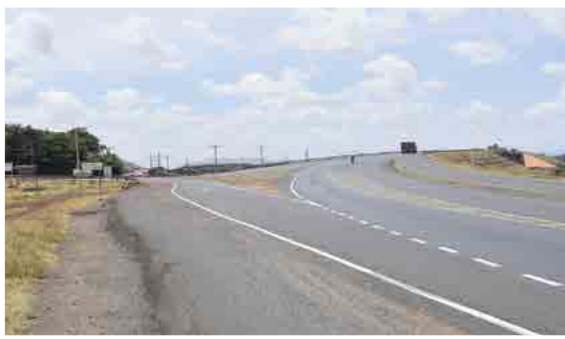
Figure 14: Unsafe configuration at Emali/Oloitoktok Junction

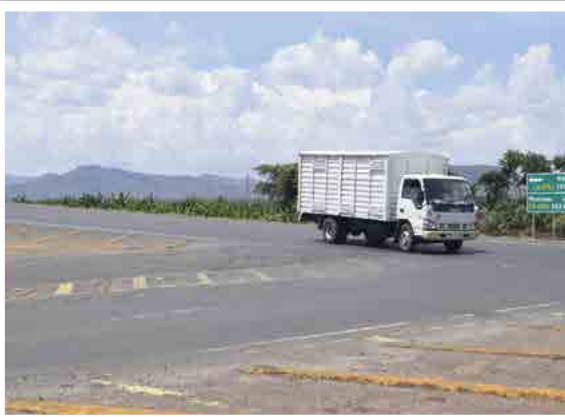
Figure 15: Lorry exiting towards Oloitoktok from the A8 Highway (note the skid marks indicating difficulties when making the turn)

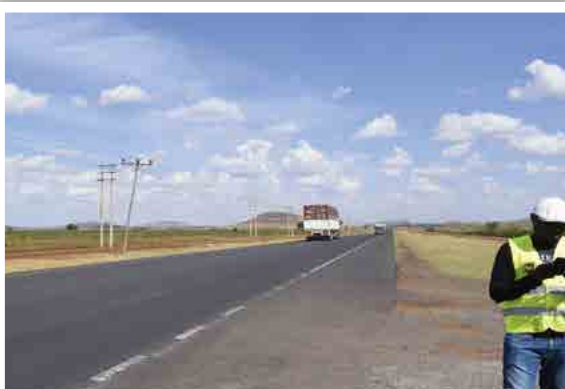
Figure 16: Long and straight stretch along Pipeline area. Faded road markings at the stretch also observed

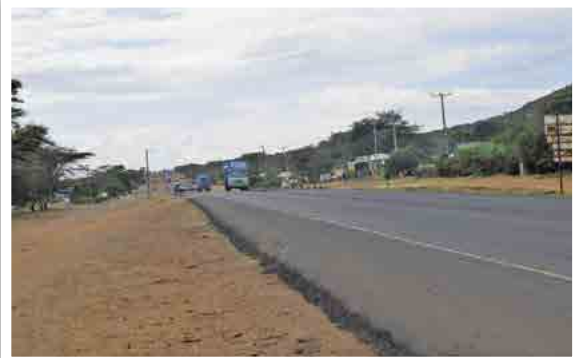
Figure 17: Kalimbini area (Long and straight stretch with a slight descent from the Nairobi side prompting motorists to overspeed and overtake recklessly)

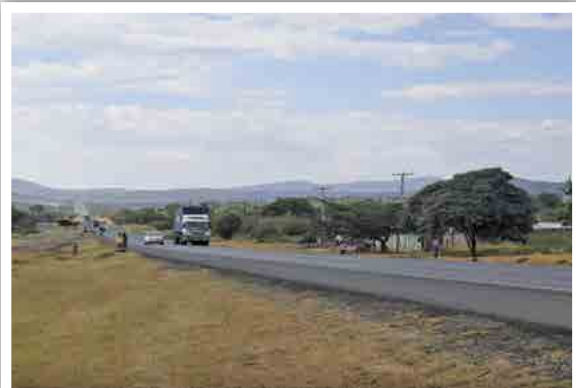
Figure 18: Ngokomi shopping centre (Long and straight stretch with gently sloping approaches on either side)

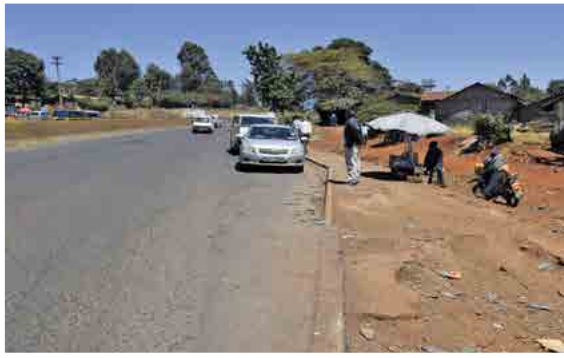
Figure 19: Dangerous location of the Nairobi bound bus bay

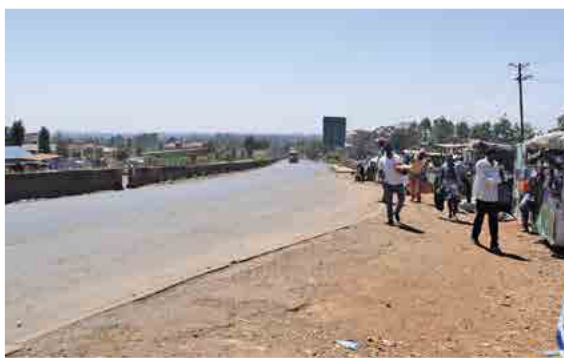
Figure 20: Encroachment of the road reserve by vendors/hawkers

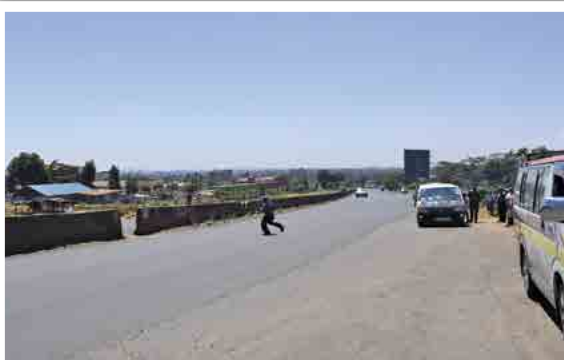
Figure 21: Rushing pedestrian crossing at a non-designated location

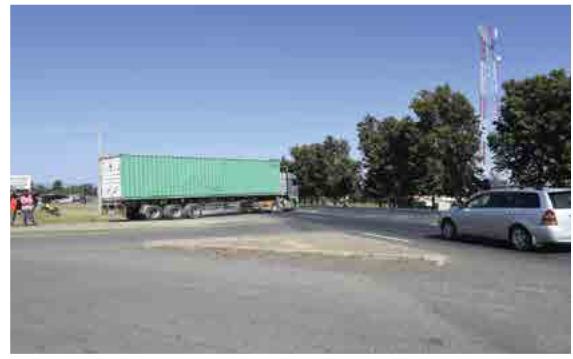
Figure 22: Heavy truck joining the A8 Highway from Njoro (note the narrow turning radius).

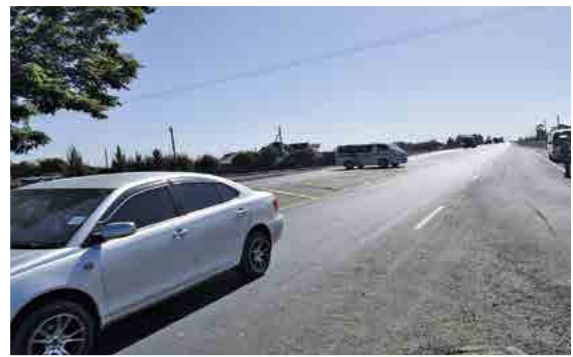
Figure 23: Matatu joining Eldoret bound traffic from Menengai

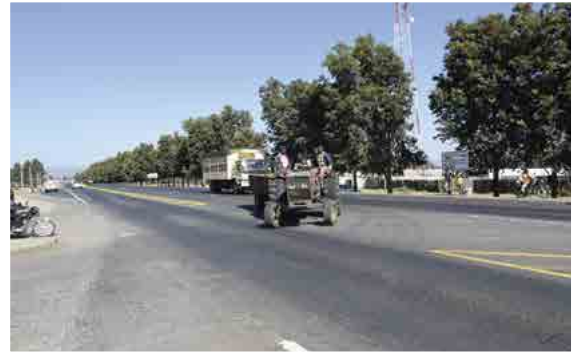
Figure 24: Lack of a provision for an accelerating lane for Eldoret bound traffic from Njoro

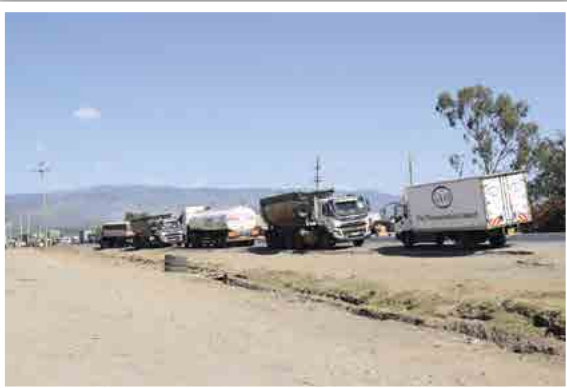
Figure 25: Heavy trucks parked on the shoulders effectively narrowing the carriageway and impairing visibility for other road users

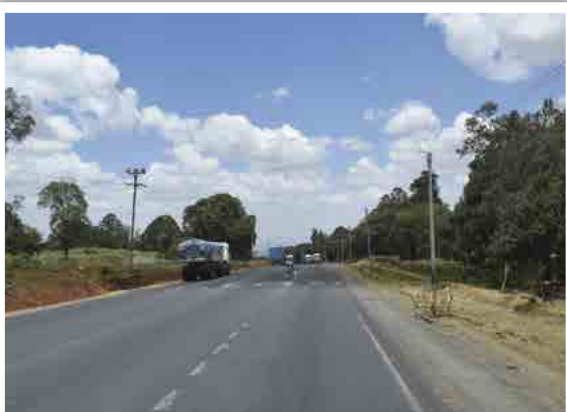
Figure 26: Hawkers/vendors selling their products on the carriageway around Sachangwan area oblivious of the safety hazards

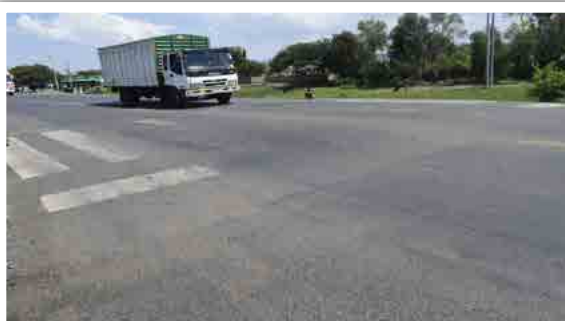
Figure 27: Faded road markings at a pedestrian crossing

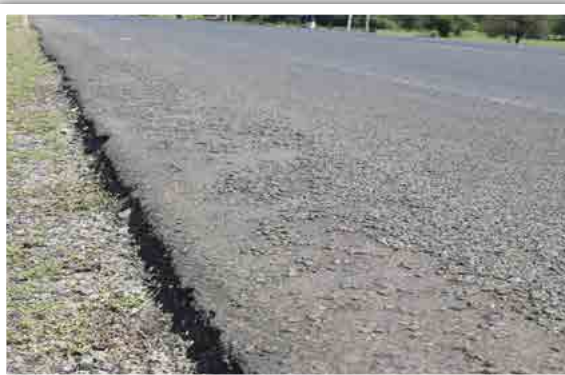
Figure 28: Hanging road shoulders

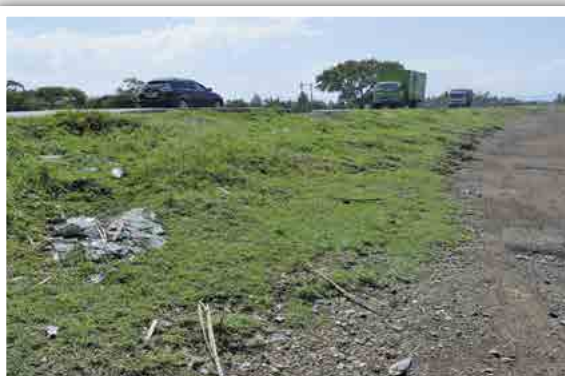
Figure 29: Missing safety fences on a high steep-sloped embankment

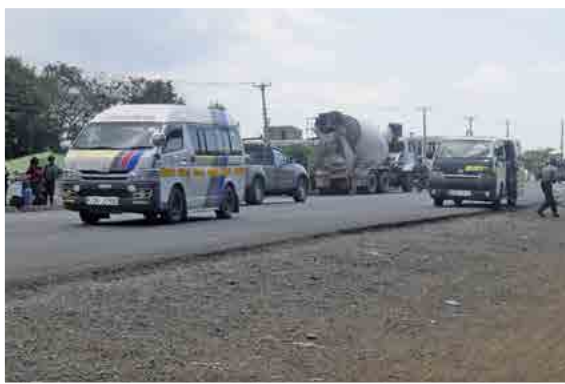
Figure 30: Dropping off/picking up of passengers at non-designated locations despite provision for a bus bay a few metres away

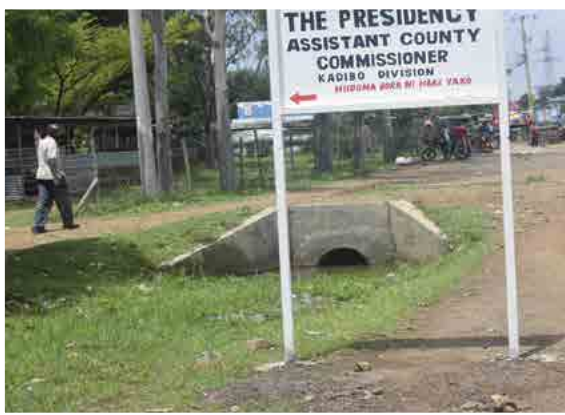
Figure 31: Silted/blocked access culvert

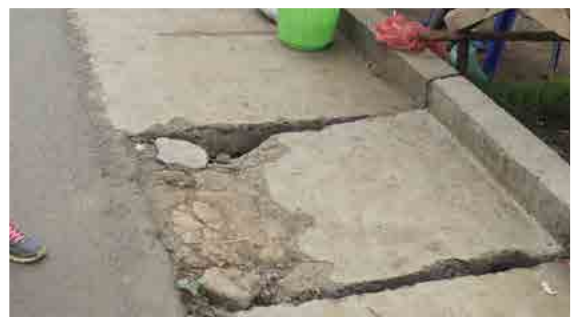
Figure 32: Damaged slab over a covered storm water drain

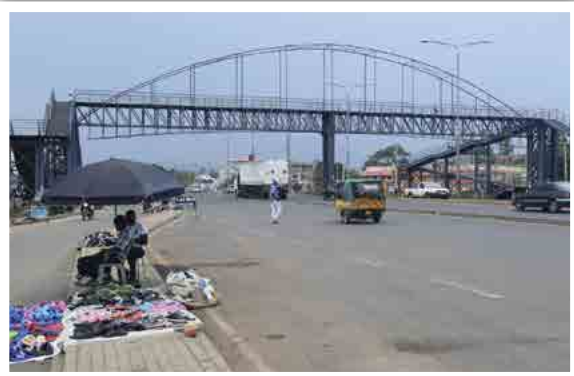
Figure 33: Pedestrian dangerously crossing the highway at grade despite provision of a footbridge

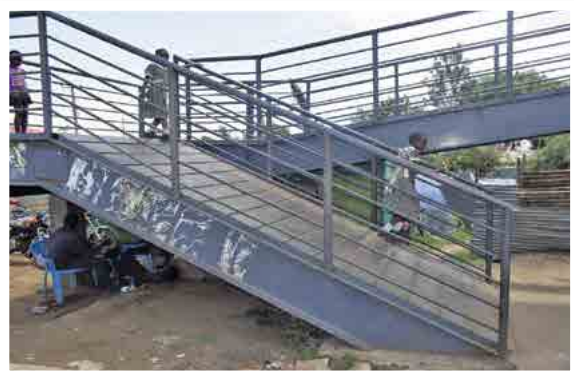
Figure 34: An abnormally steep ramp on the footbridge
