Date:	31/10/2025
Day:	Friday
Start:	6:00
Finish:	18:30

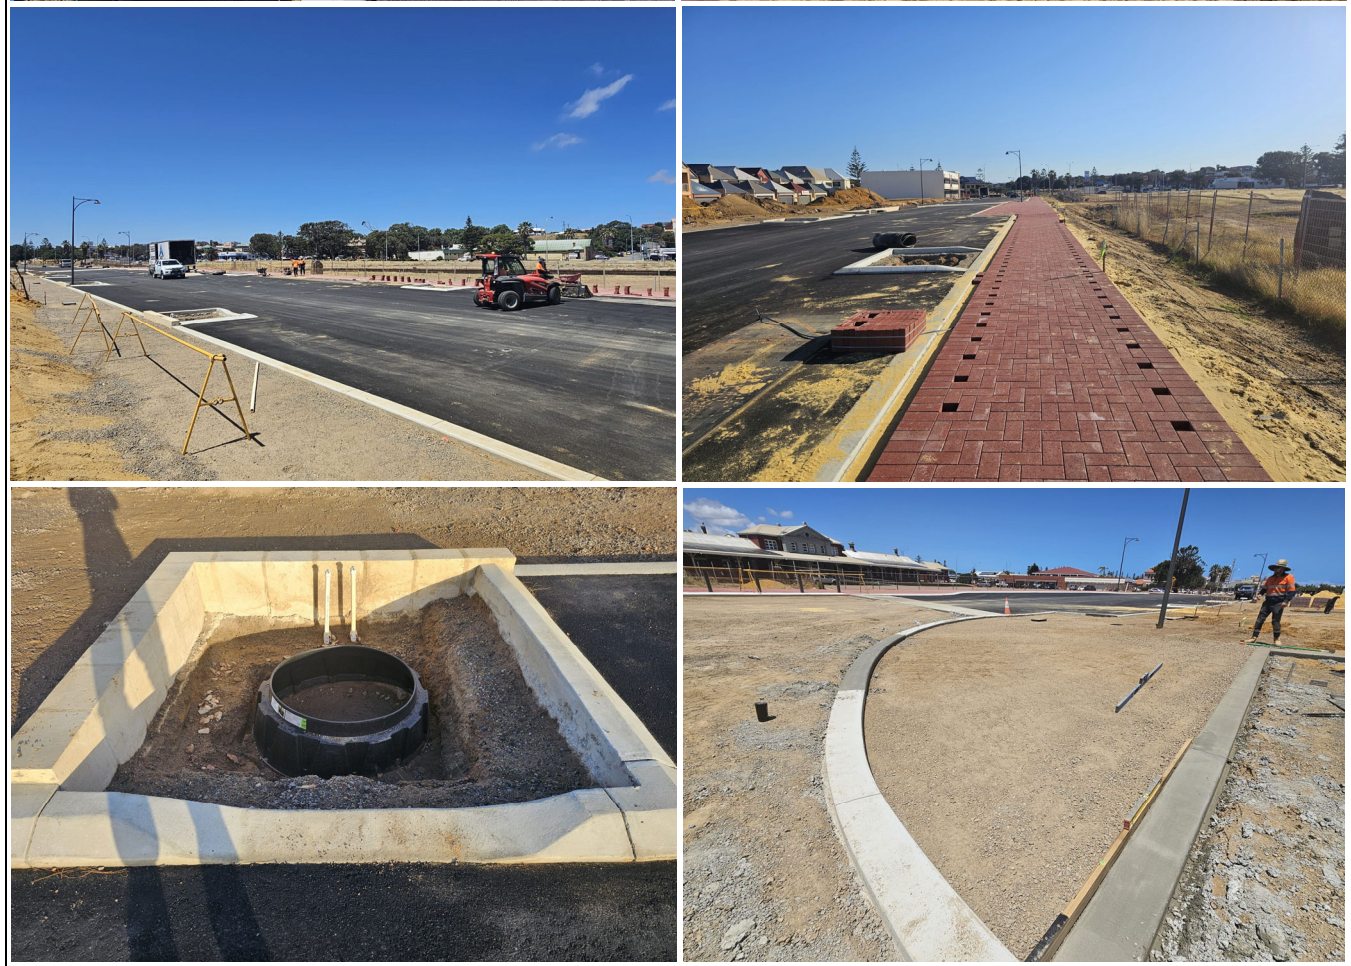
Flushing or irrigation lines is ongoing. Remaining to be completed on Monday.
Installation of Paver along NE completed and section tidy up is ongoing
Electrical pits raised to correct levels
Placement of root deflector in tree pits is ongoing
Ground Prep for paving is ongoing
