Stellaris® LM3S9B92 RevC Errata

This document contains known errata at the time of publication for the Stellaris® LM3S9B92 microcontroller. The table below summarizes the errata and lists the affected revisions. See the data sheet for more details.

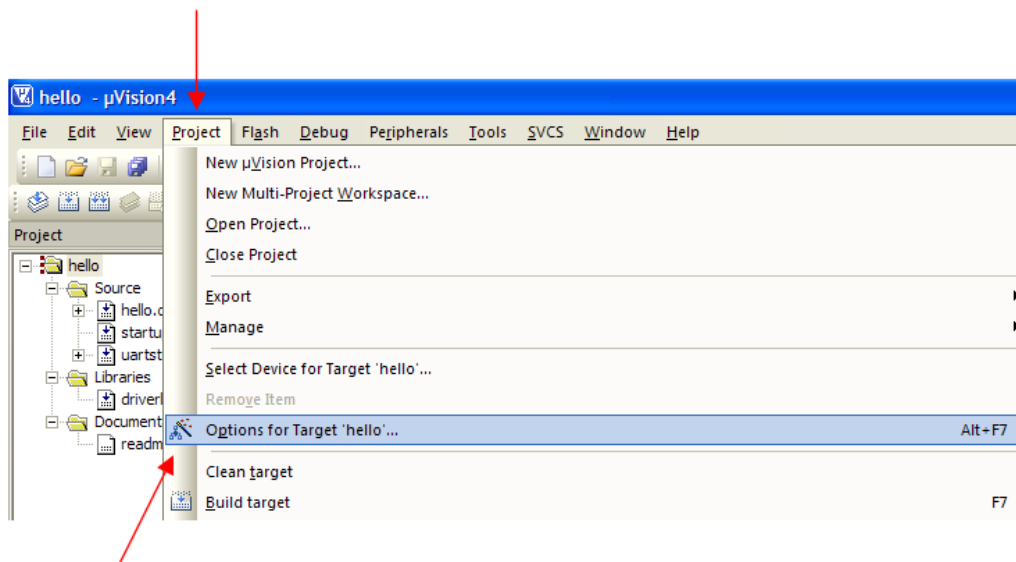
Figure A-1. Navigating to the “Run to Main()” Option

If the debugger is configured to simply reset/connect, it attempts to disassemble code in a protected region of Flash memory. The simple solution is to configure the debugger to “load/run to main”. With this configuration, the patch code gets run and the Flash interrupt gets enabled. The PC runs to the main() function when the debugger starts. This option can be found in: Project □ Options for target '<project name>' as shown in Figure A-1 on page 16.

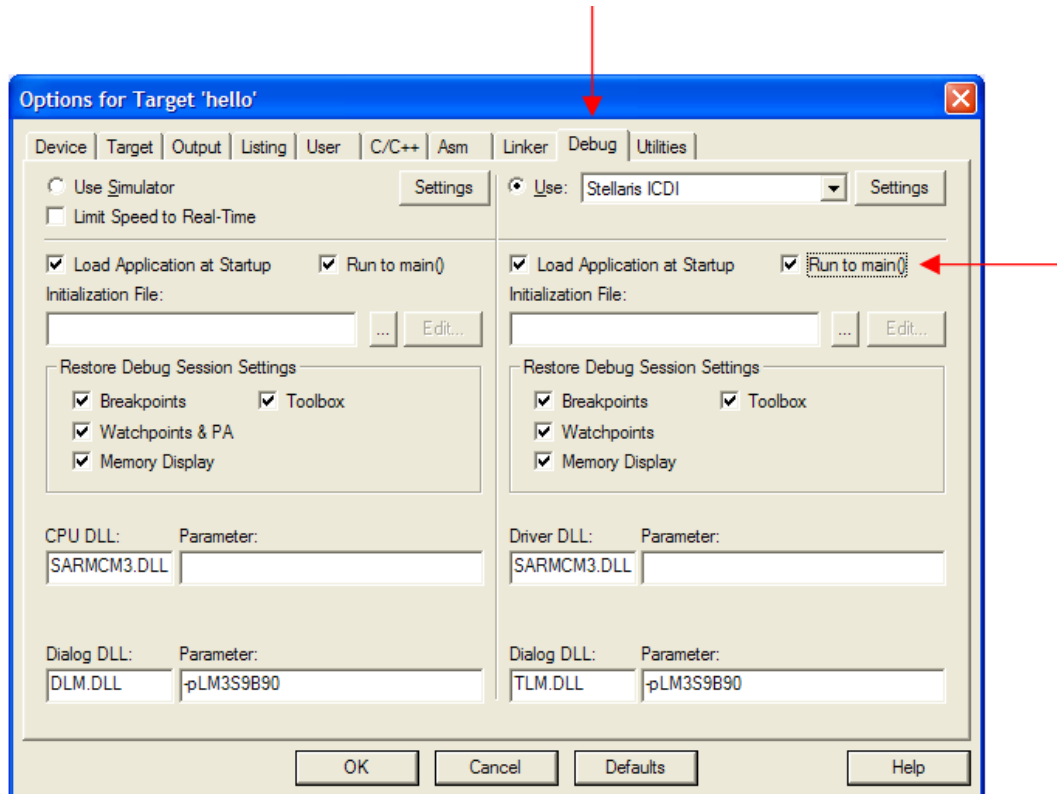
Figure A-2. Selecting the "Run to Main()" Option

When the Options window opens, select the Debug tab. Under Debug select “Run to main()” as shown in Figure A-2 on page 17.

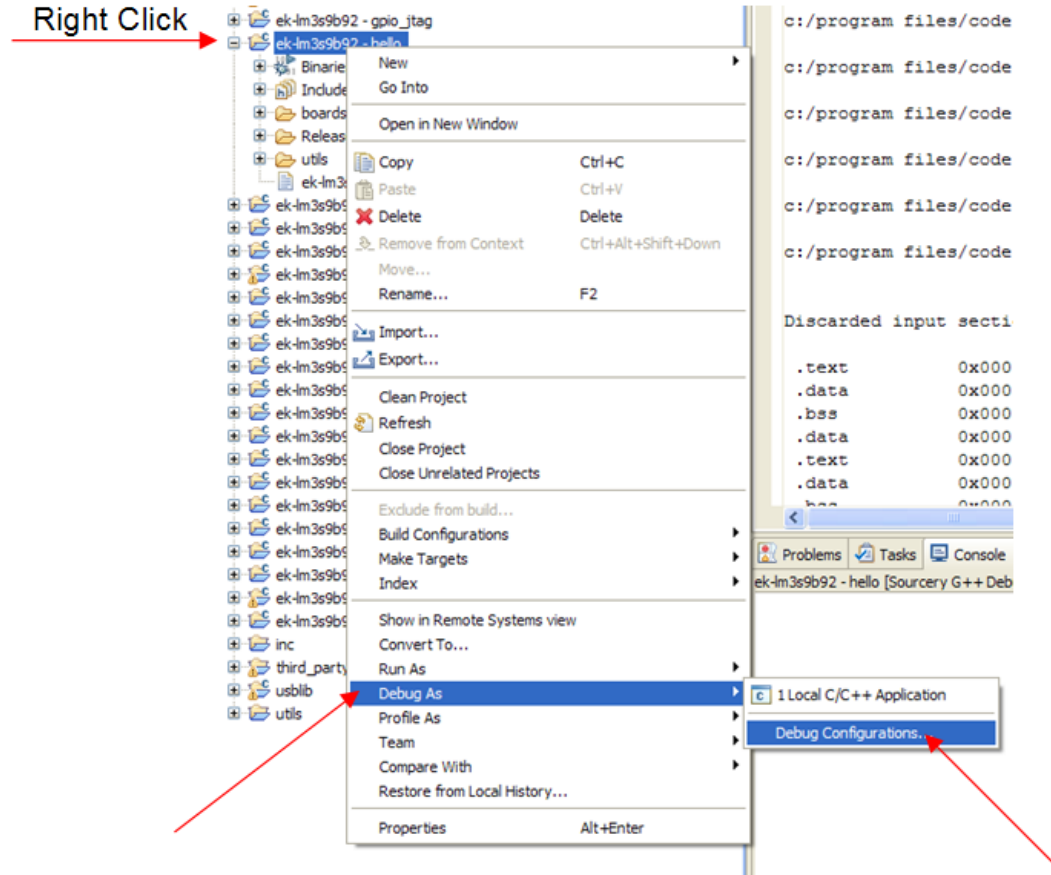
Figure A-3. Navigating to the Debugger Configurations Window

CodeSourcery does not run the patch code by default; it starts at the main() function. To get the patch code to run, manually set the stack pointer (SP) and program counter (PC). These register can be set by accessing the "Debugger Configurations..." tab. To do this, right click on the project and select Debug As ☐ Debug Configurations as shown in Figure A-3 on page 18.

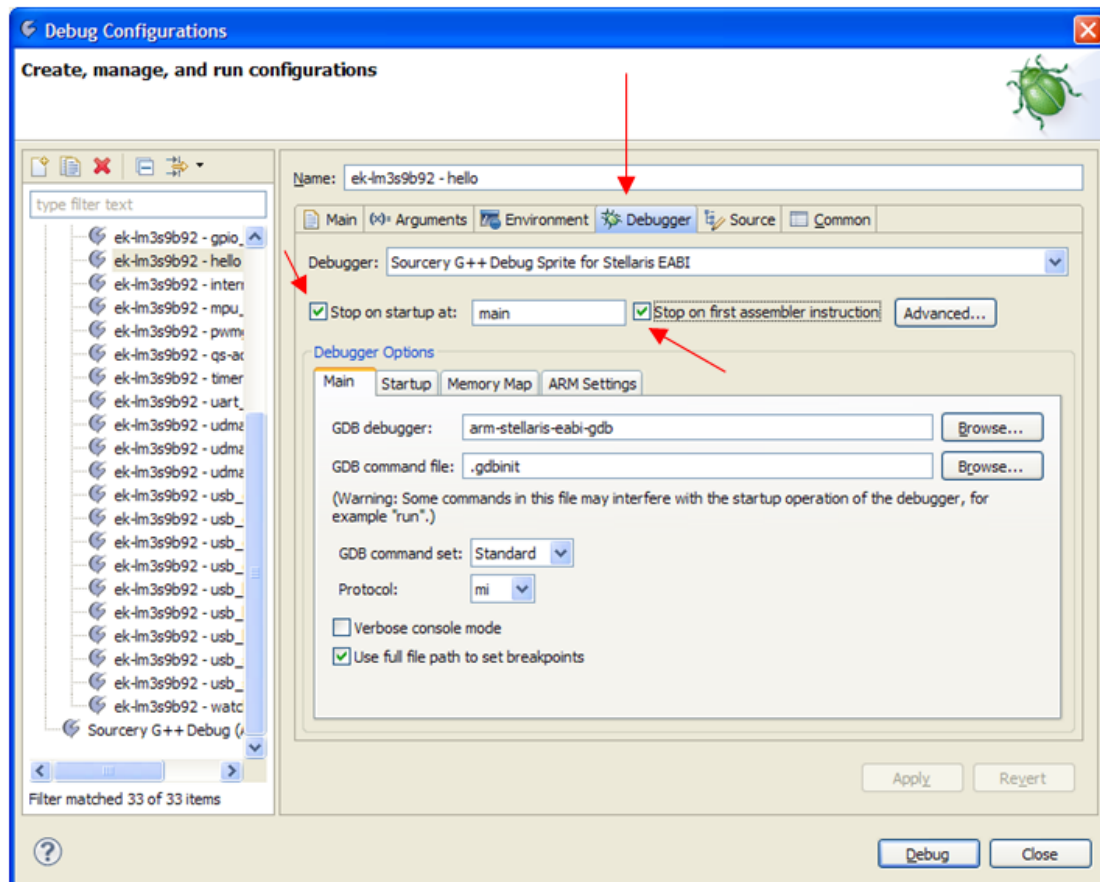
Figure A-4. Configuring the Debugger for Correct Operation

Once the “Debugger Configurations” window is up, select the “Debugger” tab and check “Stop on startup at:” and enter “main” in the text box; also check “Stop on first assembler instruction” as shown in Figure A-4 on page 19.

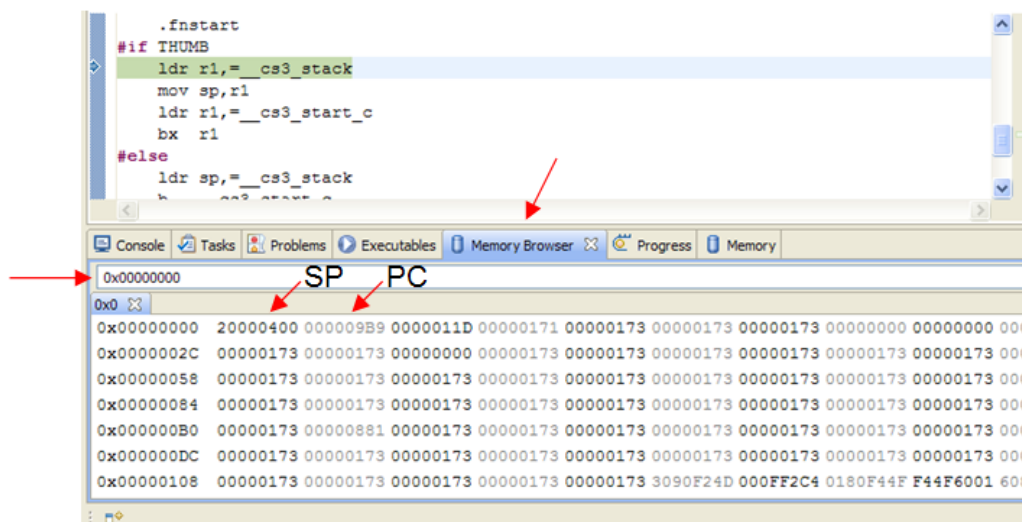
Figure A-5. Finding the Proper SP and PC to Use

Once the debugger is started, go to the “Memory Browser” window at the bottom of the screen and enter address 0x00000000. The first 2 locations show you the SP and PC for the patch as shown in Figure A-5 on page 20.

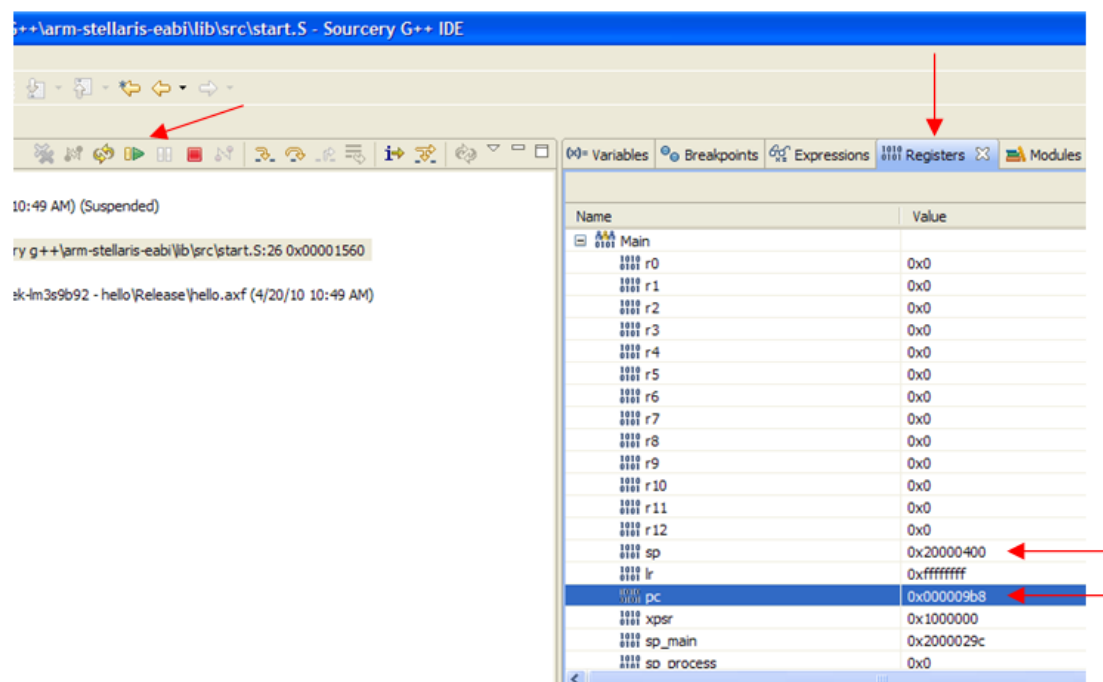
Figure A-6. Entering the SP and PC Manually

Go to the “Registers” tab and enter these values for the SP and PC manually as shown in Figure A-6 on page 20.

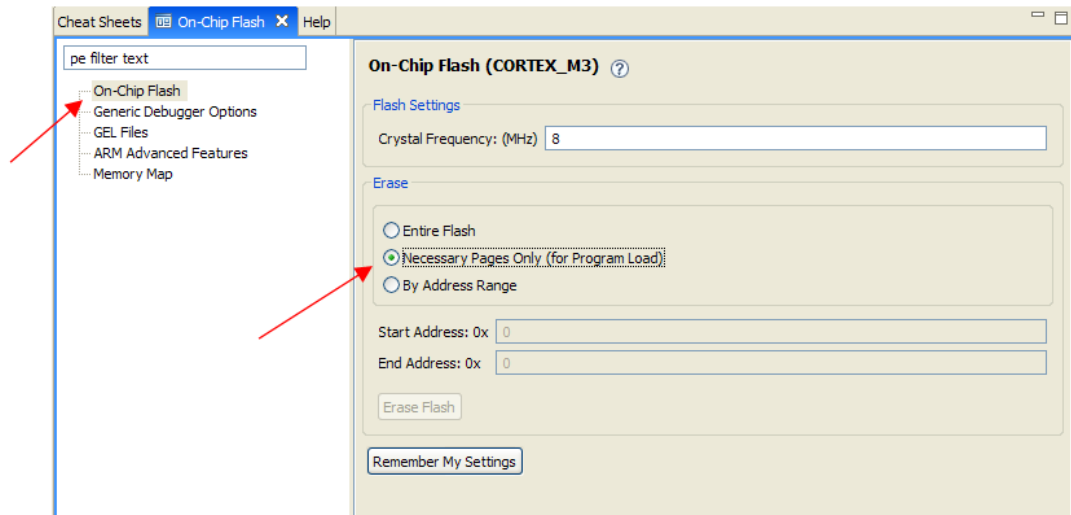
Figure A-7. Changing the Flash Erase Option

CCS does not work by default - it hangs when the debugger loads because the default flash erase option is mass erase (which won't work because the patch code is write protected). The flash erase option must be changed to page erase. To do this, start a debug session (even though it won't work correctly) to get access to the Flash settings. Once in the debug session, go to Tools ▢ On-Chip Flash then under Erase select "Necessary Pages Only (for Program Load)" as shown in Figure A-7 on page 21.

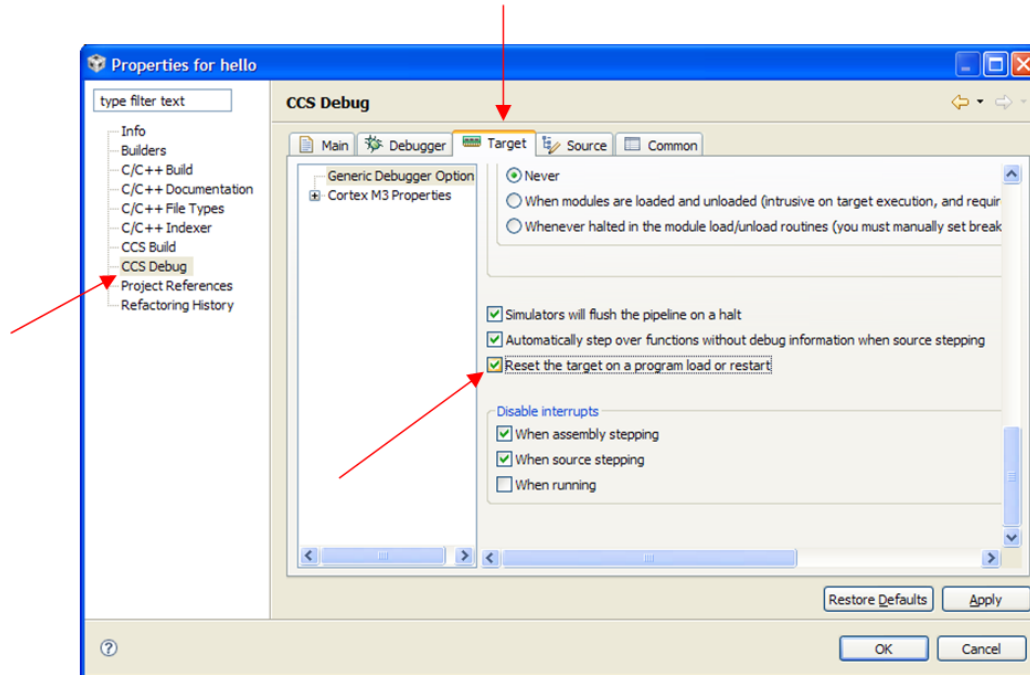
Figure A-8. Configuring the IDE to Reset on Program Load

To get the patch code to run, a "Core Reset" must be executed in the IDE. Go to Target ▢ Reset ▢ Core Reset to reset the core, which results in the patch code being run. To configure the IDE to perform a core reset automatically, go to Target ▢ Properties and on the left hand side of the window select CCS Debug. Once you select CCS Debug click on Target on the right hand side of the window. Scroll down until you see an option that says "Reset the target on program load or restart" and select it as shown in Figure A-8 on page 22.

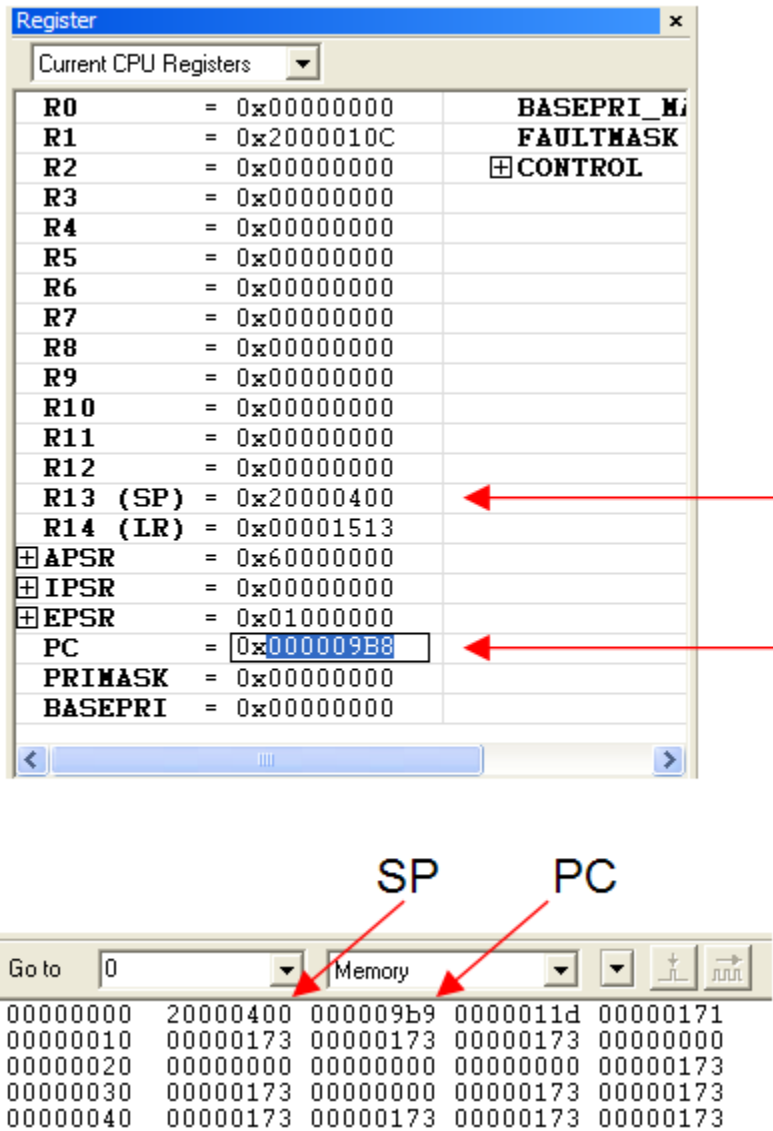
Figure A-9. Manually Configuring the PC and SP Registers

IAR has problems executing code at address 0x0000.0000 if it is not the main() application (such as bootloader examples). As a result, the PC and SP must be manually loaded. The values to load can be found at address 0x0000.0000 and 0x0000.0004 in the memory window and loaded into the PC (0x000009B8) and SP (0x20000400) as shown in Figure A-9 on page 23.
